# Managing Mississippi and Ohio River Landscapes

Kenneth R. Olson and Lois Wright Morton

Soil and Water Conservation Society  
Ankeny, Iowa

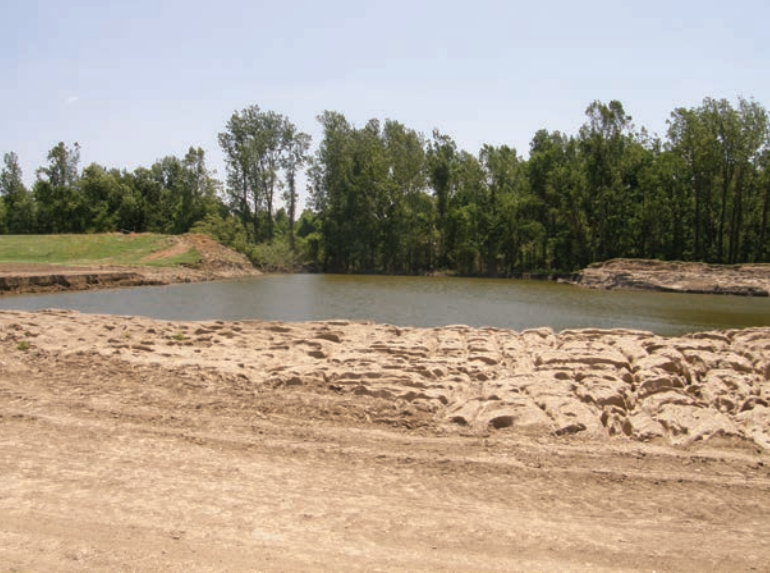
**FIGURE 1.1** The Birds Point levee breach created a crater lake that extended many feet through the levee.

flows, and the bottomlands that are sources of wealth and risk to those whose lives are intertwined with the rivers. They illustrate levee-protected agriculture and breach management when the river exceeds flood stage (figure 1.1); dredging in drought to assure a navigable channel; and locks, dams, aqueducts, and reservoirs engineered to tame the two great rivers and their tributaries for human uses. Collectively these chapters portray the multifunctional value of the rivers and human attempts

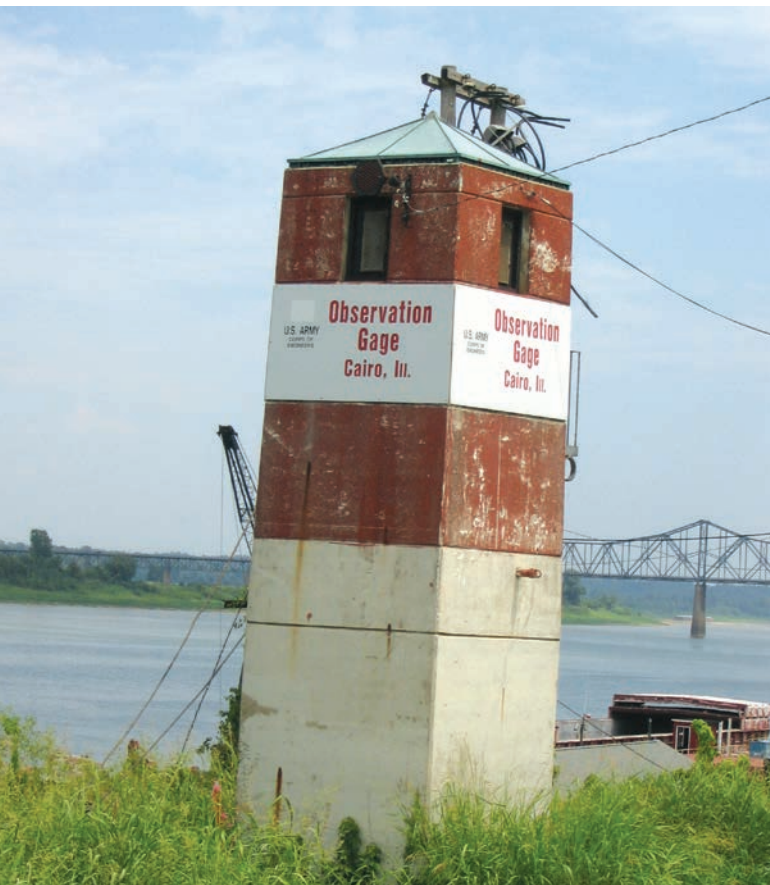
**FIGURE 1.2** The Cairo, Illinois, river gage on the Ohio River is used to determine river height and when it is necessary to open the Birds Point-New Madrid Floodway to relieve downstream river pressure.

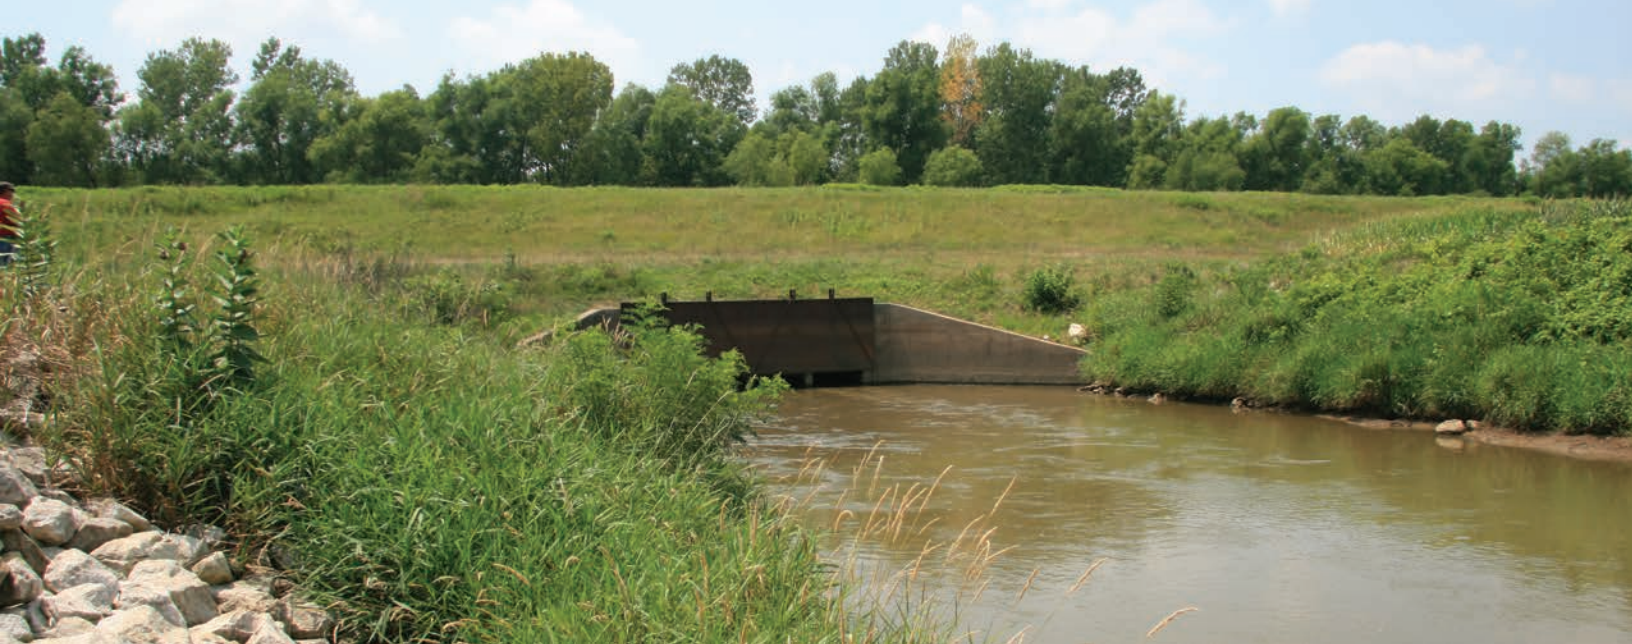
**FIGURE 1.3** One of two Sny River aqueducts transports floodwaters and sediment to settling basins.

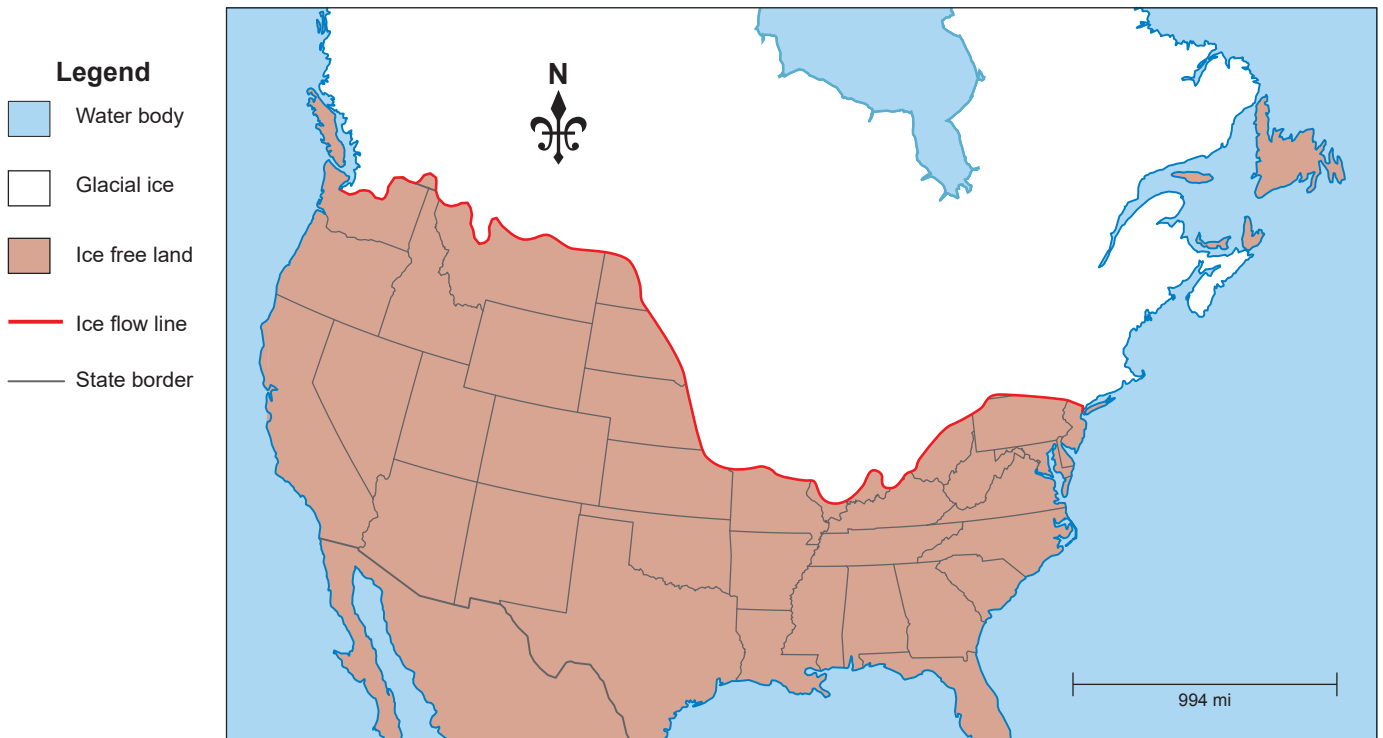
**MAP 2.2** The southernmost glacial advance in the Northern Hemisphere during the Pleistocene epoch.

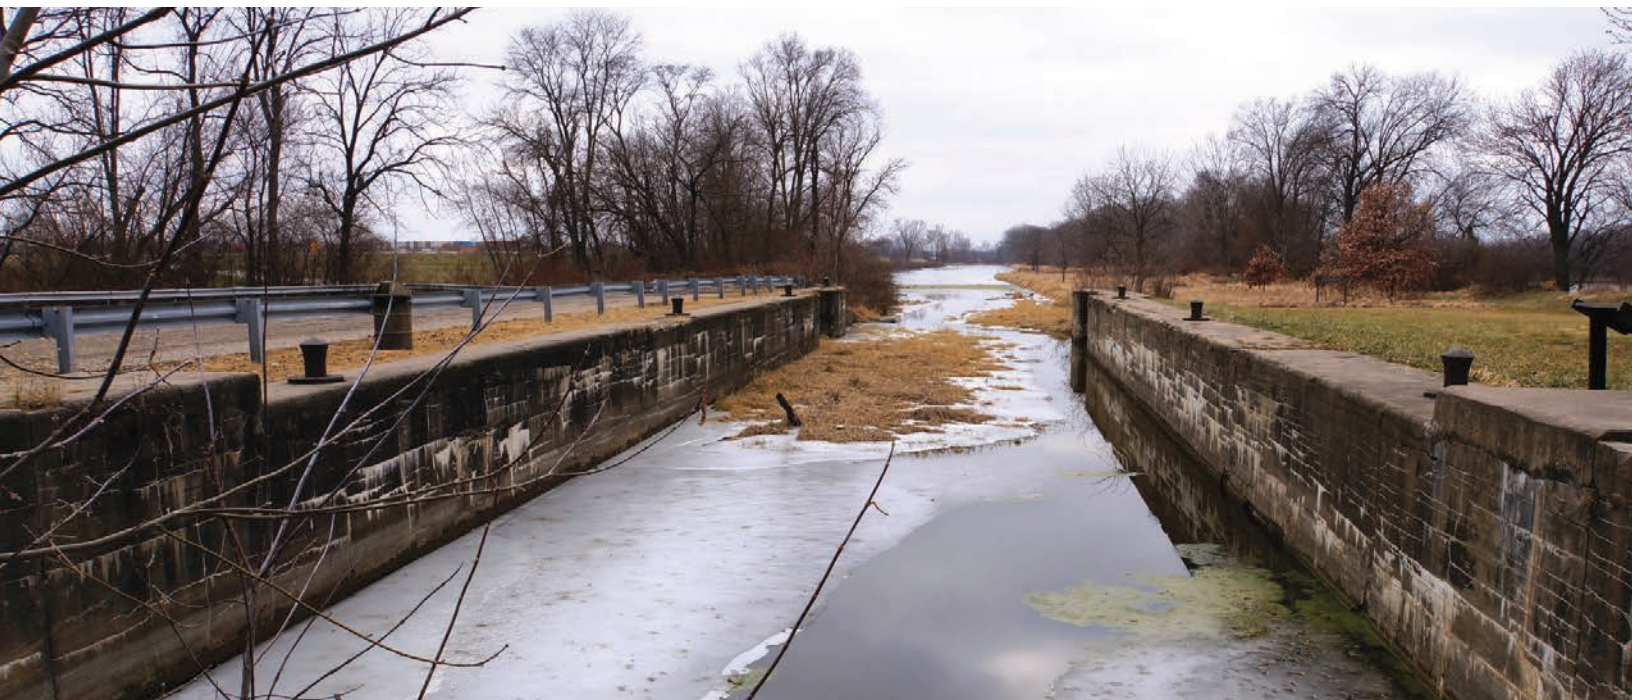
**FIGURE 2.2** The Hennepin Canal was deactivated in 1951 but preserved at various locations along the ancient Mississippi River.

The upper Mississippi River waterway runs from Minnesota to Cairo, Illinois (see map 1.1). Historically, the ancient Mississippi River entered Illinois south of Davenport, Iowa, and flowed east into the valley where the Hennepin Canal is located (map 2.4 and figure 2.2) [8]. Then, the ancient Mississippi joined with the Illinois River, flowing south from near the current city of Peoria, Illinois, toward St. Louis, Missouri. The end moraine from the Wisconsin glacier blocked the flow of the ancient Mississippi River through the valley approximately 15,000 to 30,000 years ago. The upper Illinois River headwaters now start near Chicago, Illinois, and converge with the Mississippi River at Grafton, Illinois. Had the Wisconsin glacier advance not plugged the ancient Mississippi River valley and caused the realignment to its current location, the land area south of the Hennepin Canal (map 2.4), west of current the Illinois River, and north of Alton, Illinois, would be west instead of east of the Mississippi River and part of the states of Iowa and Missouri (see chapter 3) [7, 8].

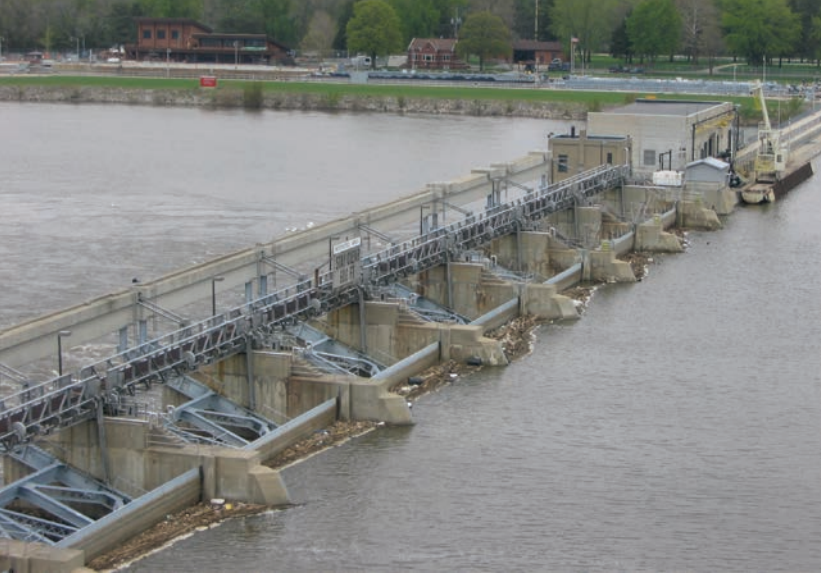
**FIGURE 3.1** Starved Rock locks and dam help maintain the nine-foot navigation channel on the Illinois River waterway.

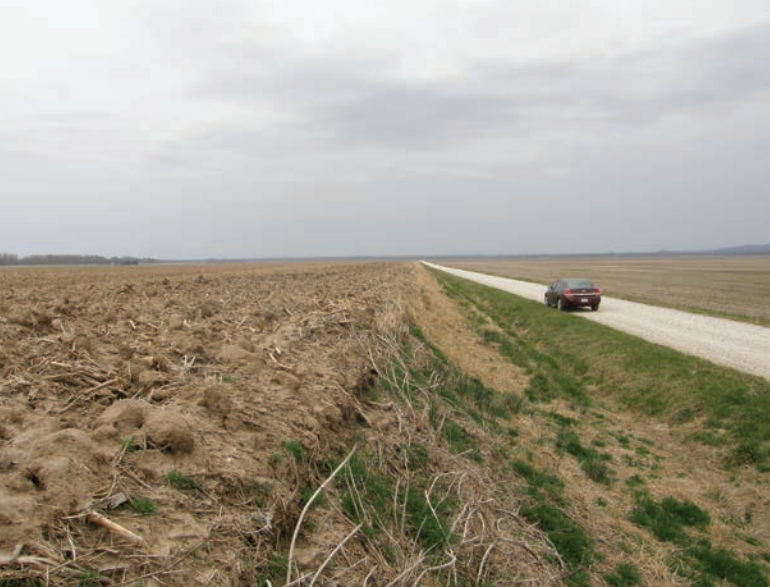
**FIGURE 4.1** A 640-acre settling basin (Kiser) filled up with sediments in the 1950s and is currently used for row crop production.

Once filled, the basins dried out and the depth of sediment shrunk. The embankments were graded to the level of the dried sediment (figure 4.1) and returned to the private landowners to be farmed. Currently, all of these earlier basins are being cultivated for corn and soybeans. The sediment-filled basins are still at least 7 feet above the surrounding fields on the bottomlands (figure 4.2). These sediment basins were mapped in the 1999 Pike County soil survey [5] as soil number 815 (Udorthents, silty). The Department of Natural Re-

(figure 4.1) after filling. Nutrient levels of agricultural lands vary considerably across the region and within tracts. Producers use grid sampling to deliver nitrogen and other nutrients where they are most needed and to avoid over application.

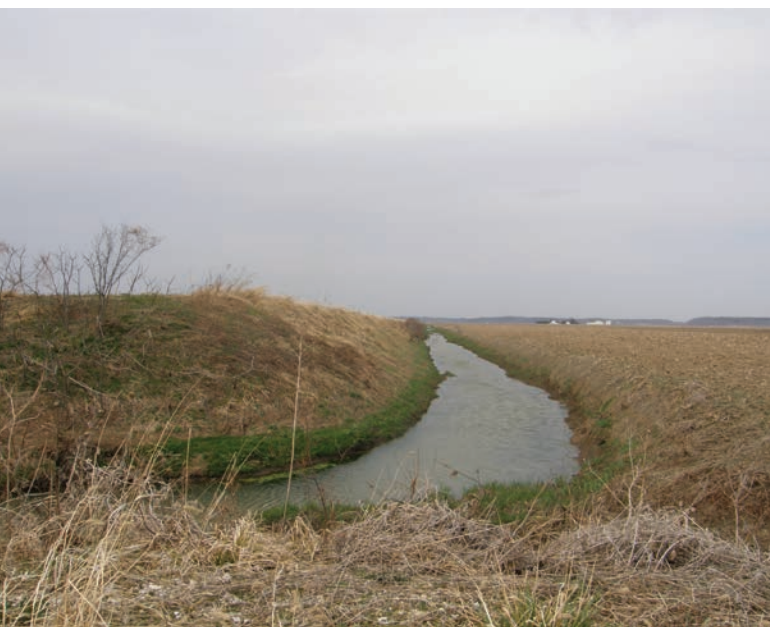
**FIGURE 4.2** A 640-acre settling basin (McCraney) filled with sediments in the 1950s and is 7 to 10 feet above the bottomlands and 9 to 14 feet above the current drainage ditch.

carried by excess waters that were periodically diverted from adjacent streams, such as Hadley, McCraney, and Kiser creeks. As a result of the 1940s and 1950s cultivation practices (moldboard plowing) in the uplands of Adams, Pike, and Calhoun counties, these and other basins filled to 10-foot depth in less than 20 years.

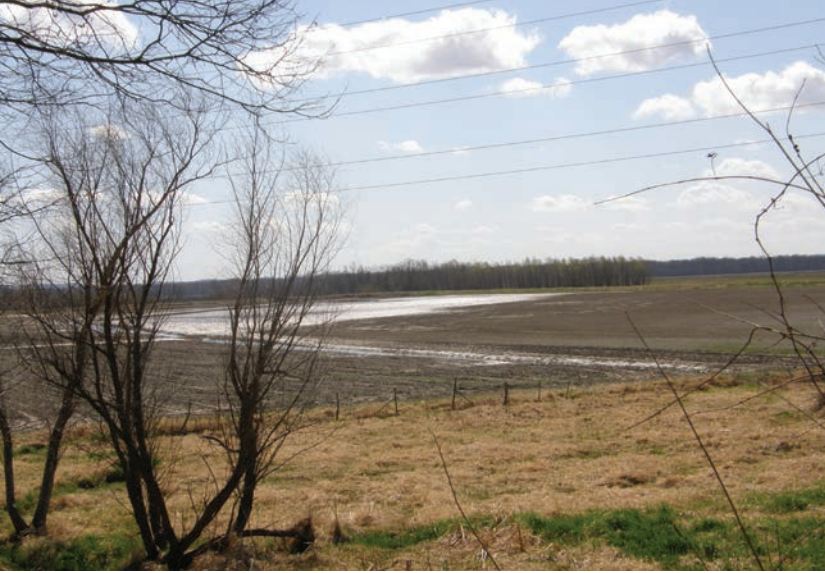
**FIGURE 4.3** The Horton-Dutch Creek settling basin is filling up with water, sediment, and nutrients. The basin levee is shown in the distance.

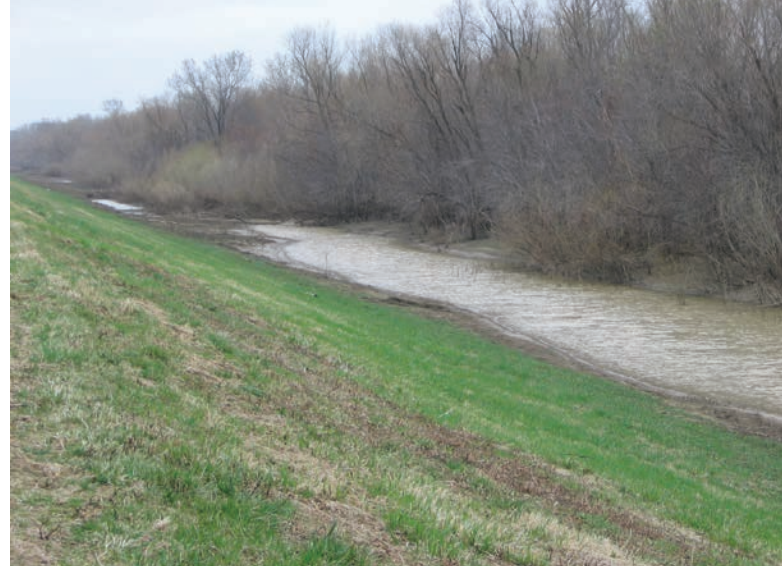
**FIGURE 4.4** The wide Kiser Creek Diversion channel is timberland between the two levees just before it drains into the Mississippi River.

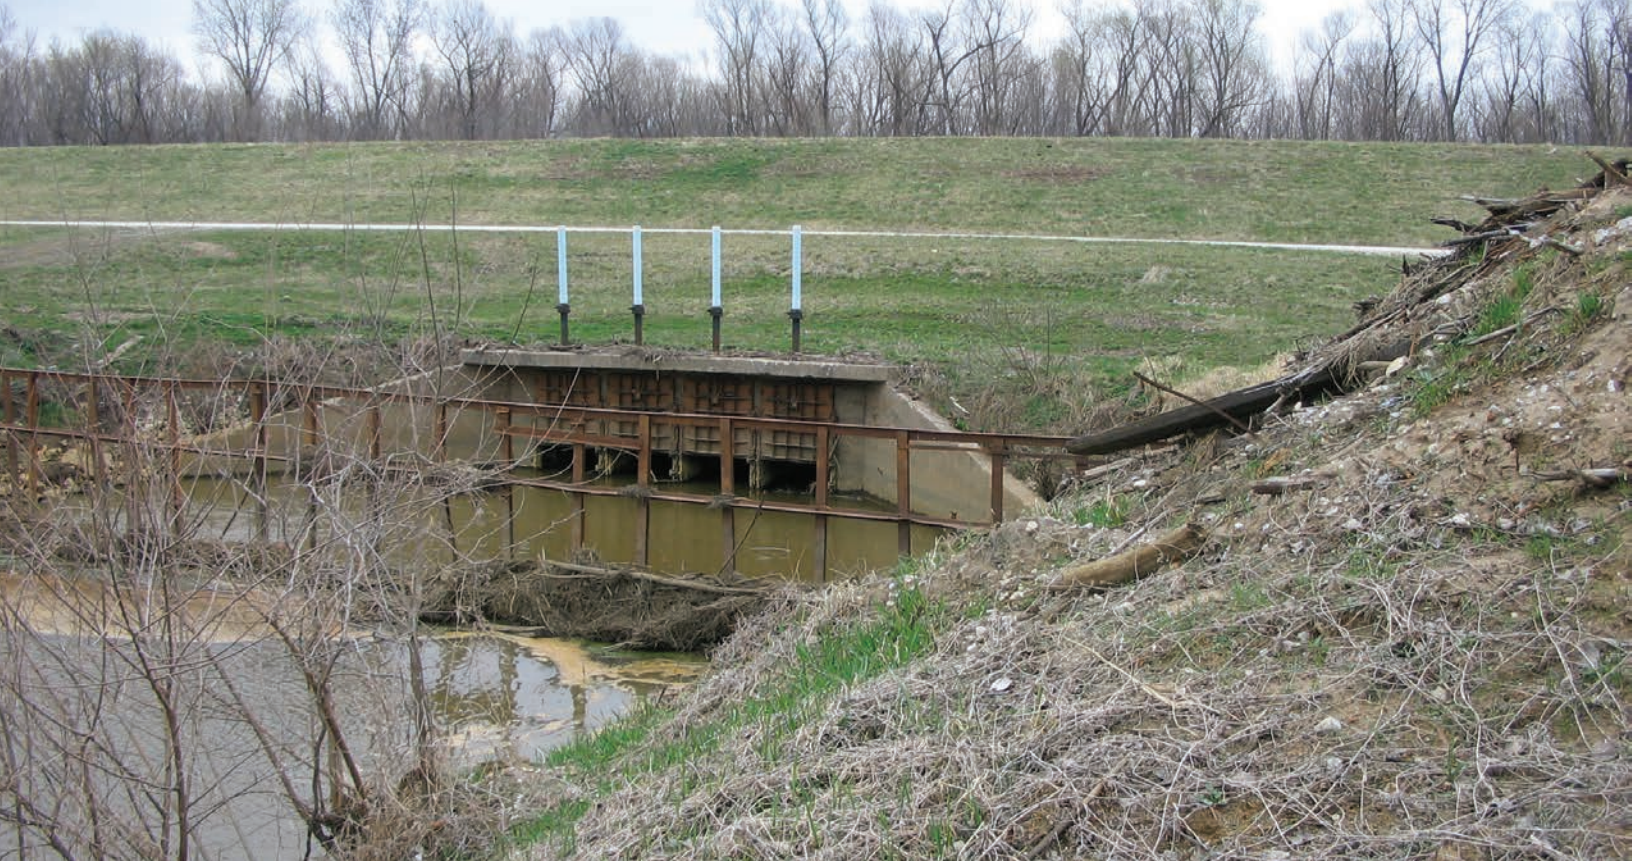
**FIGURE 4.5** The Sny River aqueduct passes under the Kiser Creek Diversion channel.

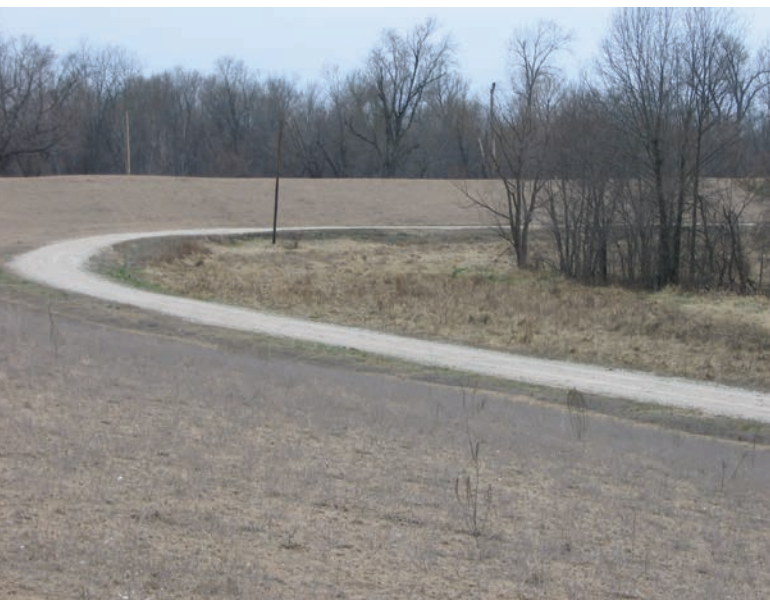
**FIGURE 4.6** The merged Mississippi River and Kiser Creek Diversion levee blocks the Sny River channel flow, and water has to be pumped over the levee to the Mississippi River.

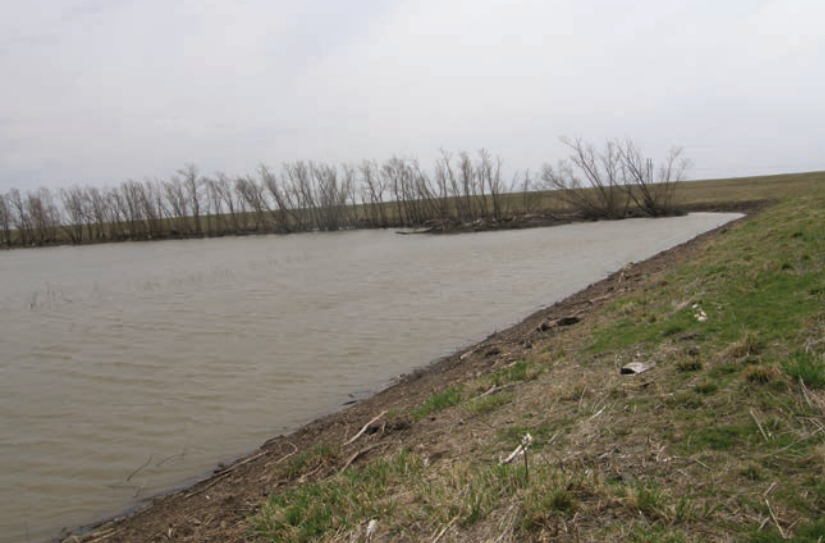
**FIGURE 4.7** The Pigeon Creek settling basin west of Hull, Illinois, is currently active during high runoff and flooding.

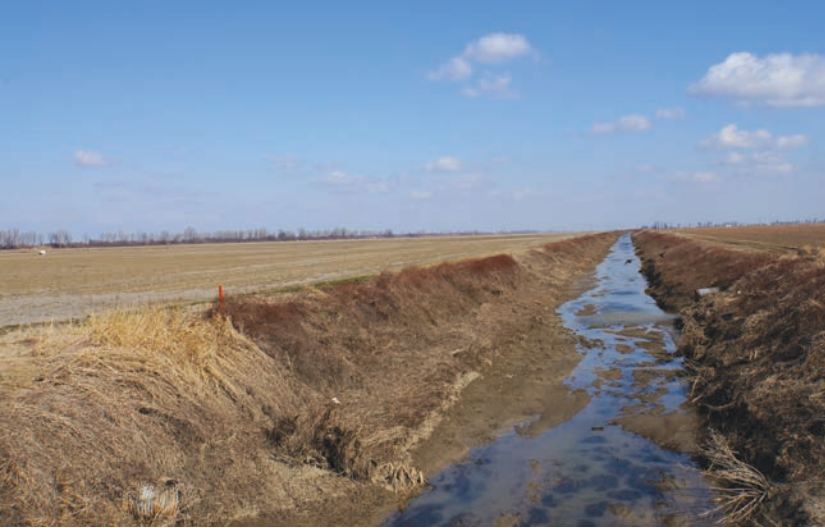
**FIGURE 5.2** Agricultural lands created by draining Big Swamp.

Little River Drainage District (LRDD; map 5.2) with support from the US Army Corps of Engineers (USACE) [4], this region drains 620,000 acres of Little River basin bottomlands (figure 5.2). It is the drainage outlet for 1.2 million acres of bottomlands and uplands to the Arkansas border and combines with 1 million acres of the St. Francis River basin as it flows into the Mississippi River near Helena, Arkansas.

The LRDD drained the Missouri Big Swamp south of the Headwaters Diversion between 1909 and 1928 by constructing 957 miles of ditches (figure 5.2) and 304 miles of levees [20]. With the west-east diversion in place, the LRDD could take advantage of the one-foot-per-mile drop from Cape Girardeau to the Arkansas border and construct a north-south gravity system of levees and ditches. The largest, 100-mile-long Ditch 1, collected the runoff from all other ditches in the district and carried it south into Arkansas where it entered through the Little River, ran into the lower St. Francis River, and later emptied into the Mississippi River, a distance of 250 miles (map 5.3). By 1928, the district had completed construction of the levees and ditches and had drained 520,000 acres of bottomland and transported runoff water from 620,000 acres of uplands. Two detention reservoirs and one sedimentation basin were created to

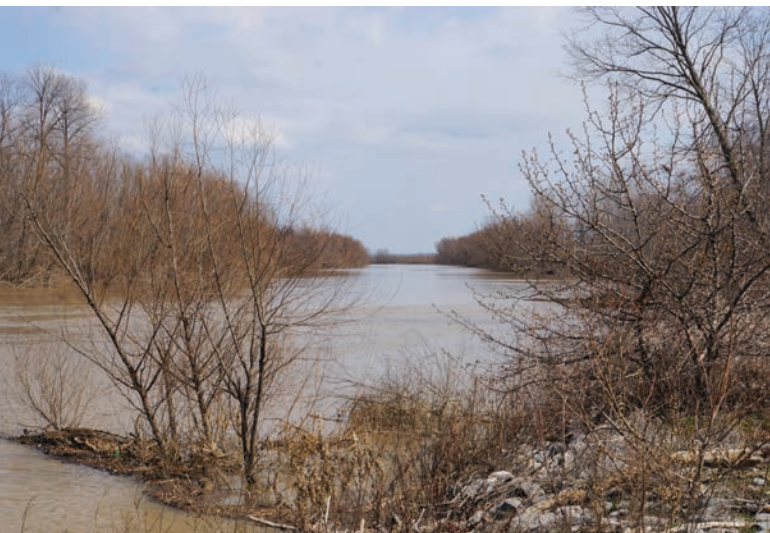
**FIGURE 5.4** The diversion channel flows east from the Castor River to the Mississippi River and outlets south of Cape Girardeau.

On November 27, 1912, the LRDD awarded the \$1.25 million project to D.C. Stephens Company of Buffalo, New York [11]. The contract called for creation of a 30-mile drainage channel with an outlet at the Mississippi River just south of Cape Girardeau, Missouri. The channel was to be 100 feet wide and 20 feet deep (figure 5.4). The project required the clearing of 4,000 acres of timber and creation of 40 miles of levees (figure 5.5) on the south side of the Headwaters Diversion channel. The moving of 8.8 million cubic yards of soil made it the largest single contract for earth movement in the world, even larger than the Panama Canal. Headwaters from the Castor River were to be diverted into the new

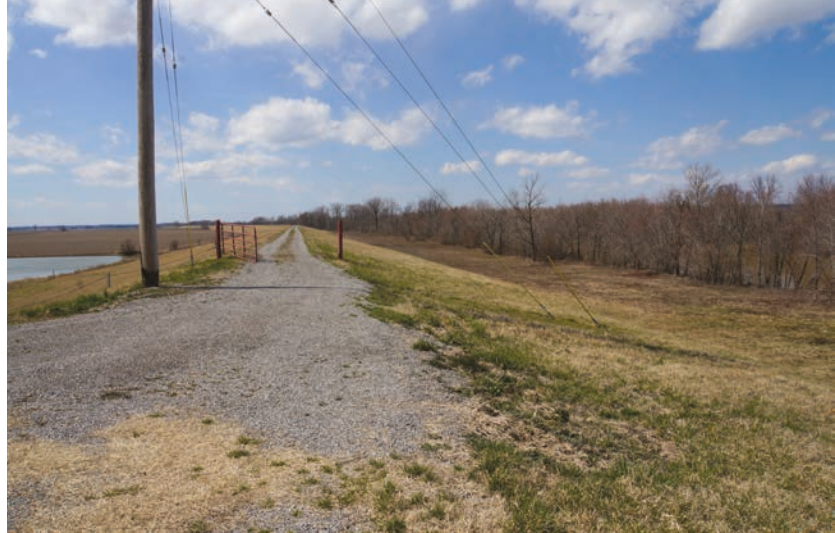
**FIGURE 5.5** The diversion embankment protects agricultural bottomlands from the Missouri Ozarks upland stream runoff and Mississippi River backwater at flood stage.

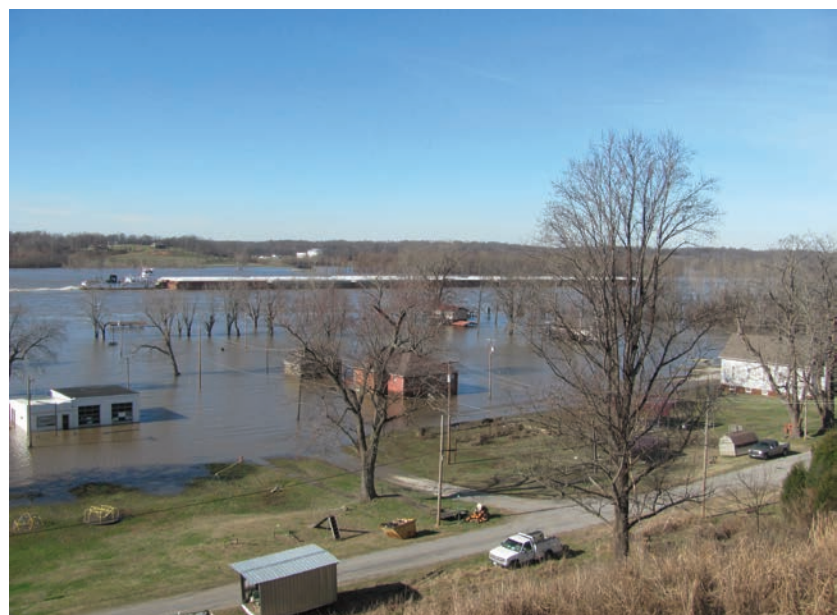
**FIGURE 6.5** Mississippi flooding at Thebes, Illinois, on January 5, 2016. The floodwaters covered the playground and the riverbanks and flooded homes and business that were not on stilts. A tugboat is pushing barges upriver in the background.

The increase in Mississippi River peak flow placed additional river pressure on levees and led to increased flooding, especially during the floods of 1927, 1937, and 2011. The Kentucky, Illinois, and Missouri farmers' and landowners' response to the additional volume and height of the Mississippi River from the diversion channel valley and the prevention of the Mississippi River floodwaters from flowing into the ancient Mississippi River valley and Big Swamp was to build floodwalls and levees. The Great Flood of 1927 resulted in Cairo building a floodwall and strengthening levees and the creation of the Birds Point–New Madrid Floodway. The Len Small (built in 1943)–Fayville (built in 1969) farmer levee in Illinois [15, 18], the Hickman levee in Kentucky, and the Commerce farmer levee in Missouri were also constructed and strengthened after the completion of the Headwaters Diversion. Over time, the Kentucky landowners were able to get the USACE to strengthen the mainline Hickman levee, which did not fail in either 1993 or 2011. However, the Len Small–Fayville levee failed in 1993, and both the Commerce farmer and Len Small–Fayville levees failed during the 2011 flood. In late December of 2015 and early January of 2016, a rare winter storm over the Ozarks dropped more than 10 inches of rain over three days and set a record Mississippi River crest at Thebes of 47.74 feet, almost 2 feet over previous record flood stage (figure 6.5). Down-

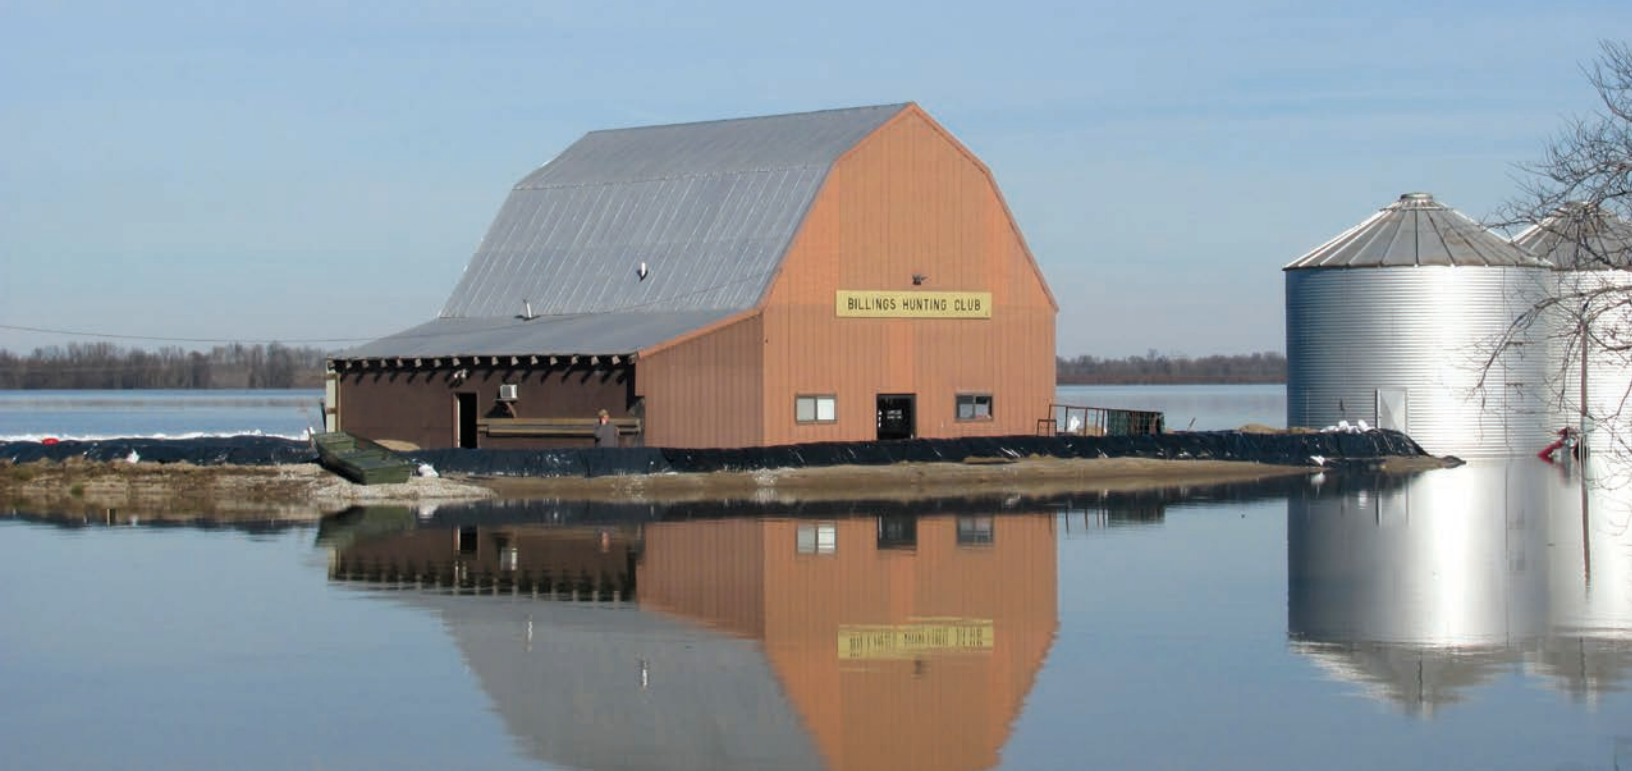
**FIGURE 6.6** After the Len Small levee breached on January 2, 2016, Mississippi River floodwaters flowed into Miller City, Horseshoe Lake, and Olive Branch. Many of the Olive Branch home and business owners both north and south of Route 3 built sandbag barriers to protect their structures from the floodwaters.

stream, the river pressure caused the Len Small levee to fail again and flooded farmland, buildings (figure 6.6), and homes within miles of the breach.

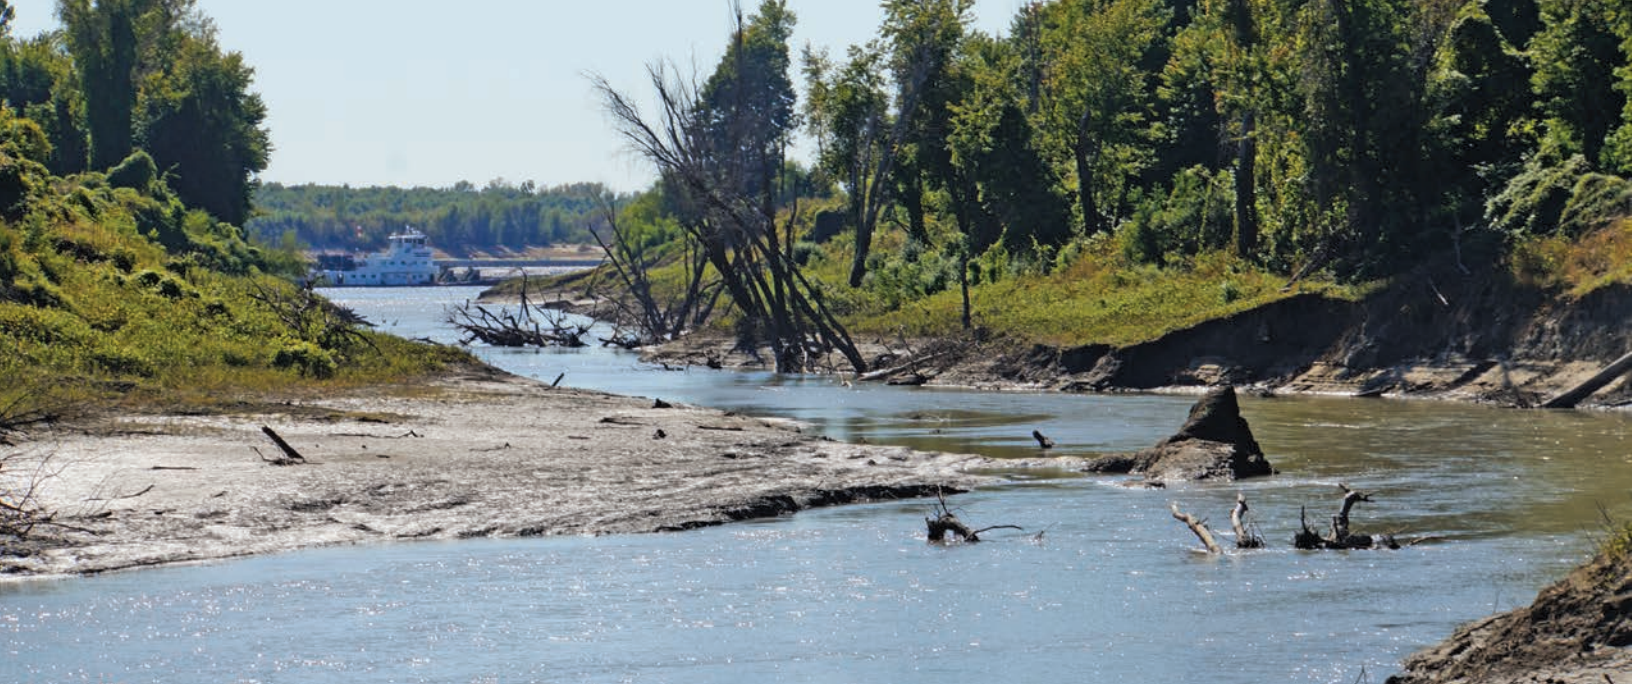
**FIGURE 7.1** A riverboat on the Mississippi River can be seen passing the outlet of Main Ditch that drains through the 1,500-foot frontline levee gap at New Madrid, Missouri, to the Mississippi River.

When the Mississippi River reaches 290 feet above sea level near New Madrid, Missouri, bottomlands adjacent to the river, farmland, roads, ditches, and wetlands begin to flood. Concurrently, at the lower end of the New Madrid Floodway, the rising Mississippi backs up into Main Ditch (figure 7.1), the 1,500-foot gap in the frontline levee designed to drain the floodway and St. Johns Levee and Drainage District to the river (map 7.1). When this occurs, the Main Ditch gates on the setback levee (figure 7.2) are closed to protect the St. Johns Bayou basin from Mississippi River backflow. However, with the Main Ditch gates closed, precipitation within the basin has no outlet as it drains to Main Ditch and, as a result, backs up tributary streams and floods a substantive portion of agricultural lands and the town of East Prairie, Missouri. For example, after the 7.5 inches of rain during the first three days of May of 2011 and the closing of the gates, the internal drainage system backed up floodwaters throughout the St. Johns Bayou basin all the way to East Prairie.

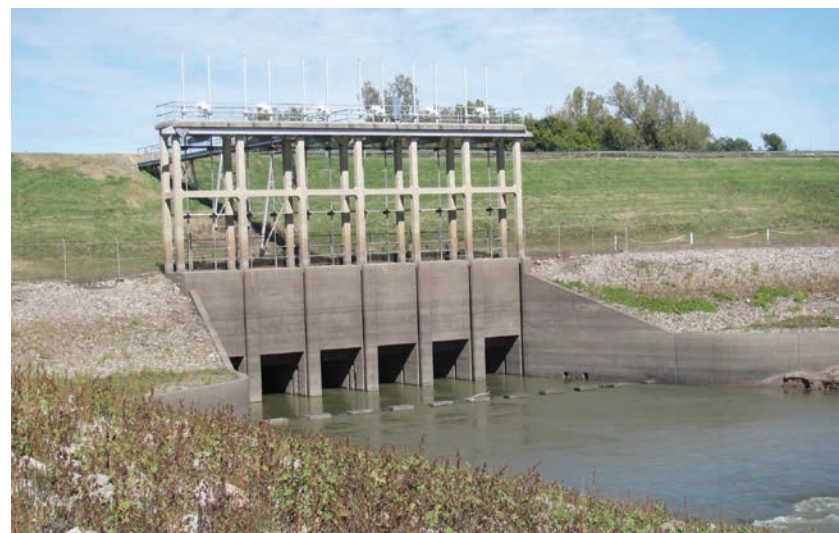
**FIGURE 7.2** When open, the New Madrid Floodway setback levee gate drains the 200,000-acre St. Johns Bayou basin to Main Ditch and into the Mississippi River. It is closed under flood conditions to prevent Mississippi River backup water from flowing into the basin.

the Mississippi River. While much of the farmland behind these levee systems is protected from flood-swollen waters of the Ohio and Mississippi rivers as they converge at Cairo, Illinois, and flow south, thousands of acres of bottomlands are flooded through the gap in the lower New Madrid Floodway frontline levee (figure 7.1). In addition, the closure of the setback levee gates at the gap (figure 7.2) results in the internal flooding of many more thousands of acres in St. Johns Bayou basin.

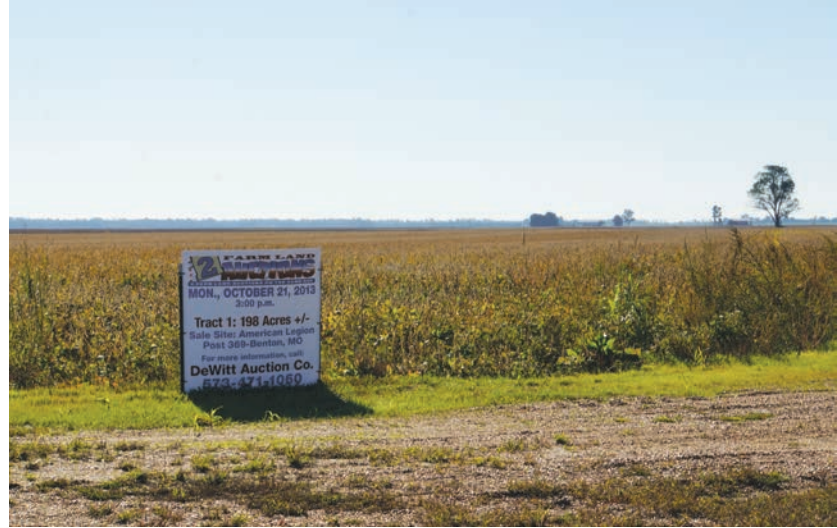
**FIGURE 7.5** A land auction sign is posted on land protected by the Commerce farmer levee, which was breached in May of 2011.

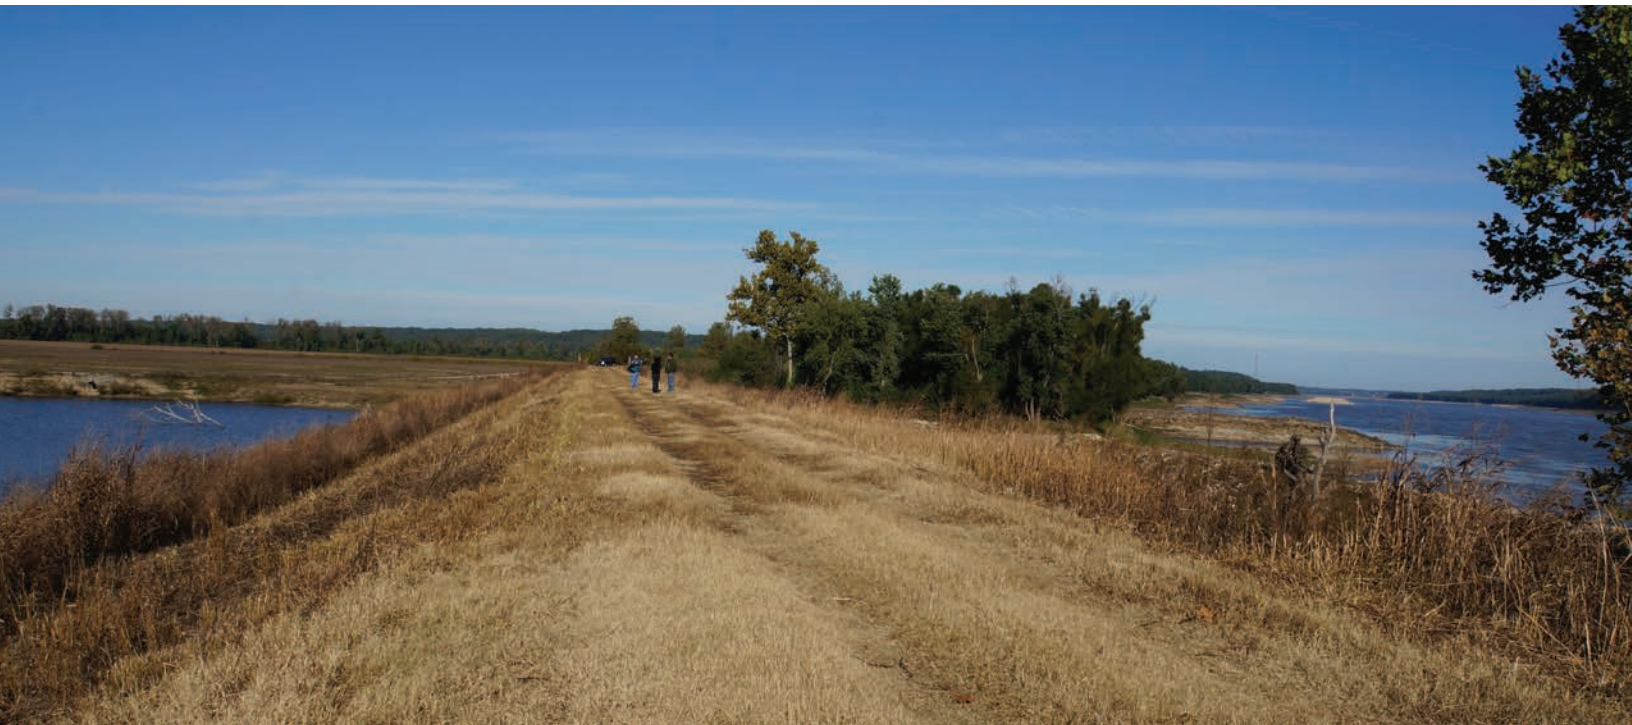
**FIGURE 7.4** The Commerce Farmer Levee and Drainage District repaired a 2011 levee breach located two miles south of Commerce, Missouri. Note the Mississippi River on the right and the crater lake on the left created by the force of water pouring through the breach.

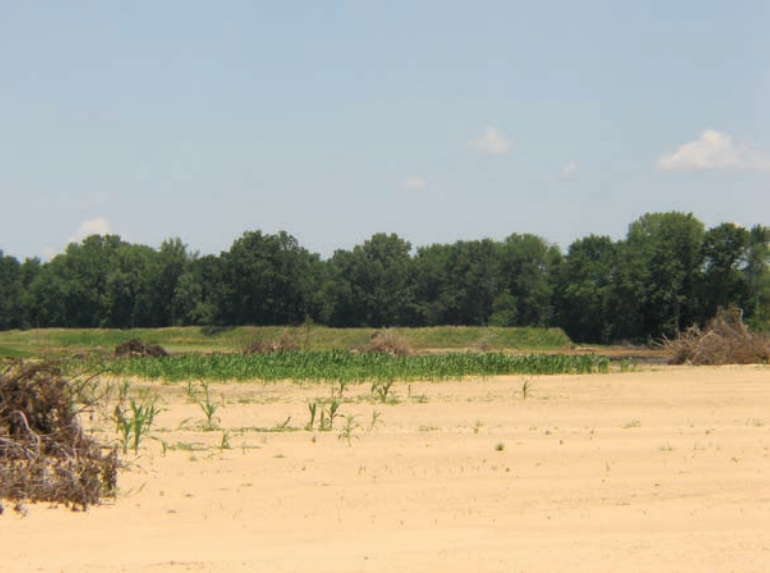
**FIGURE 8.1** A sand delta created by a breach covers a corn field with tree residue transported from the river and levee into an agricultural field.

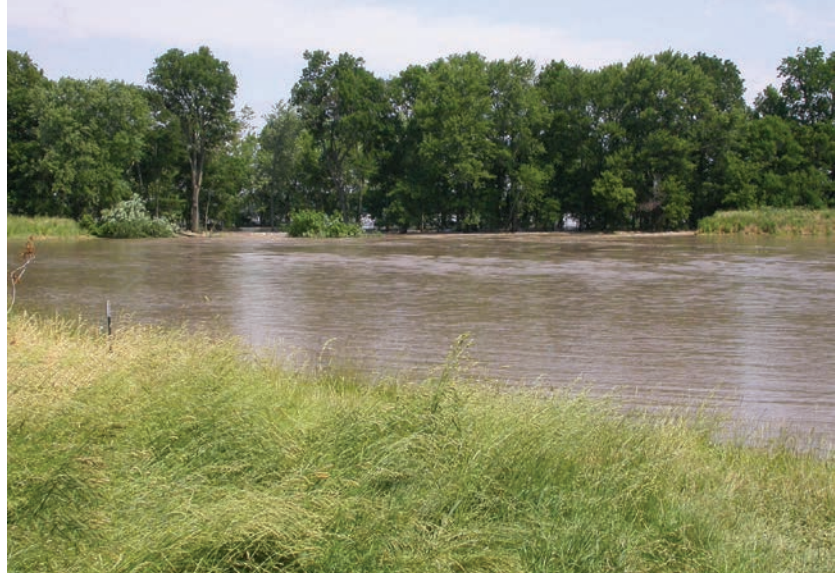
**FIGURE 8.2** Water pours through a breached levee on the Embarras River in June of 2008.

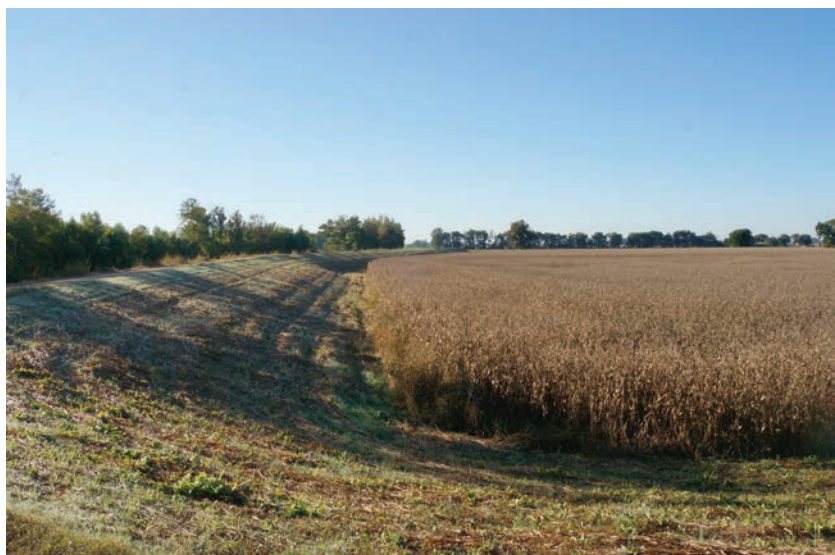
**FIGURE 8.3** The Commerce farmer levee located south of Commerce, Missouri, protects a soybean field ready for harvest.

In the United States, the Mississippi River and tributaries drain 41% of the continental land mass including millions of acres of agricultural lands protected by thousands of miles of earthen levees (figure 8.3) and floodwalls. By 1926, an extensive system of private and public levees along the Mississippi River was engineered to secure agricultural lands and river cities against flooding [1] from the confluence of the Ohio and Mississippi rivers at Cairo, Illinois, all the way south to the Gulf of Mexico. Today the US Army Corps of Engineers (USACE) and local levee and drainage districts continue to actively manage river levels to maintain navigation and protect against flooding. Prior to the construction of these levees, most river bottomlands experienced crop loss every time the

The levee is a massive earthworks designed to contain and channelize the river at flood stage and protect agriculture and other land uses against flooding. It has a flat crown with three-to-one sloped sides. The texture of the materials used in earthen levee construction can vary from silty clay to sandy. Grasses with thick, dense roots are planted on the levee to hold the soil in place and reduce the erosive effect of water. Breaks in the levee, called breaches, can occur when a portion of the levee is eroded or breaks from a subsurface weakness. The higher the levee, the greater the force of the river on the protected land when a breach occurs. A levee as high as a three- or four-story building can explode with the same power and suddenness of a dam bursting. Silty clay levees with a sand core can be affected by vegetation and animal burrowing, which in turn influences the susceptibility of the levee to erosion and natural

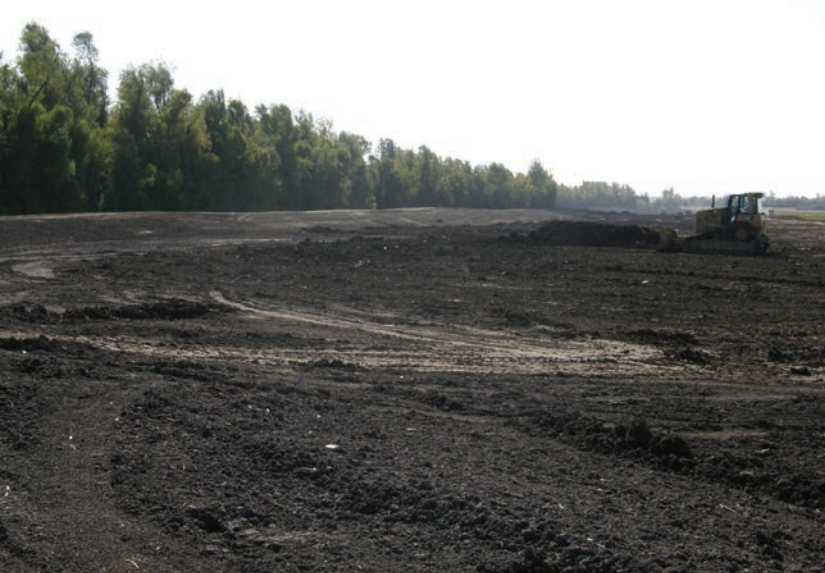
**FIGURE 8.4** A levee at Birds Point, Missouri, is reconstructed after the induced breach of 2011.

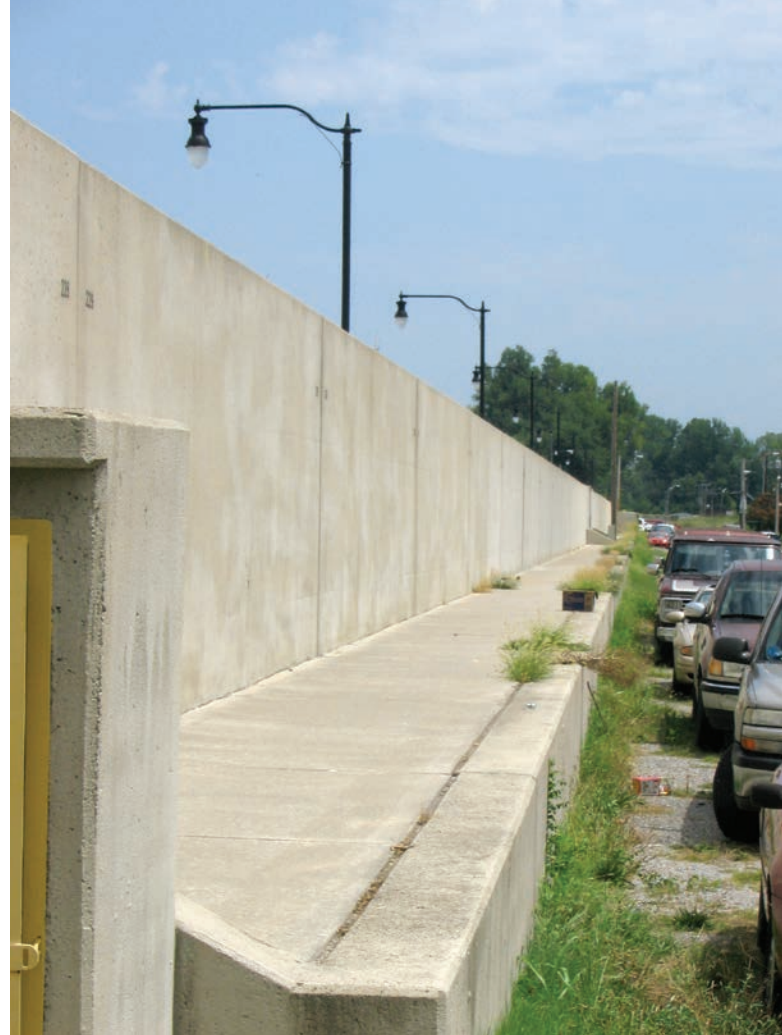
**FIGURE 8.5** The concrete floodwall on the east side of Cairo, Illinois, protects the city from Ohio River flooding.
