# Managing Mississippi and Ohio River Landscapes

Kenneth R. Olson and Lois Wright Morton

Soil and Water Conservation Society  
Ankeny, Iowa

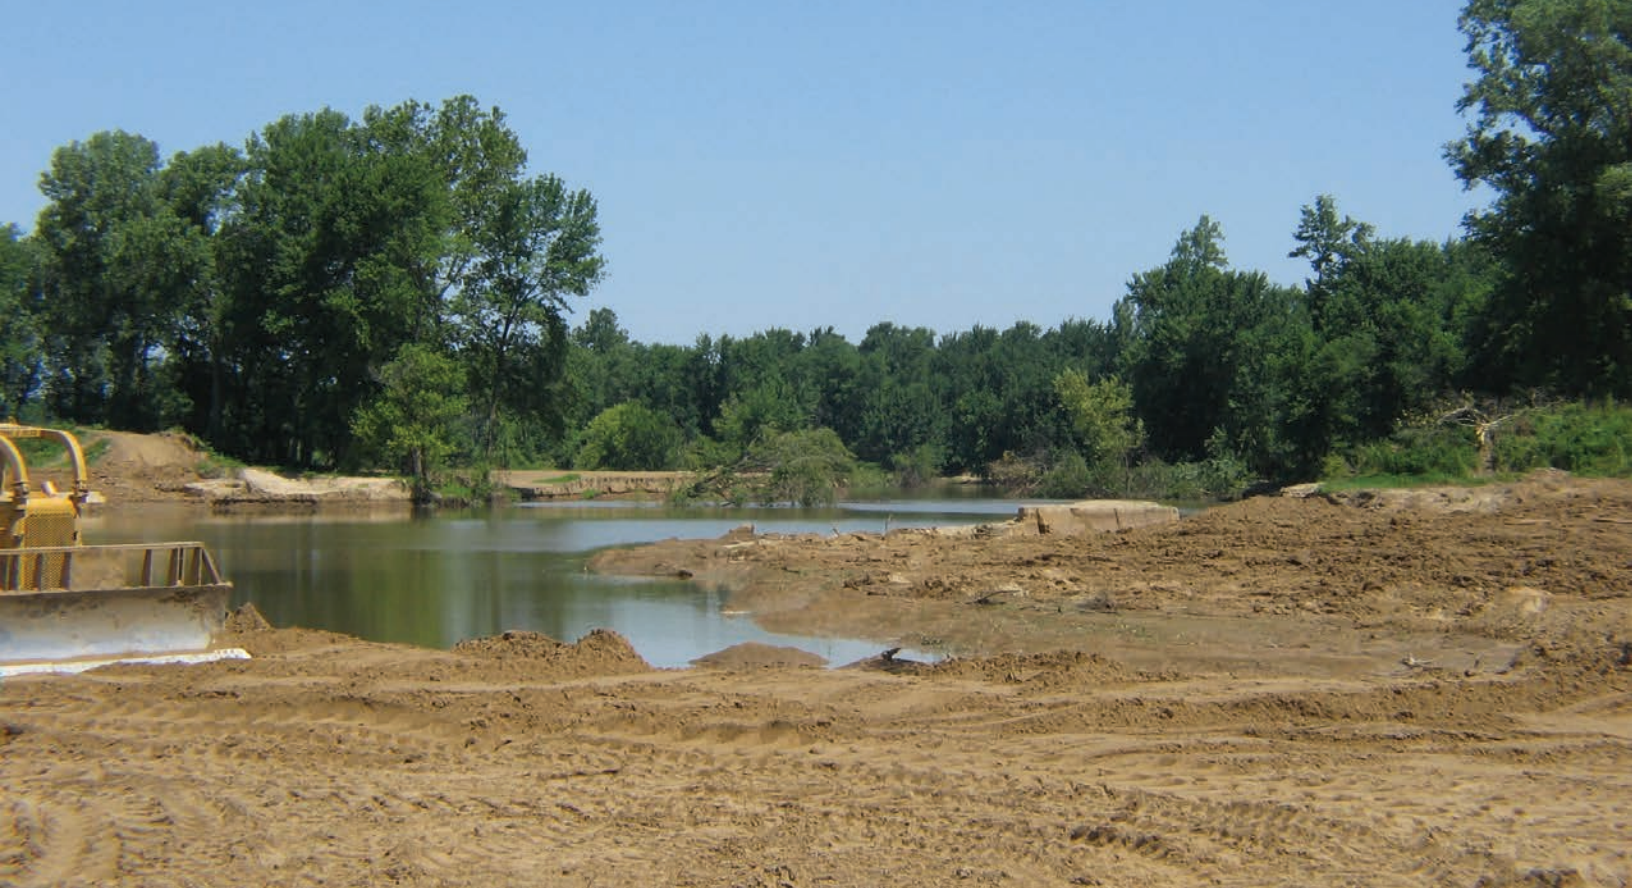
**FIGURE 8.7** A crater lake extends 300 feet through the levee breach.

As the floodwater tops or breaks through an earthen levee, it often drops many feet to the bottomland inside the levee and causes deep erosion of the soil and underlying geologic parent material (figure 8.7). Most crater lakes are many feet deep [3]. As the floodwater flows rapidly into the previously protected bottomland,

gullies originating adjacent to the crater lake are cut into the soil and can extend 30 feet to more than 300 feet beyond the lake. Geologic materials, soil, sandbars, and sediment carried downriver and from the degraded earthen levee are deposited in the bottomland after the floodwaters slow down (figure 8.7) [4]. The thick sand can be deposited on agricultural crops and other vegetation on the land surface as well as in drainage ditches and in road ditches.

Levee breaches often occur where a levee is placed across a filled-in meander channel as a result of piping (see figure 8.7) and sand boils, which undermine the earthen levee. This situation happened at two levee breaks southeast of Sainte Marie, Illinois (map 9.2). About 300 feet of levee was lost at each break. Blowout holes or craters were created that were 1 to 3 acres in size and retained water. Three- to ten-foot-deep gullies extended a few hundred feet from the blowout holes, and hundreds of 65-foot high trees were transported

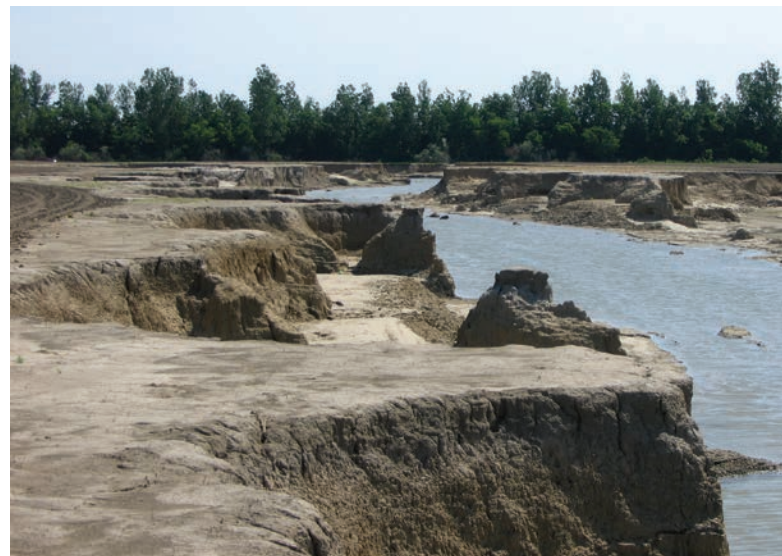
**FIGURE 8.8** An O'Bryan Ridge gully created from an induced breach in May of 2011 is filled with water and removed land from agricultural production.

These deeply eroded soils, or gully fields (figure 8.8), are extremely difficult and costly to reclaim [7]. Often bulldozers are used to push in the tops of the vertical gully walls to fill in the bottom and then grade the side slopes. The pushing of topsoil into the gullies (figure 8.9) places the soil material on slopes that are highly erodible, and the exposed subsoil and parent material of the scrapped areas lower the productivity of the original soils. Topsoil must be hauled in to raise the soil organic carbon content of the soil if the land is to be returned to the previous level of agricultural productivity. Terracing is another option for reshaping the side slopes above the gully bottom. This approach will still result in the loss of long-term soil productivity and crop yields since the newly created soils will be less productive than the original soils as a result of mixing topsoil

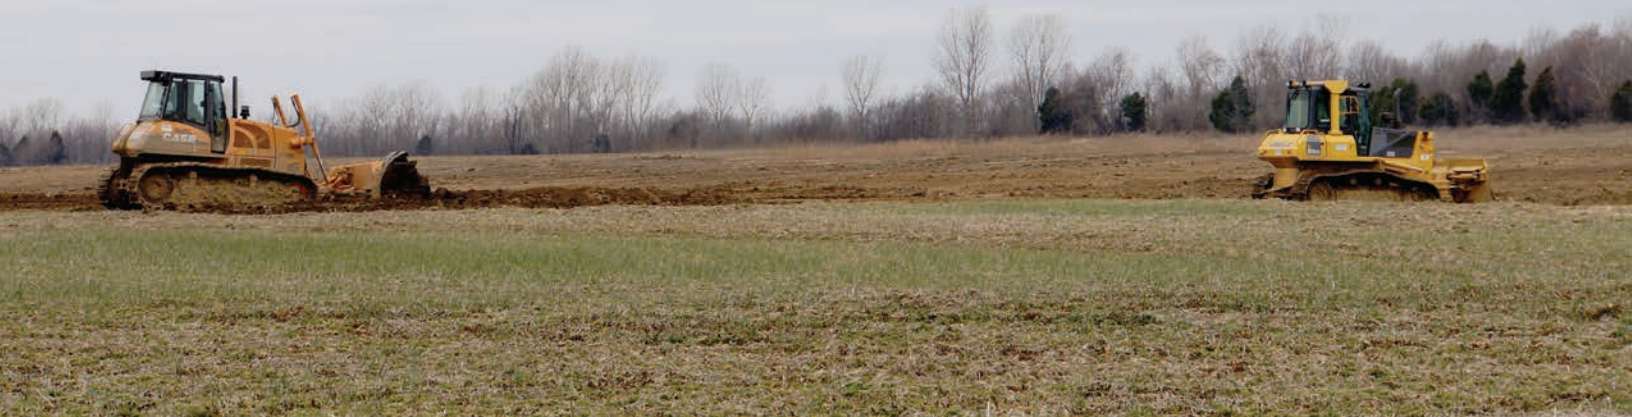
**FIGURE 8.9** Bulldozers push soil into wetlands and ponds at the bottom of the gullies in O'Bryan Ridge.

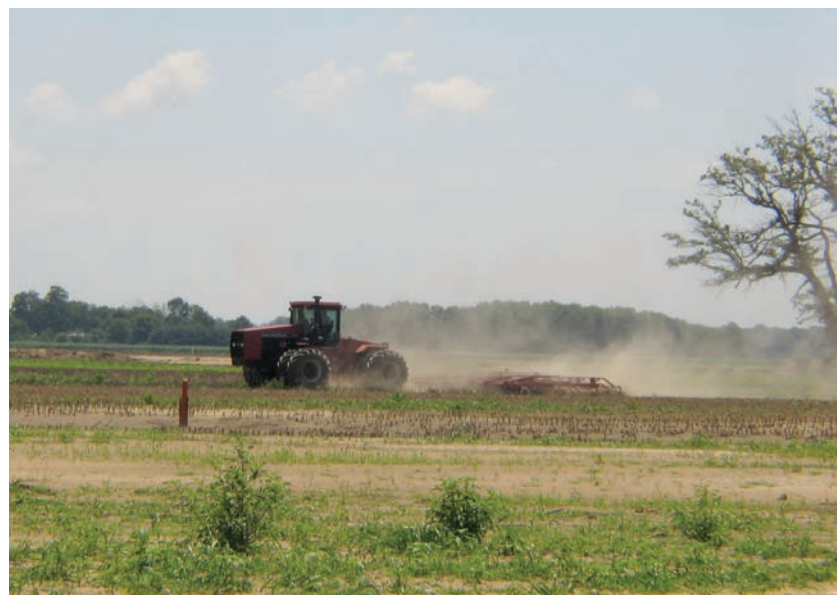
**FIGURE 8.10** Tillage equipment incorporates sediment left behind from flooding into the topsoil.

After the floodwaters recede and the land drains, the soil can either be dried and planted or left idle but tilled to eventually mix in the sediments to help dry out the fields depending on the timing of the flooding. Thin layers of silt and clay deposits can be treated by sunlight, drying, and tillage to incorporate into the plow layer. Tillage equipment, such as chisel plows and moldboard plows, can be used on the areas with thin sand deposits (less than six inches) in an attempt to mix the sand into the underlying bottomland with silty and clayey topsoil (figure 8.10). Crop damages depend on the type of crops

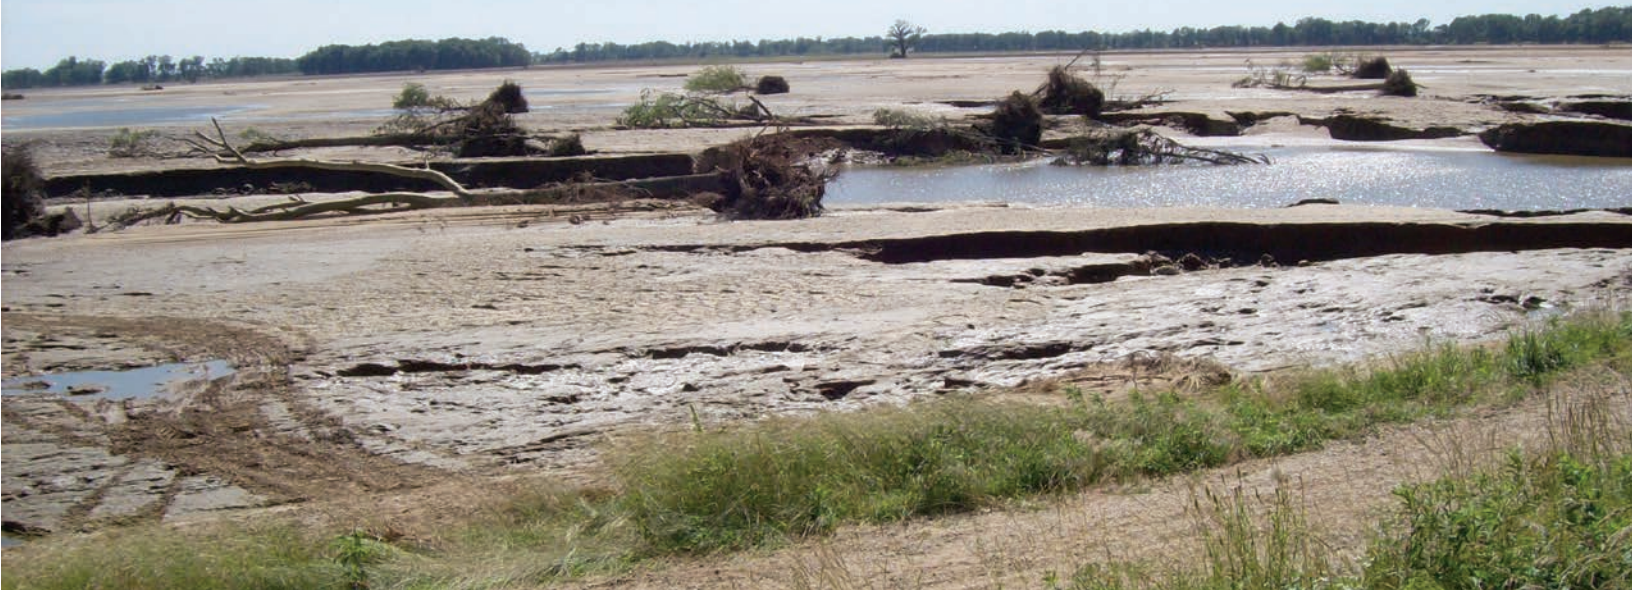
**FIGURE 8.11** Trees on the river side of a levee are transported by floodwaters through the levee breach into adjacent fields.

ously protected floodplain (figure 8.11). Deep gullies can extend many hundred feet into the bottomland, and hundreds of mature trees can be transported hundreds to thousands of feet. Deltaic sand deposits up to three feet thick can cover many acres on the floodplain at each breach site with additional acres covered with a thin layer of sand. The remaining hundreds of acres of previously protected floodplain soils receive a thin coating of silt and clay and can remain under floodwaters long enough to drown the current year's crop if it was planted and not already removed by the wall of advancing floodwater. After a few weeks, the floodwater usually drains from the bottomland and back into the river or slowly evaporates and infiltrates bottomland soils sufficiently for local landowners to begin the task of moving the trees from near the blow-out holes and floodplain and begin filling in the craters and gullies [4].

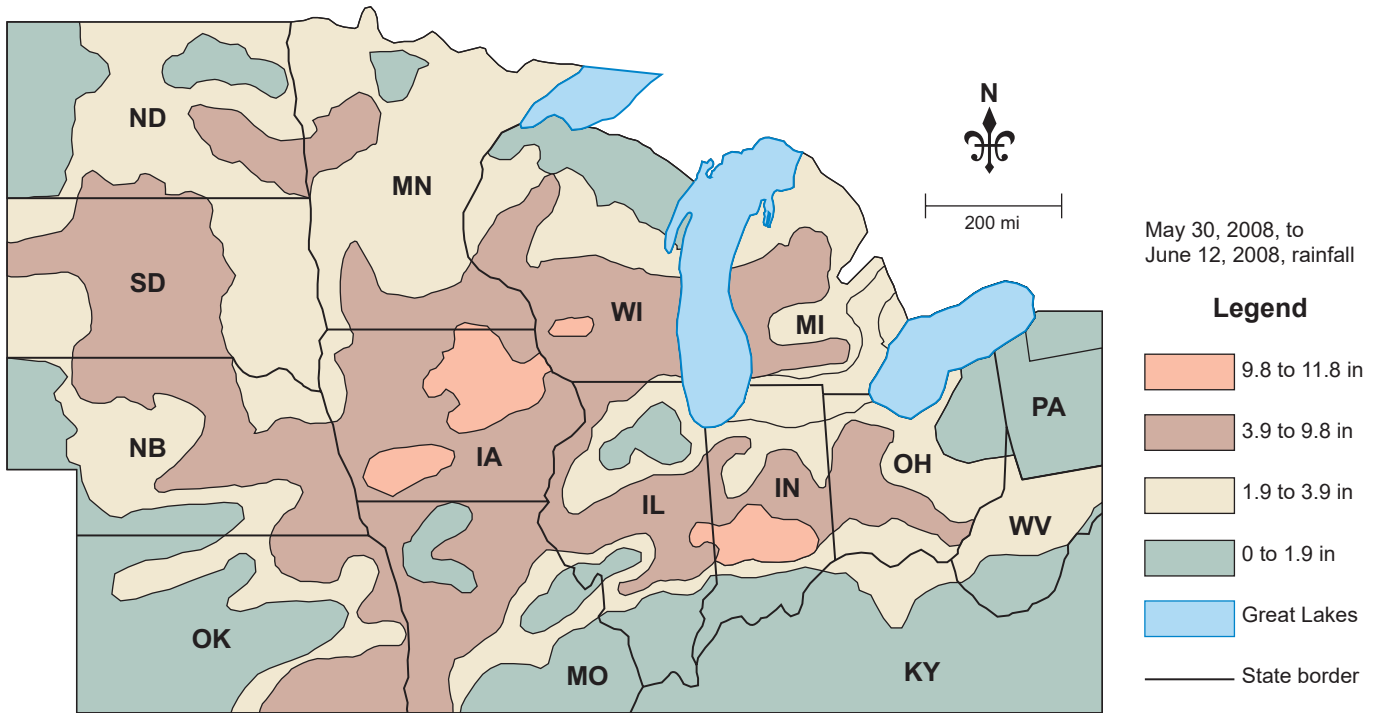
**MAP 9.1** Total rainfall between May 30 and June 12, 2008, in the north-central United States. Modified from a National Oceanic and Atmospheric Administration weather map for the same time period.

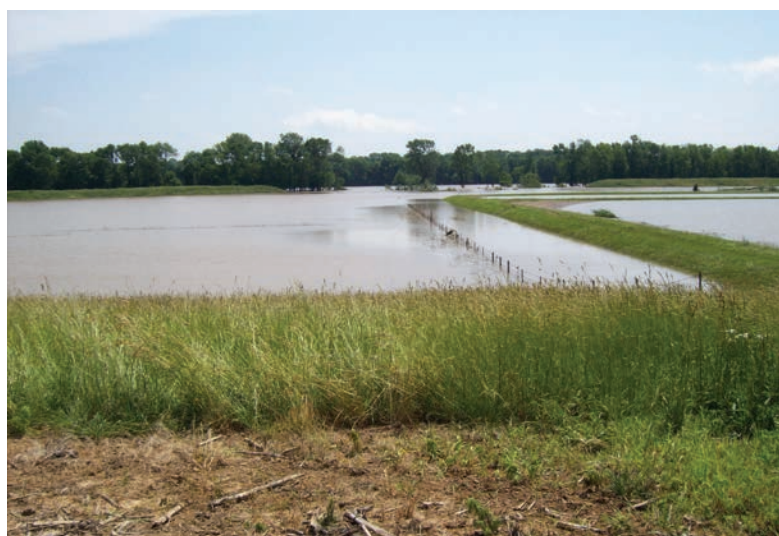
**FIGURE 9.3** Full temporary storage ponds surrounded by flooding from the Embarras River near Sainte Marie, Illinois, in June of 2008. Photo credit: Ken Flexter, Jasper County Natural Resources Conservation Service Field Office, Newton, Illinois.

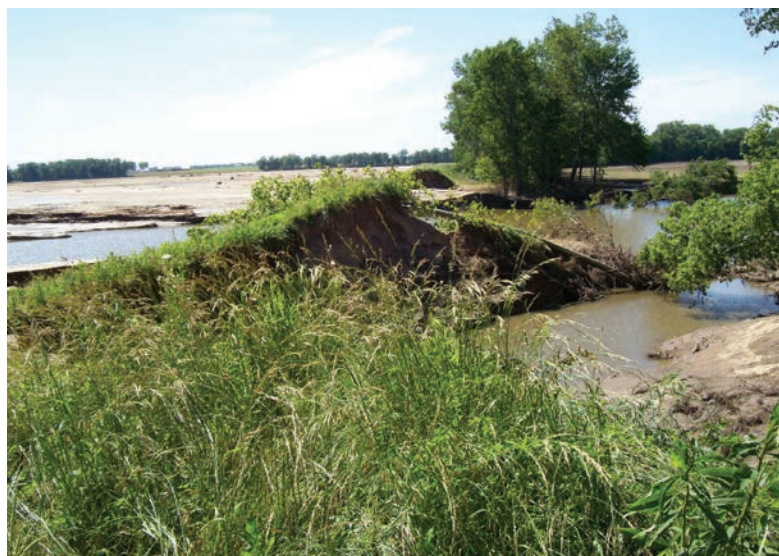
**FIGURE 9.4** The Embarras River cuts through a levee near Sainte Marie, Illinois, in June of 2008.

The areas that were not protected by levees and flooded received a thin layer of silt and clay, but the soils did not suffer permanent damage although the 2008 crop was lost. This was not the case where levees failed. Water removed hundreds of feet of the levee embankments (figure 9.4) and eroded thousands of cubic feet of soils and underlying outwash parent material to depths of 10 to 20 feet below the base of the earthen levee when the levees broke (figure 9.5). The force of the rushing water uprooted trees growing between the river and the levee and, after the breach, deposited them on the previously protected floodplain (figure 9.6). The 2008 crop on the floodplain soils behind the broken levees was a total loss, and permanent soil damage was great.

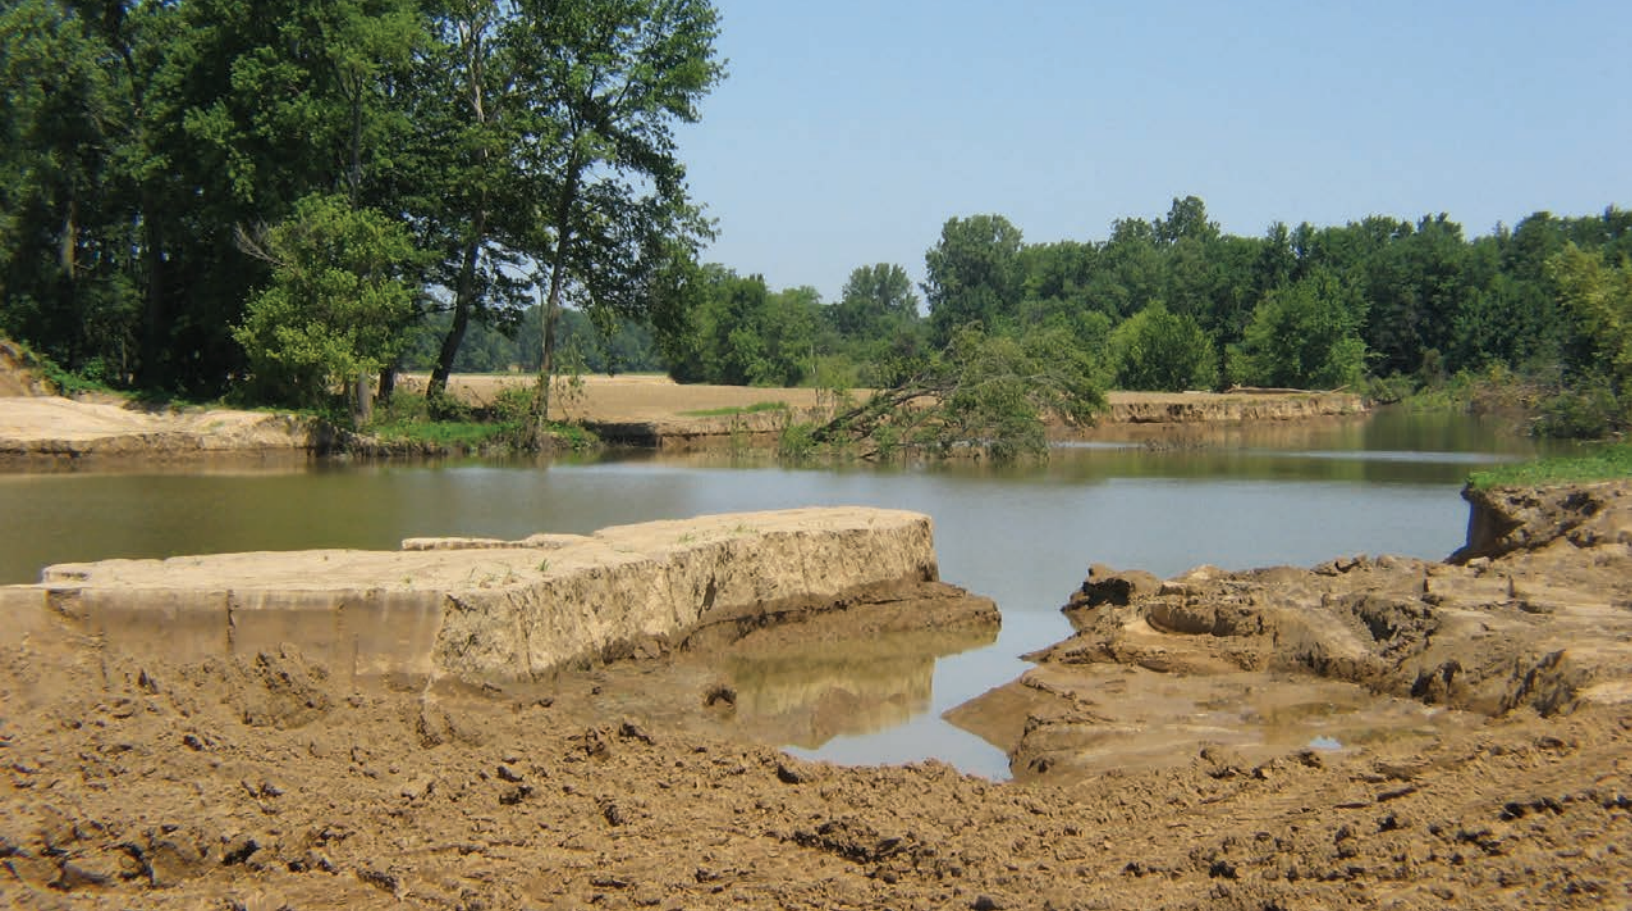
**FIGURE 9.5** In the background is the Embarras River, Illinois, adjacent to a missing 300-foot section of the levee and the crater lake that was created by rushing waters.

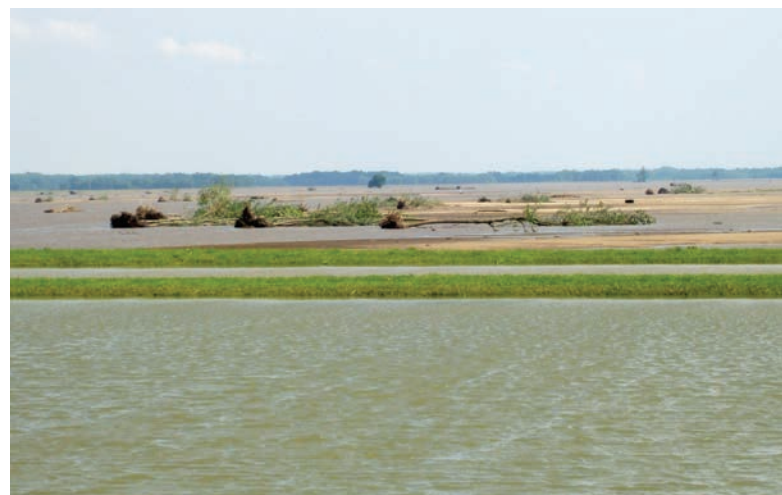
**FIGURE 9.6** Agricultural fields are covered by deltaic sand deposits, water, and trees moved and deposited by rushing water through a levee break on the Embarras River, Illinois, in June of 2008. Photo credit: Ken Flexter, Jasper County Natural Resources Conservation Service Field Office, Newton, Illinois.

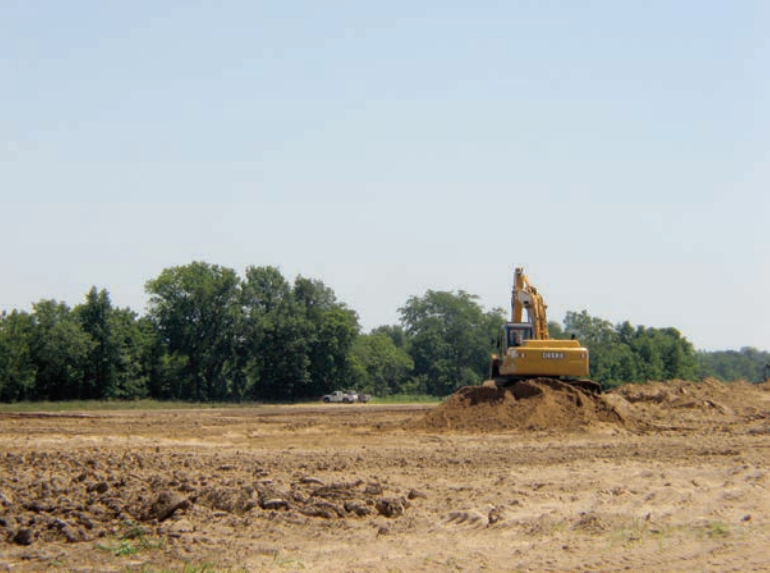
**FIGURE 9.7** Sand is piled for transport off the agricultural lands previously protected by a levee.

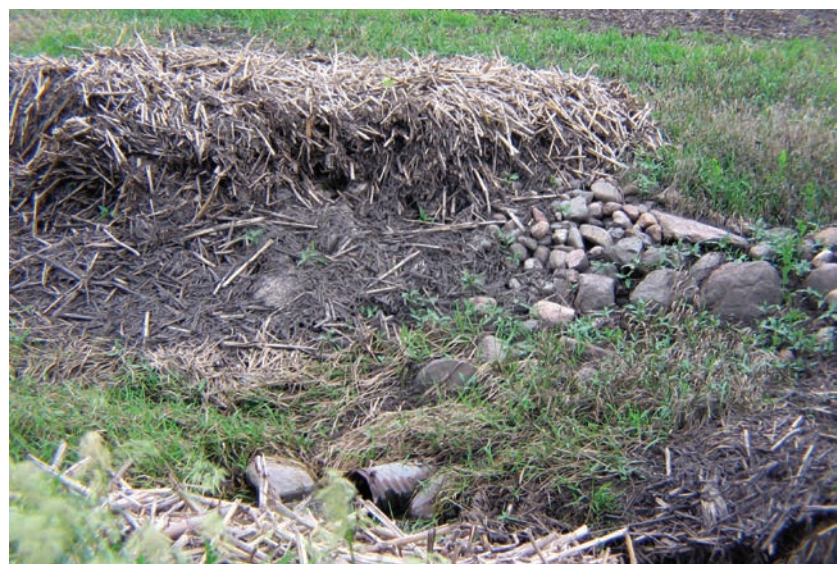
**FIGURE 9.8** Corn stalks clog drainageways, waterways, and culverts after flood events.

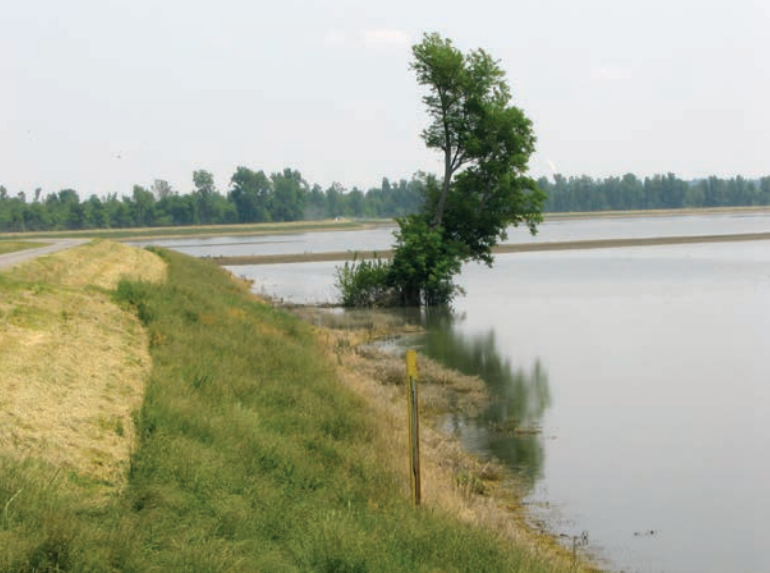
**FIGURE 10.1** The New Madrid Floodway and basin still had four to six feet of floodwater on May 20, 2011, 18 days after the US Army Corps of Engineers induced a breach at Birds Point, Missouri.

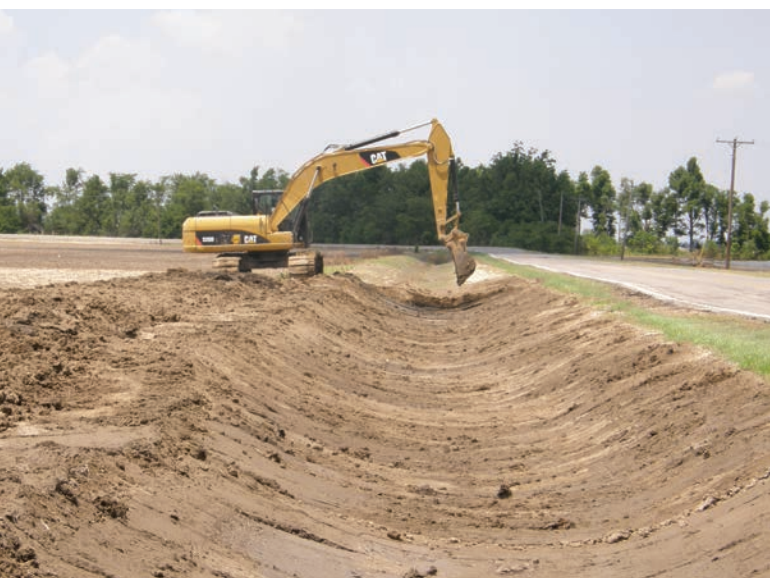
**FIGURE 10.2** Excavator cleaning out sediment in road ditches. Photo credit: Brett Miller, USDA Natural Resources Conservation Service soil conservation technician.

The 20,000 to 30,000 acres of drowned, fully grown but not grain filled wheat trapped significantly more sediment (few inches; figures 11.5 and 11.6) than fields with soybean stubble. More than 30 excavators worked from late May to November of 2011 to remove debris and sediment that was blocking drainage ditches (figure 11.7) in order to speed up the drainage process and to accelerate the drying out of low-lying areas. The sediment in private drainageways of most qualified landowners was removed with a 75% cost share from the USDA Farm Services Agency Emergency Services Agency's Emergency Conservation program. It took until October of 2011 for half of the last 15,000 acres to dry out sufficiently to allow tractor traffic and planting of wheat in the fall of 2011. The other half of the idle land (figure 11.4) was eventually tilled to mix in the sediment and to help dry out the fields. These remaining fields were planted to soybean or corn in 2012. In some places (especially along Route 77), the road ditches were filled with 3 to 6 feet of fine sediment and sand. In addition, there were hundreds of acres of thick sand deposits at both the Birds Point and the Big Oak Tree levee breaches, which had to be removed in 2011 and 2012.

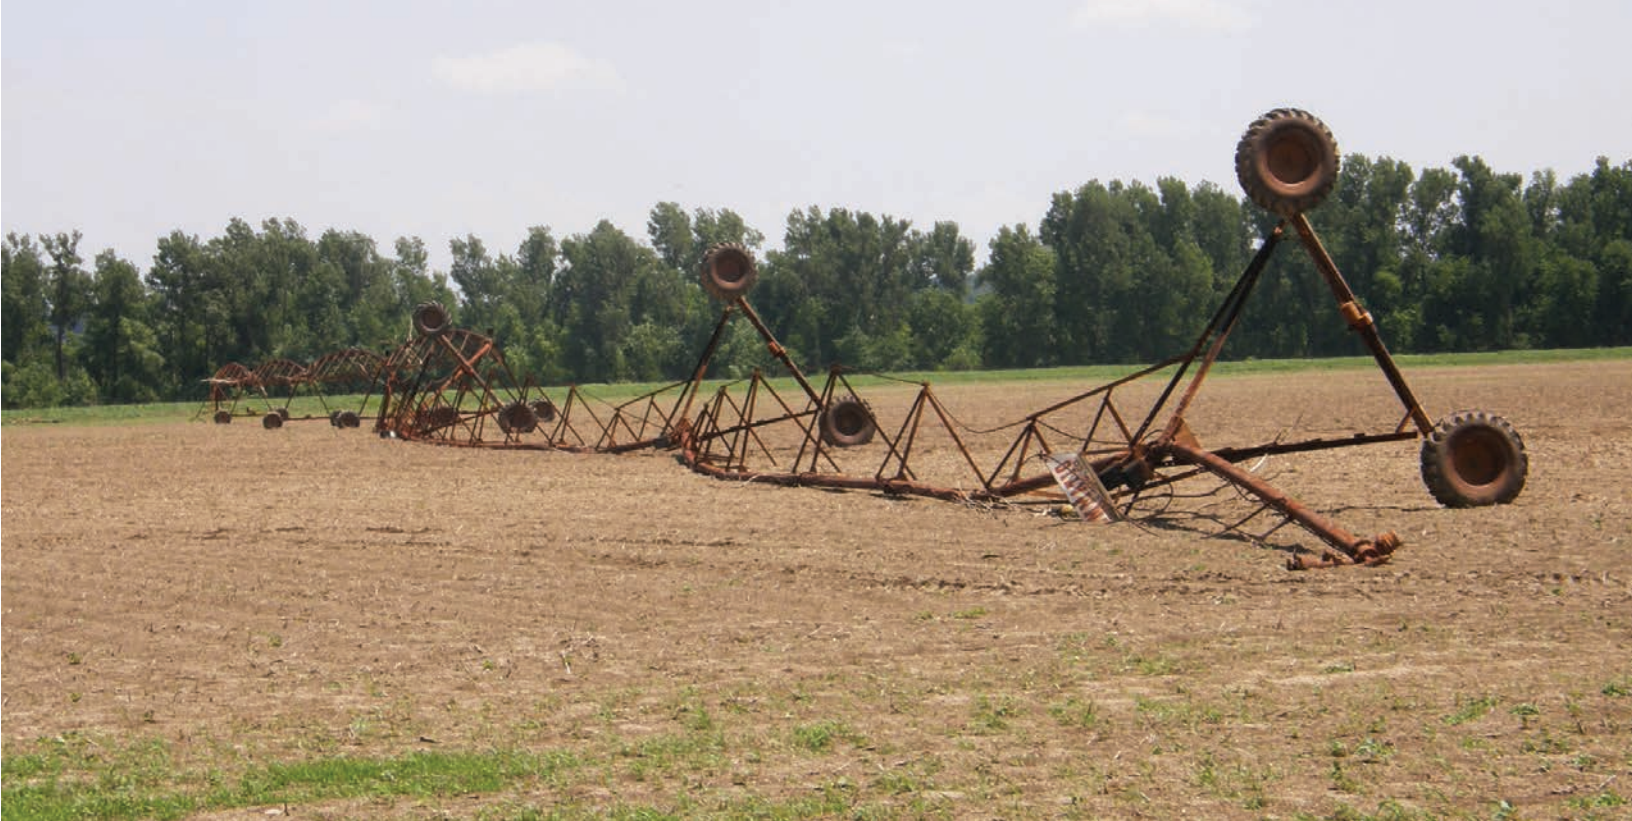
**FIGURE 10.3** An irrigation system was overturned by the force of floodwater and wind and then buried by a thick sand deposit. Photo credit: Brett Miller, USDA Natural Resources Conservation Service soil conservation technician.

Significant crater lakes existed in June of 2011 at two locations where the explosives were used (Birds Point, Missouri, fuse plug and the frontline levee near Big Oak Tree State Park, Missouri). The extreme force of the rushing water widened the holes in the levees (1.24 miles) at the Birds Point fuse plug and created six crater lakes adjacent to the levee breach. Each Birds Point crater lake was approximately 1.3 acres in size. At a few Birds Point sites, there were gullies extending into the fields from the crater lakes and subsequent creation of a deltaic sand deposit that was 1 to 4.6 feet thick and approximately 7.4 to 49.4 acres in size. Both the crater lakes and the thick sand deposits resulted in a permanent loss of agricultural land until the craters were filled in 2012 and the sand removed in 2013 [7]. The frontline levee near Big Oak Tree State Park had only one 16-acre crater lake extending through the levee and to the west (away from Mississippi River) and a thick, 3.3- to 6.6-foot deltaic sand deposit approximately 74 acres in size with additional sand deposits between 1 to 3.3 feet and more than 173 acres in size. This thick deltaic sand deposit was removed to permit the land to be returned to agricultural use. The road and drainage ditches along Highway 77 in Mississippi County approximately 2.5 to 3.7 miles south of Wyatt, Missouri, were filled with 3 to 6 feet of sediment and sand. Figure 10.2 shows an excavator removing about 2 feet of sediment from the road ditch. Irrigation systems were occasionally overturned by the force of water and wind and then buried by deltaic sand deposits (figure 10.3).

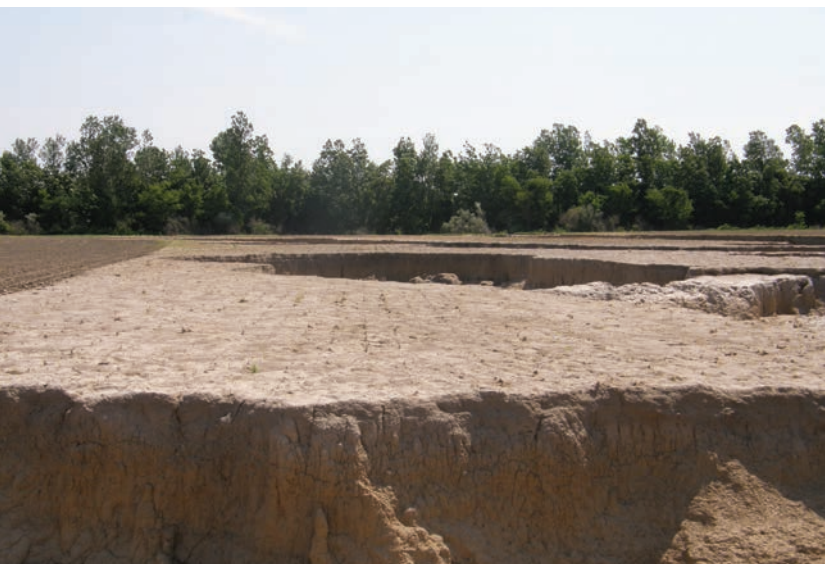
**FIGURE 10.4** Gullies extended into cropland. Soybean stems and roots can be seen between the gullies. The gullies were created during the use of the floodway in May of 2011.

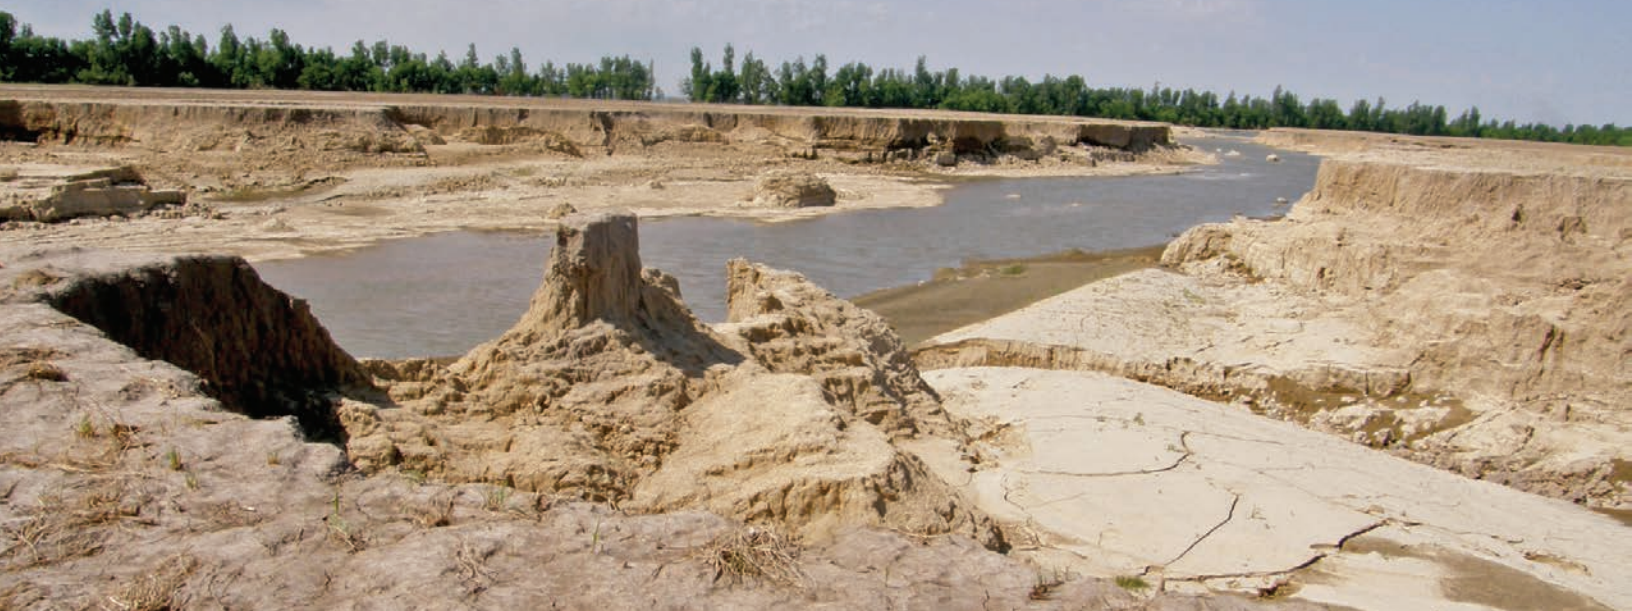
**FIGURE 10.5** Gullies and channels were created from May 4 to May 16, 2011. The main channel and attached gullies were 12 feet deep and removed cropland from production.

ters flowed rapidly over the higher flat land surface and then dropped back to lower bottomland soils to the west and south. This rapid dropping of floodwater in existing drainageways created turbulence and eroded the higher Dundee silt loam soils. Once an erosional channel was created, the channel concentrated the water, and up to 0.6-mile-long gullies (channels) were created. These gully fields were primarily located 5 to 10 miles to the south and west of the Birds Point levee breach and were not connected to the crater lakes next to the levee breaches. Some of the gullies were 12 feet deep, 150 feet wide, and

0.6 miles long (figure 10.5). Less than three-fourths of each gully field was planted to soybeans in June of 2011. The force of water, which created these large gullies (approaching small canyons in size), also removed road beds and resulted in the washout of a bridge.

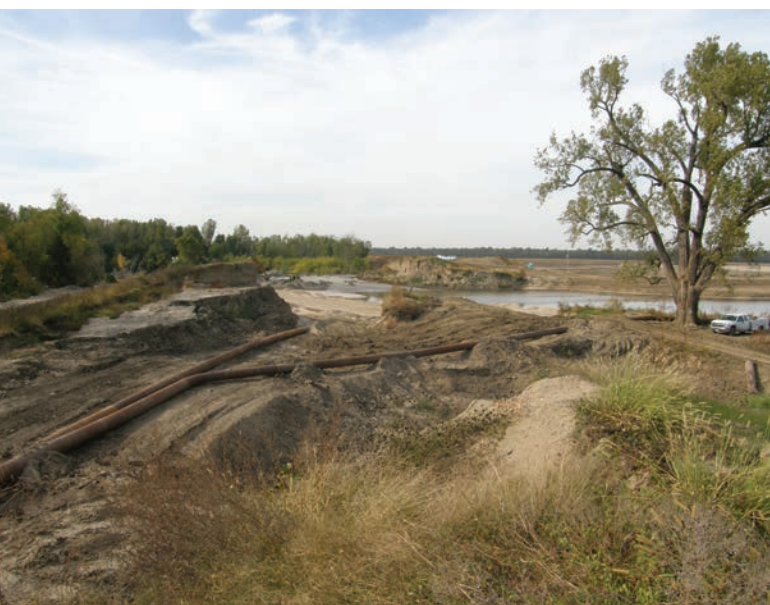
**FIGURE 10.6** A crater lake was formed at the Big Oak Tree frontline levee when the fuse plug was blown and floodwaters rushed into the floodway.

The decision to blow up the frontline levees of the New Madrid levee system (figure 10.6) in three places had significant consequences for rural Missouri landowners, farmers, and residents in the New Madrid Floodway. The impact of the floodwaters on the floodway appears to have

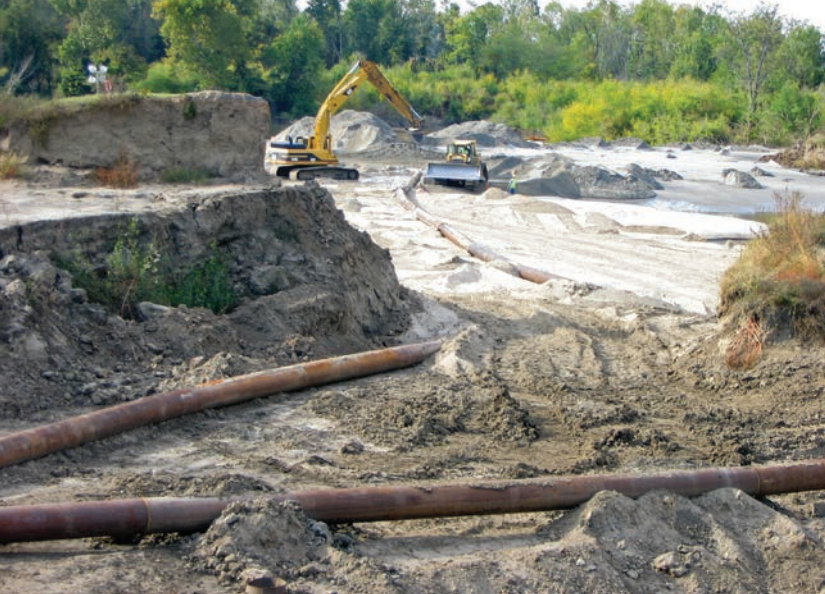
**FIGURE 11.1** The Big Oak Tree levee blast site was repaired in October of 2011 and reconnected to the 62.5-foot frontline levee.

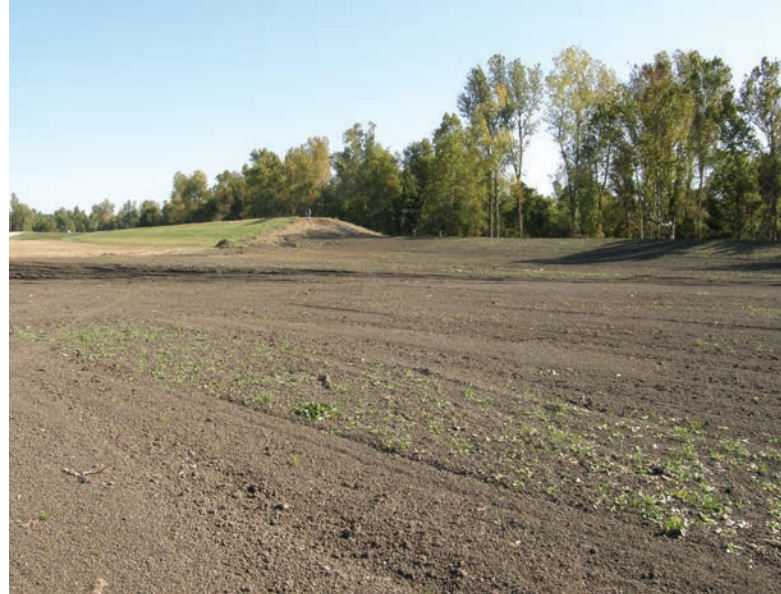
**FIGURE 11.2** The 2011 Birds Point levee patch built to 51 feet rather than the original 60.5 feet.

In the fall of 2011, the USACE began reconstructing the Birds Point and New Madrid fuse plugs and frontline levee near the Big Oak Tree State Park (figure 11.1). Initially, the fuse plugs at blast sites 1 and 2 (map 11.1), which were at 60.5 feet prior to the explosions, were rebuilt to only 51 feet (figure 11.2) because of insufficient federal funds to repair the levees [5]. The lower levee height was of great concern to floodway landowners who thought their lands were at considerable future

the USACE obtained additional funds from Congress to rebuild the levee patches (figure 11.2). Since 1884, the Mississippi River flooding exceeded the 55 feet only seven times including the record floods of 1927, 1937, and 2011 [6]. According to Michael Ward, assistant professor of animal ecology and conservation in the Department of Natural Resources and Environmental Sciences at the University of Illinois, the Big Oak Tree frontline levee repair was delayed, until after nesting birds (least tern [*Sternula antillarum*], a state endangered species) left the area in the fall of 2011. The frontline levee near Big Oak Tree State Park (figure 11.3) was then rebuilt to 55 feet in October and November of 2011 to prevent potential flooding in spring of 2012. The top of the frontline levee patch was covered with canvas since it was too late to establish a vegetative cover (figure 11.3).

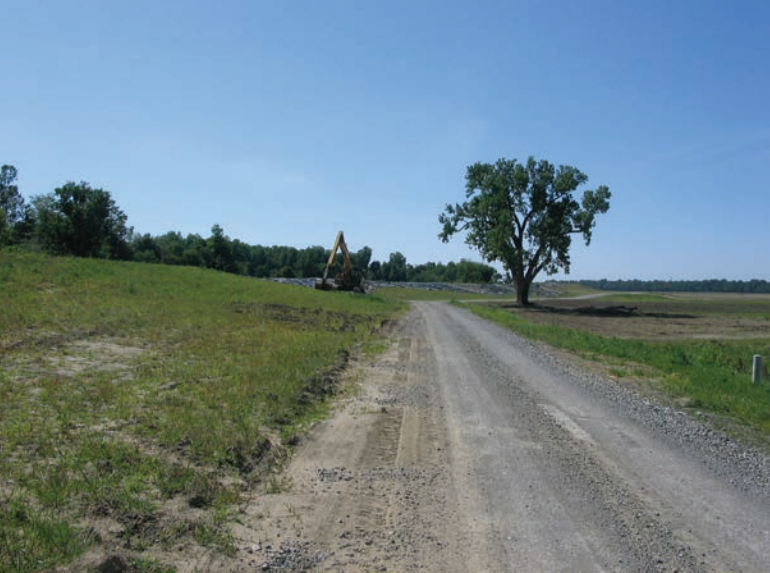
**FIGURE 11.3** The site of the third explosion on the frontline levee is located near Big Oak Tree State Park. The levee is being reconstructed where the crater lake extended into agriculture lands.

In March of 2012, the USACE received \$22 million to raise the patched floodway levees from 55 to 60.5 feet at the fuse plugs locations and to 62.5 feet at the frontline levee. On May 30, 2012, the USACE released contracts to private contractors to begin raising the three levee patches to original height. A protest letter from a private contractor, who lost the bid due to paperwork problems, delayed the start of the repairs at Birds Point for about seven weeks. Thanks to drier than normal weather, much of the levee work was completed by November of 2012 [7]. The USACE filled in the crater lakes and reestablished washed-out roads at the base of the levee, reconnecting levee roads to the west and south (figure 11.3).

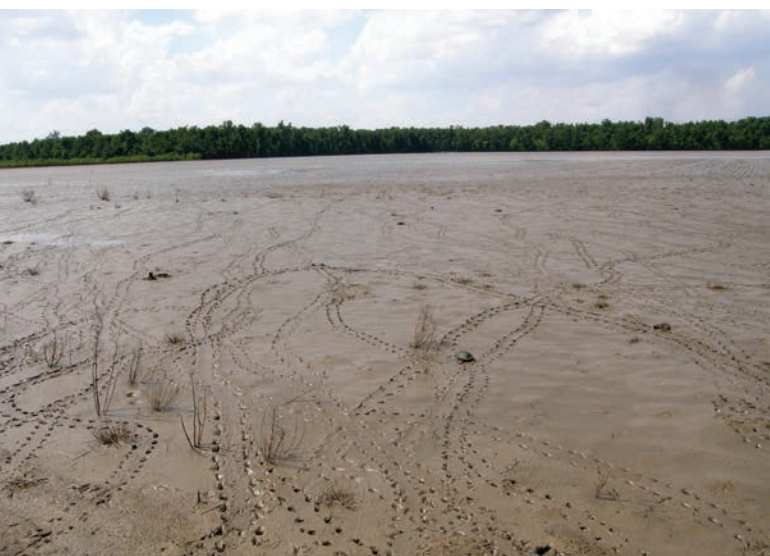
**FIGURE 11.4** Low-lying soils remained wet on October 24, 2011, more than five months after the floodway opening and could not be cropped in 2011.

The total 2011 crop loss included 20,000 to 30,000 acres of low-lying clayey soils [10, 11] (figure 11.4) and 20,000 to 30,000 acres of drowned winter wheat (figure 11.5), which either remained too wet to plant to soybean in 2011 or, if planted to wheat, did not result in a harvested crop in 2011. About 1,500 acres of agricultural lands, near the blown-up levees at Birds Point and Big Oak Tree, had crater lakes and gullies and were not farmed in 2011 since the craters were only partially filled in and the thick sand deposit at the Big Oak Tree breach was only

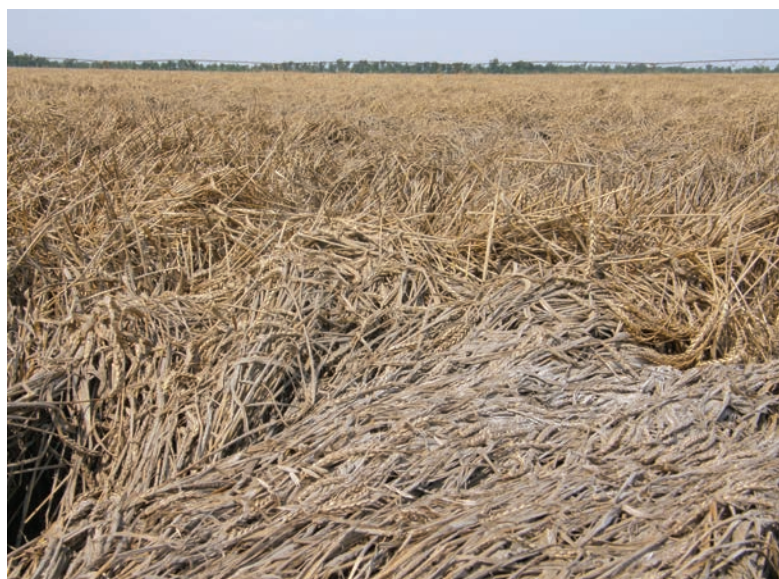
**FIGURE 11.5** Drowned wheat collected significant sediment and protected against soil erosion.

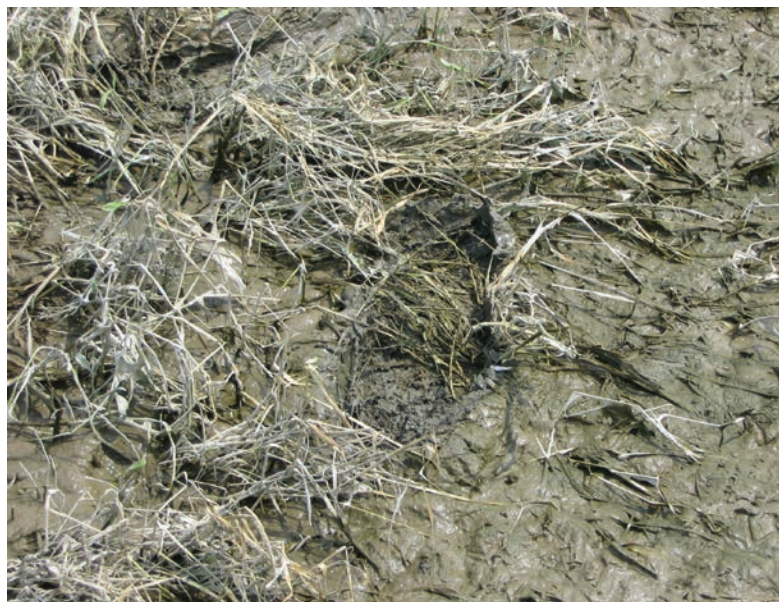
**FIGURE 11.6** Organic and clay coating on plants after flooding and floodwater drainage can often be tilled into the soil.

Thin coatings of silt covered much of the 133,000 acres in the floodway. The sediment deposits were much thicker in the drowned wheat fields with extra plant residue. Most of the thin silt and clay deposits were exposed to sunlight with tillage to speed dry and incorporate deposits into the plow layer (figure 11.6). Through the Emergency Watershed Protection (EWP) program administered by the USDA Natural Resources Conservation Service (NRCS) and sponsored by county governments or drainage districts, the sediment deposits in large drainage ditches were removed. Sediment deposition on private farm waterways was removed on a cost share basis by a program administered by the Farm Services Agency and NRCS with \$3 million in technical support. Excavators in Consolidated Drainage District 1 of Mississippi County scooped out silt from the drainage ditches (figure 11.7) and loaded it onto trucks to create ditch banks further down the ditch. The work was accelerated when the president of Consolidated Drainage District 1 signed an amendment to an

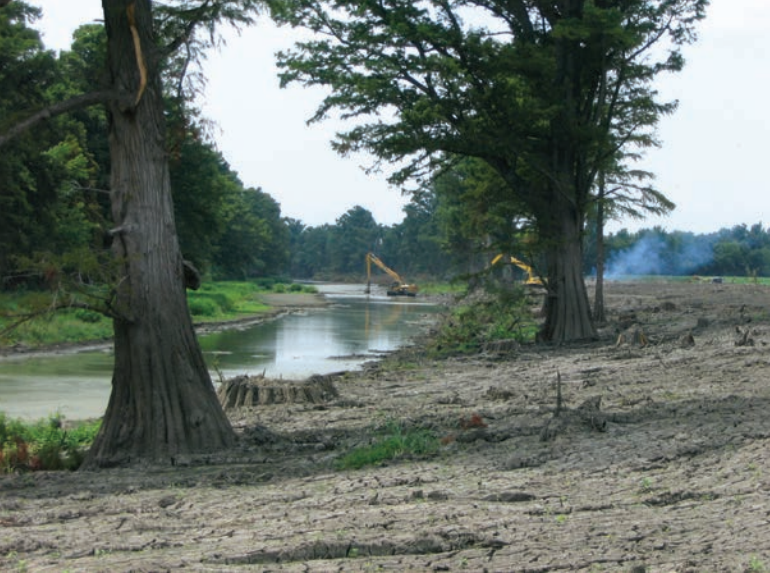
**FIGURE 11.7** Two excavators remove sediment from a drainage ditch and spread it on the stream bank surface.

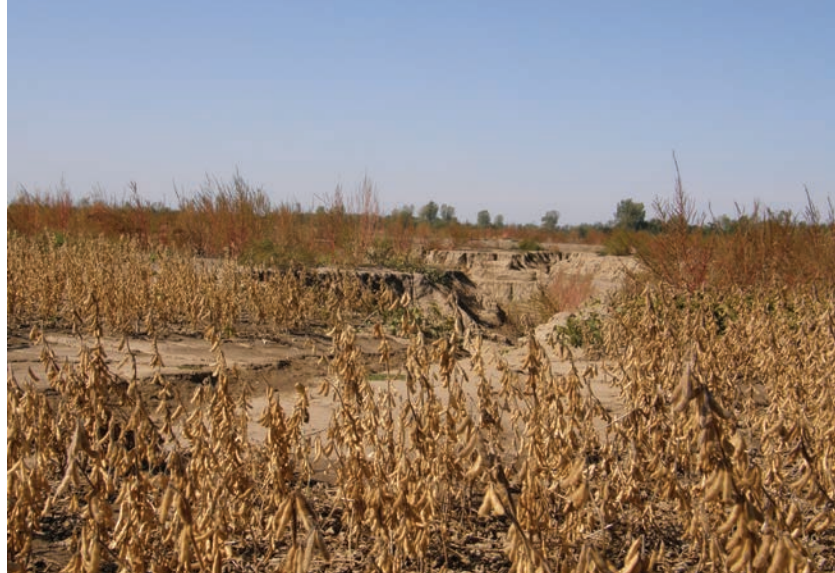
**FIGURE 11.8** The 2011 soybean crop was planted around the gullies, which prevented farmers from cultivating hundreds of acres of land.

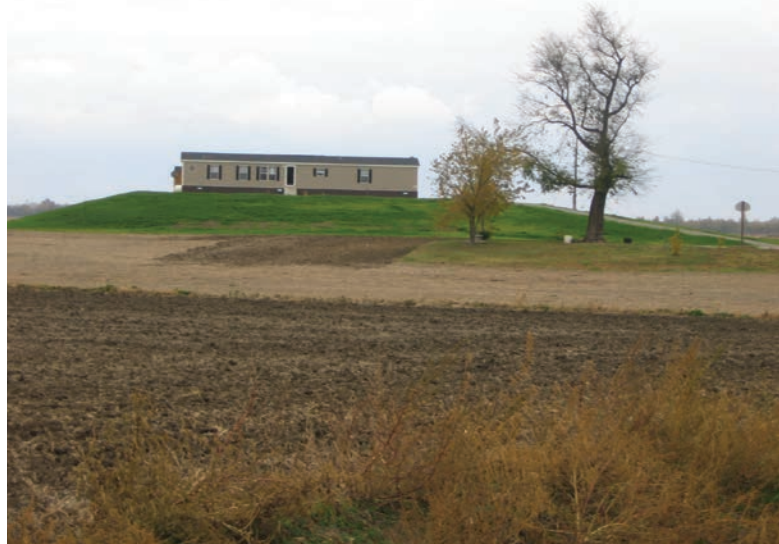
**FIGURE 11.9** A home is rebuilt on an eight-foot-high mound of soils to protect against future flooding.

The bottomland soils of the New Madrid Floodway are some of the most productive cropland in the state of Missouri, in the north-central United States, and in the nation. Reclamation efforts subsequent to the flood have been substantive. There were very significant crop losses in 2011. Crop insurance provided replacement income for farmers who had purchased insurance. Even as the gully fields were reclaimed, the regraded soils have more parent material mixed into the new root zone, which will likely lower the crop yields and productivity of the soils due to the lower soil organic carbon content, greater slope, and lack of topsoil and subsoil materials in the root zone. Most of the damaged agricultural lands were reclaimed, tilled, and planted to crops in fall 2011 and 2012, except for part of the big gully field on O'Bryan Ridge, the filled-in Birds Point and Big Oak Tree crater lakes, and the remaining deltaic sand deposits. Public dollars helped to cover the \$16.2 million in crop insurance payments, \$10 million for the USACE to repair and raise the levees to 51 feet and then to 55 feet, and eventually another \$22 million to restore the damaged levees back to the original height. A few homes were reestablished on soil mounds to protect against future flooding (figure 11.9).

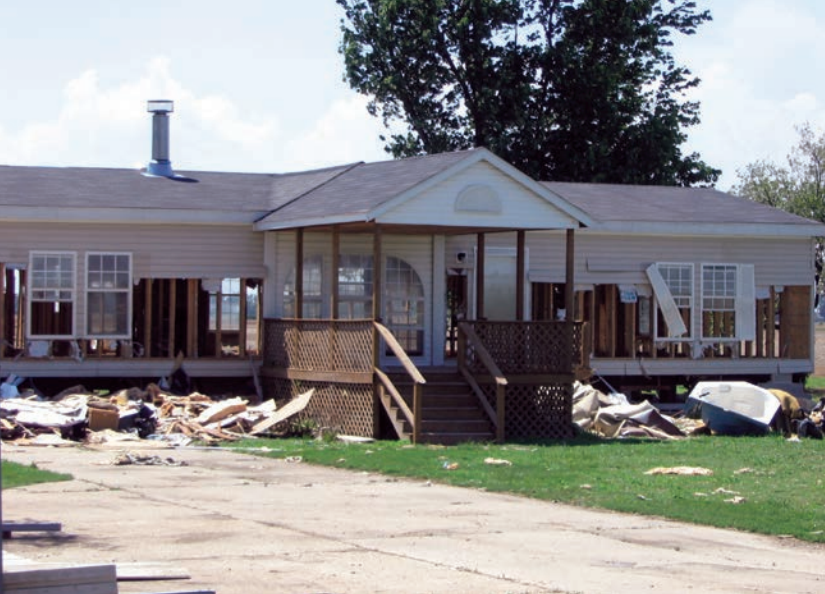
**FIGURE 12.2** One of the 80 homes in the floodway damaged by the 6 to 10 feet of floodwater in 2011.

The May 2, 2011, induced breach at Birds Point levee, the first explosion site, and the flooding of the New Madrid Floodway resulted in evacuation of homes and businesses but no loss of life. However, there was severe damage to most of the 80 homes (figure 12.2), a few churches, and 120 barns (figure 12.3) and shed structures that were impacted by the force of flowing water and the 3 to 6 feet of temporarily stored water [9]. Water pressure caused loss of the lower half of walls, damaged most wooden floors, and in over 100 cases completely destroyed structures. Only eight home sites were raised with soil and sand by approximately 10 feet (figure 12.4) by the end of 2014. The local roads and bridges sustained considerable damage from the floodwaters. The Mississippi County transportation department requested \$75 million from the USACE to repair the roads and bridges. That request was denied in July of 2012. However, another request for funds was submitted in 2012 to repair the roads damaged by the heavy trucks used to haul soil materials from west of Wyatt to patch the Birds Point levee fuse plug and fill in the crater lakes.
