# Managing Mississippi and Ohio River Landscapes

Kenneth R. Olson and Lois Wright Morton

Soil and Water Conservation Society  
Ankeny, Iowa

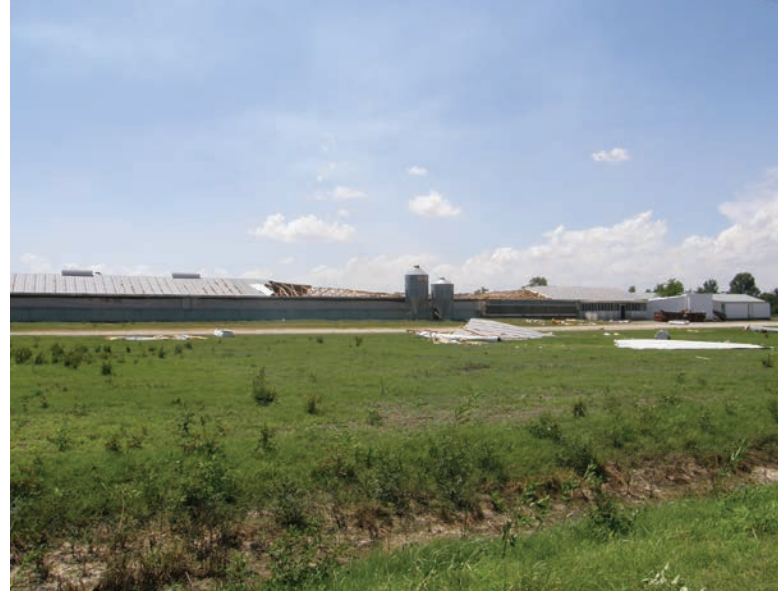
**FIGURE 12.3** Farm structures including a hog confinement facility were damaged by floodwaters and wind when the floodway was opened in 2011.

The May 2, 2011, induced breach at Birds Point levee, the first explosion site, and the flooding of the New Madrid Floodway resulted in evacuation of homes and businesses but no loss of life. However, there was severe damage to most of the 80 homes (figure 12.2), a few churches, and 120 barns (figure 12.3) and shed structures that were impacted by the force of flowing water and the 3 to 6 feet of temporarily stored water [9]. Water pressure caused loss of the lower half of walls, damaged most wooden floors, and in over 100 cases completely destroyed structures. Only eight home sites were raised with soil and sand by approximately 10 feet (figure 12.4) by the end of 2014. The local roads and bridges sustained considerable damage from the floodwaters. The Mississippi County transportation department requested \$75 million from the USACE to repair the roads and bridges. That request was denied in July of 2012. However, another request for funds was submitted in 2012 to repair the roads damaged by the heavy trucks used to haul soil materials from west of Wyatt to patch the Birds Point levee fuse plug and fill in the crater lakes.

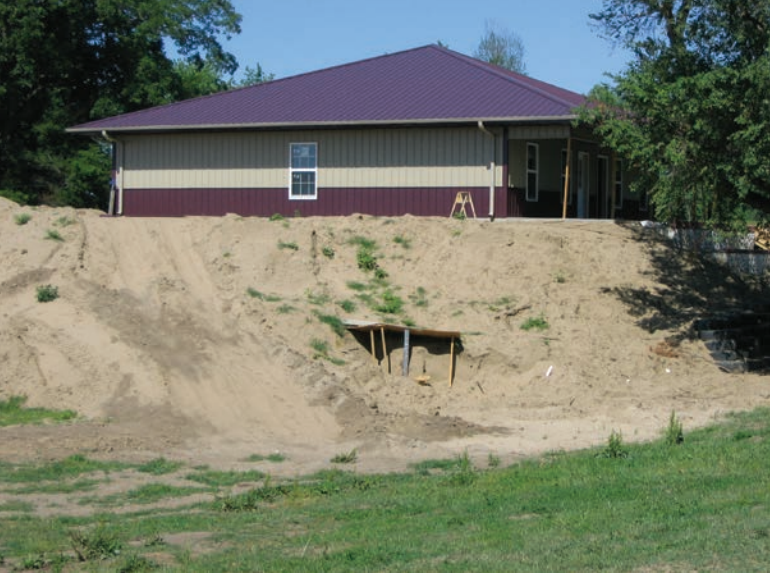
**FIGURE 12.4** One of the new homes was built on 10 feet of soil materials to prevent future flood damage.

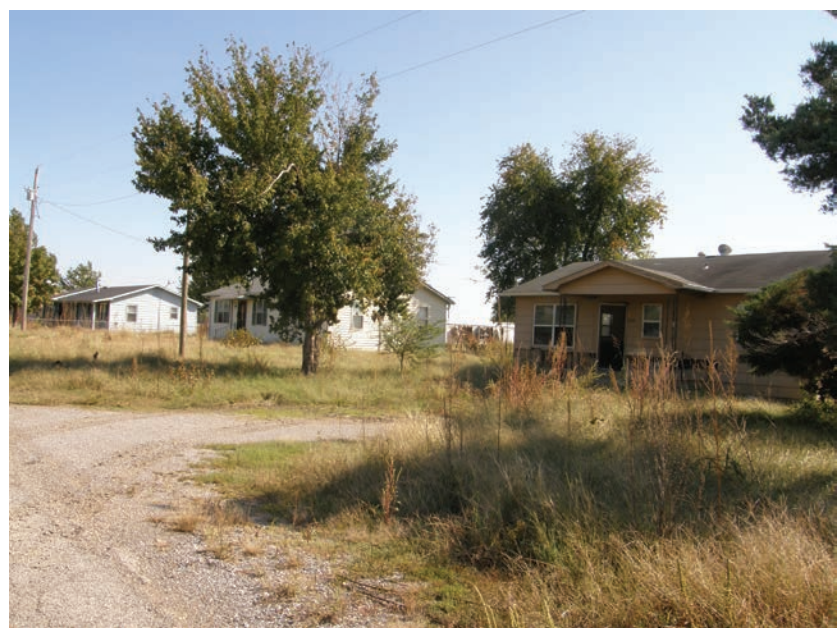
**FIGURE 12.5** Homes in the village of Pinhook in November of 2011 were abandoned after they were damaged by 6 to 10 feet of floodwater.

In 2011 and 2012, the residents of Pinhook searched for land and money to relocate together outside the floodway. Assessment of the Village of Pinhook by the Federal Emergency Management Association (FEMA) determined nearly every home's damage to be greater than 50% of its value. Consequently, the Pinhook residents would have to elevate their homes on stilts if they wanted to legally rebuild there. FEMA offered up to \$30,000 to each homeowner for these repairs. Most Pinhook residents, many of them senior citizens, did not accept those conditions. Some homeowners in Pinhook had home insurance but not flood insurance [11, 12]. A FEMA buyout was eventually accepted by owners of 21 properties (figure 12.5) totaling \$1.17 million, according to the Bootheel Regional Planning and Economic Development Commission. On November 9, 2011, the community of

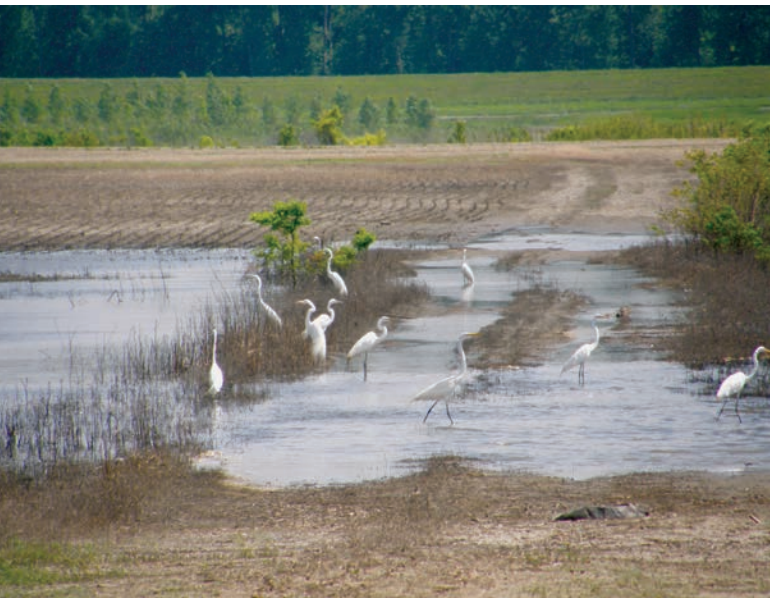
**FIGURE 12.6** Birds build nests in the low, wet areas adjacent to the Big Oak Tree levee blast site where the inflow of floodwater created crater lakes and ponds.

A second, more modest redesign would keep the frontline levee in the current location and convert about 2,500 acres of levee-protected but flood-vulnerable acres of low-lying bottomlands from agricultural use to parkland and wetlands (map 12.1). These are the lands located adjacent to blast site 3 (figure 12.6) between the Seven Island Conservation Area and the Big Oak Tree State Park (map 12.1). Part of this area could be purchased by the State of Missouri to expand Big Oak Tree State Park. Landowners in the floodway, the Department of Natural Resources, State of Missouri, levee and drainage districts, and USDA NRCS should explore the potential land use change options for the area surrounding the Big Oak Tree State Park. Other adjacent low-lying bottomlands may be eligible for a USDA NRCS Wetlands Reserve Program permanent easement using two 30-year easements or a restoration cost share agreement if this program is renewed. If purchased with state or federal resources, these wetlands and parklands would provide multiple benefits, retaining current storage capacity at flood stage as well as enhancing local wildlife habitat (map 12.1) with ecological and recreational values. This area historically was late to dry out since it collected the greatest depth of floodwater when the Mississippi River was high and when the floodway was opened, with substantive repair costs following flooding. Returning this 2,500-acre area to its original wetland condition would have an economic impact on current agricultural uses. However, the rebuilding of the ecological infrastructure would also reduce future flood restoration costs in terms of crop land reclamation, damage to roads, and leveed structure repairs. Any

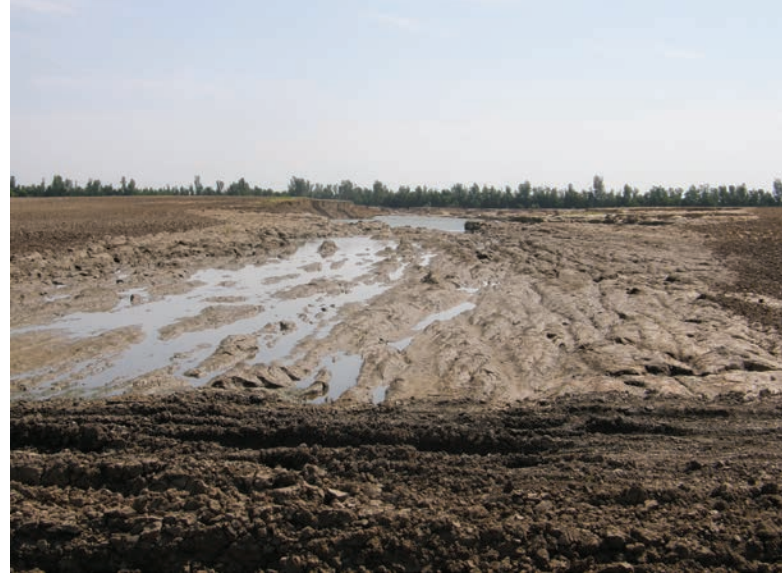
**FIGURE 13.1** Land scouring of the bottomland located below the gully fields.

Missouri by inducing a breach in the Birds Point fuse plug levee (map 13.1). An unintended conversion of agricultural land to wetlands and ponds occurred within the land scoured bottomlands (figures 13.1 and 13.2) in the O'Bryan Ridge field. These gully lands have since been partially regraded and reshaped in an effort to return the agricultural land to production.

Three major gully fields were created on O'Bryan Ridge as a result of the induced breach [6]. Two of the gully fields were reclaimed in 2011 and 2012. The third major gully field, owned by Levee District Number 3 (figures 13.1, 13.2, and 13.3), is examined here to assess the effects of gullies on soil properties, soils, soil productivity, land use change, and agricultural production. This gully field did not qualify as a priority area identified by the USACE as needing immediate restoration and repairs. All the priority areas including levees, crater lakes, and roads were restored by the fall of 2012.

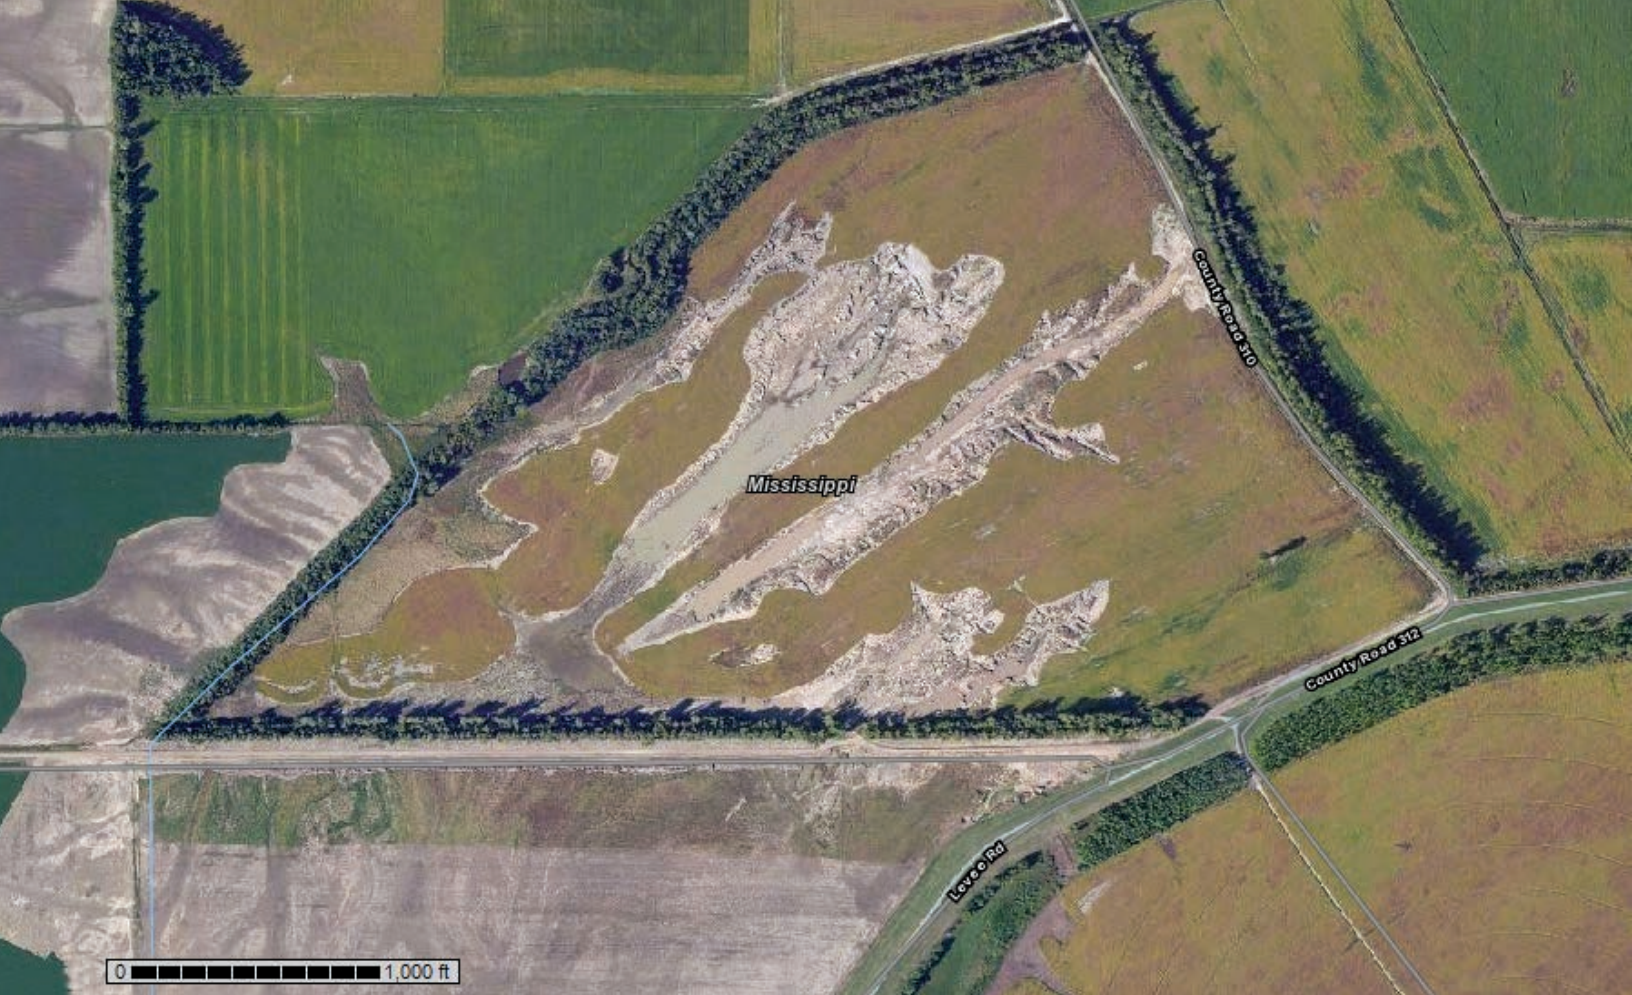
**FIGURE 13.2** May of 2011 aerial view of O'Bryan Ridge gully fields.

acres of the 195-acre field could not be farmed as a result of the deep gullies (figure 13.2 and map 13.2b). Farm equipment had to be kept back from the 12-foot-high vertical edges of the gullies (see figure 10.4), and the land between the gullies could not be cultivated [5]. In June of 2011, the farmers needed access to their fields and the USACE needed access to levees for maintenance, so CR 310, on the east side of the gully field, was reconstructed by partially filling in a 12-foot-deep and 100- to 160-foot-wide gully (figures 13.2 and 13.3). The field was again planted to soybean in 2012, 2013, and 2014. No attempt was made to reclaim the gully fields until the spring of 2013, or two years after floodway use by the USACE.

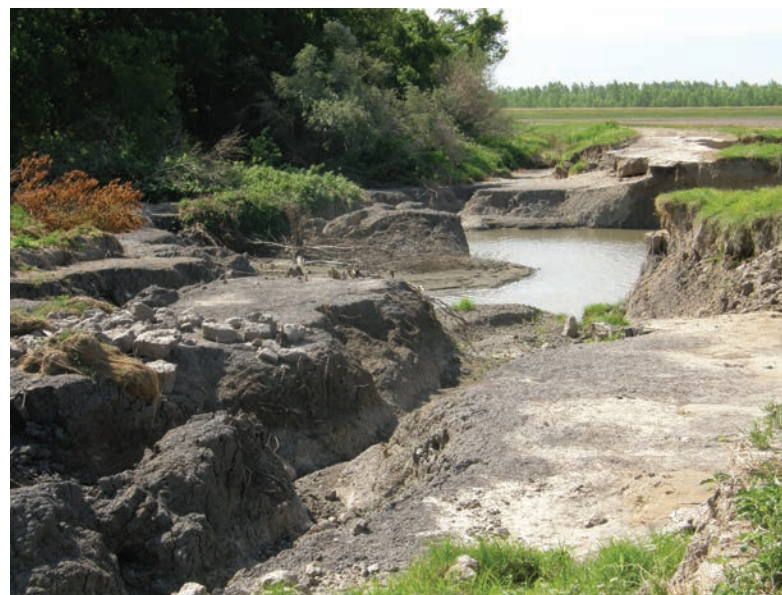
**FIGURE 13.3** Gully development in the O'Bryan Ridge soybean field caused trees to fall into channels and undercut County Road 310.

breach and craters, the floodwaters ponded in front of O'Bryan Ridge, an old Mississippi River meander bank or natural levee, which was about 6.6 to 8.3 feet higher than the alluvial bottomlands and approximately 6 miles long and 0.6 mile wide. Once the ponded floodwater reached 6.6 to 8.3 feet, the water began to flow rapidly over the soybean field on O'Bryan Ridge. As the floodwater dropped off the ridge, it concentrated in old drainageways and waterways (figures 13.2 and 13.3), cut gullies into the alluvial bottomland (Sharkey soils) on the west side of O'Bryan Ridge due to hydraulic jumping, and created canyon-sized gullies (figure 13.3; see figure 8.8) up to 0.6 mile in length through the entire width of the ridge [5].

The disastrous consequences of flooding and severe land scouring from the induced breach were probably not anticipated by landowners since the floodway had not been used since 1937 (or in most landowners' lifetimes). The bottom of the trenches eroded more than 3.3 feet below the bottomland surface (figure 13.3) and 12 feet below the surface of the O'Bryan Ridge [6, 7]. A channel was created 0.6 mile from west to east (figure 13.2), which undercut the gravel road (County Road [CR] 310) and extended into the wooded bottomland border area. A series of canyon-sized gullies cut into the O'Bryan Ridge in a dendritic pattern (figure 13.2; see figure 10.5). Some did not cross the entire 0.6-mile ridge. Other gullies cut through the tree line on the south side of the gully field, dissected CR 312 on the south of O'Bryan Ridge, and nearly reached a section of the adjacent frontline levee. The gullies between CR 312 and the frontline levee qualified as a USACE priority area and were reclaimed in the fall of 2011 and spring of 2012.

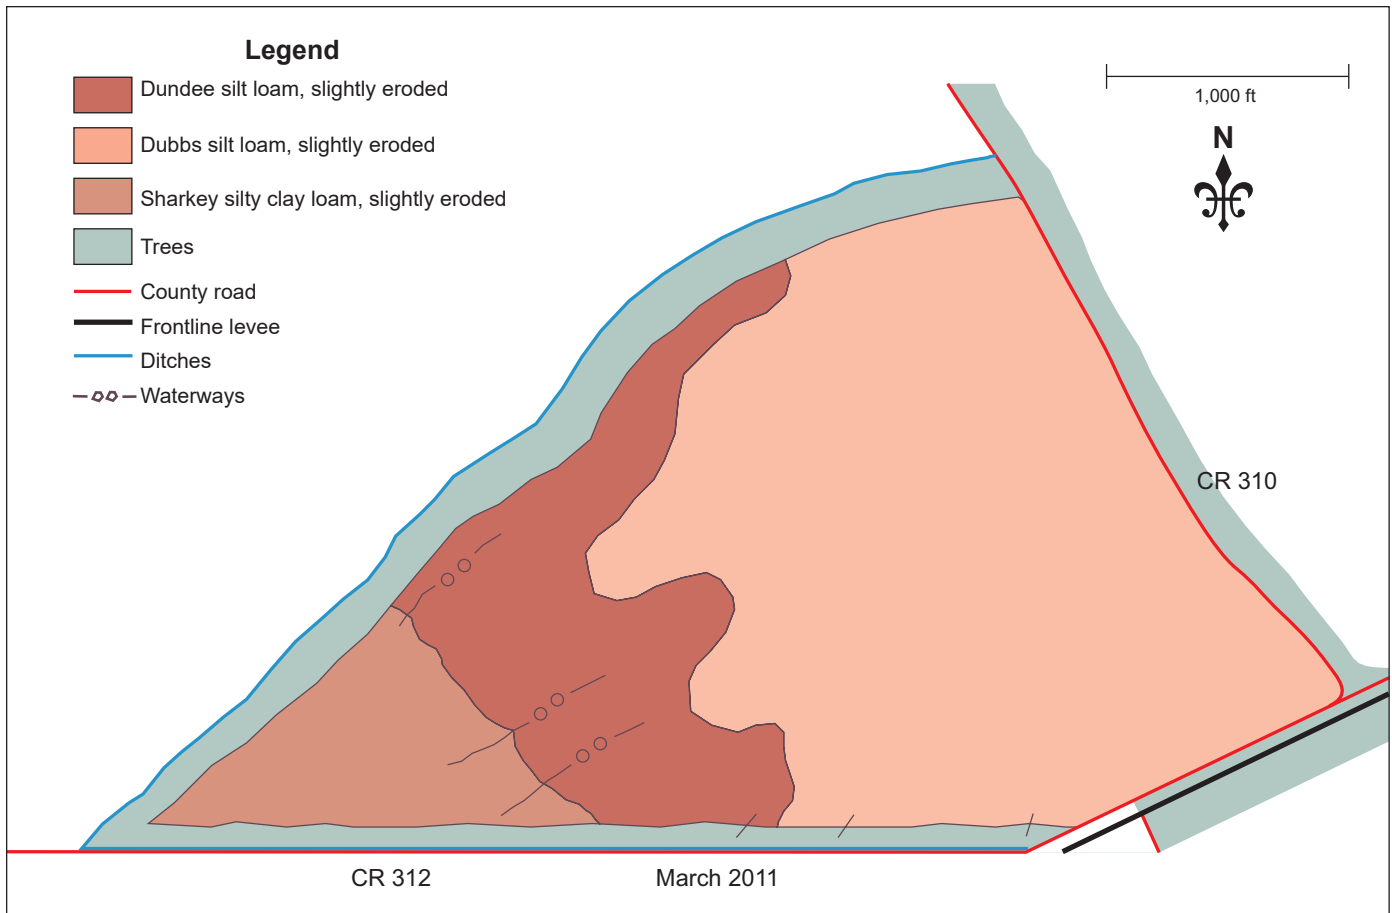
**MAP 13.2a** March of 2011 soils prior to levee breaching in the floodway on O'Bryan Ridge. Cultivated Dubbs and Dundee soils form a natural levee to the east of Sharkey bottomlands.

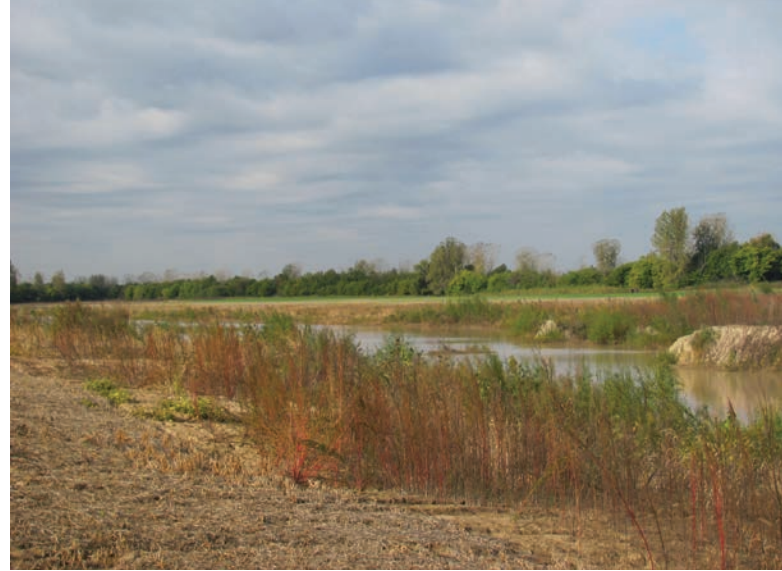
**FIGURE 13.4** The deep gullies in O'Bryan Ridge became wetlands and ponds.

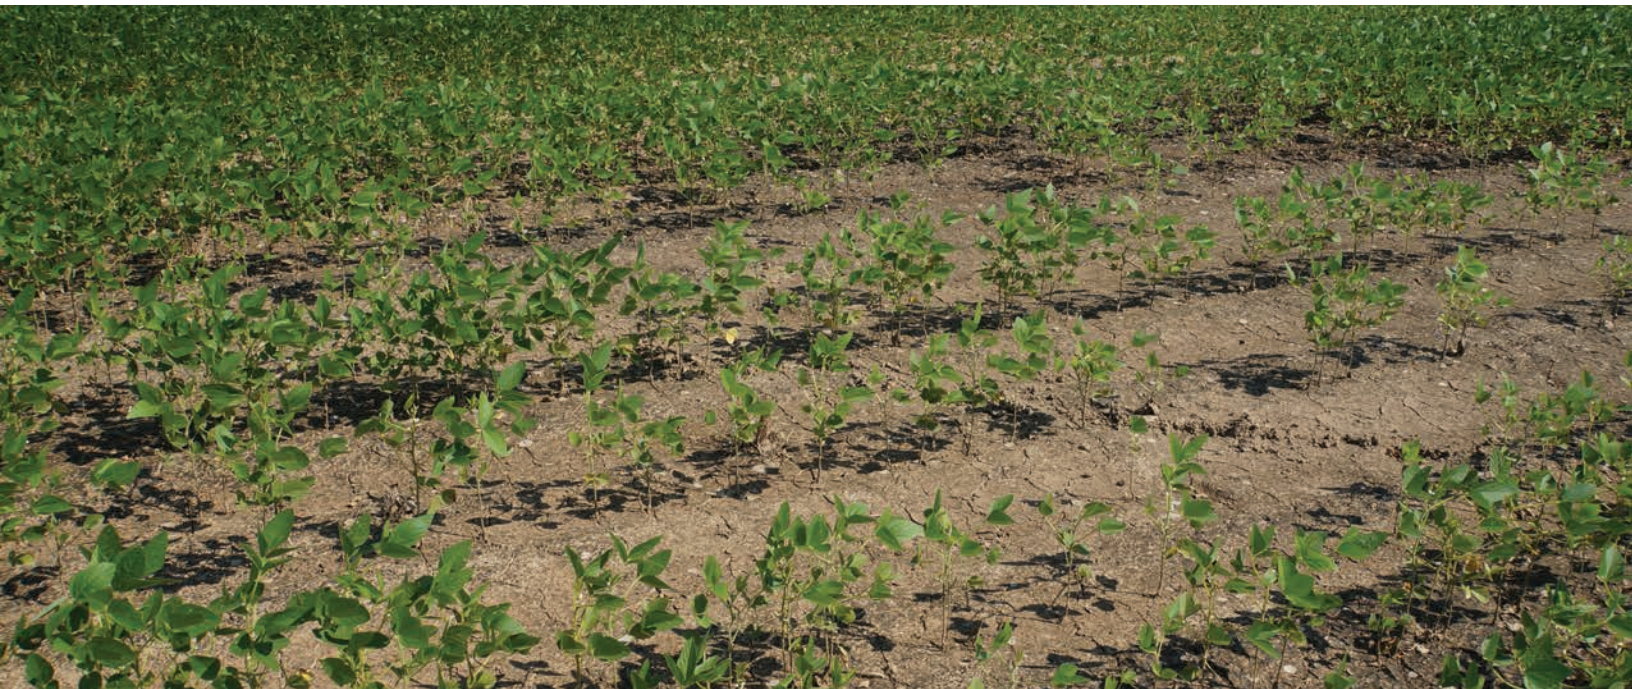
**FIGURE 13.5** Soybeans growing on Udifluents and adjacent land scoured ridgetops.

The soybean plant heights in August of 2015 on the Udifluents soils were much lower than on the adjacent land scoured ridgetops (figure 13.5). Soybean plant biomass and plant height normally correlate well with grain yields. This suggests that four years after the floodway use the soybean yields of the graded soils were most likely significantly lower than the eroded ridgetop soils and the soybean yield loss is likely permanent. Even extensive reclamation efforts in the spring of 2014 (map 13.3b) could only mitigate and restore part of the soil productivity and yield capacity loss. The land use change to wetlands appears to have been temporary, and the land has been returned to agricultural use through grading and reshaping. The 195-acre levee district field, which formerly produced an average of 8,550 bushels of soybeans in 2010, produced an average of 4,820 bushels in 2011 and 2012—a loss of 44% or 3,730 bushels after gully field creation (map 13.2b).

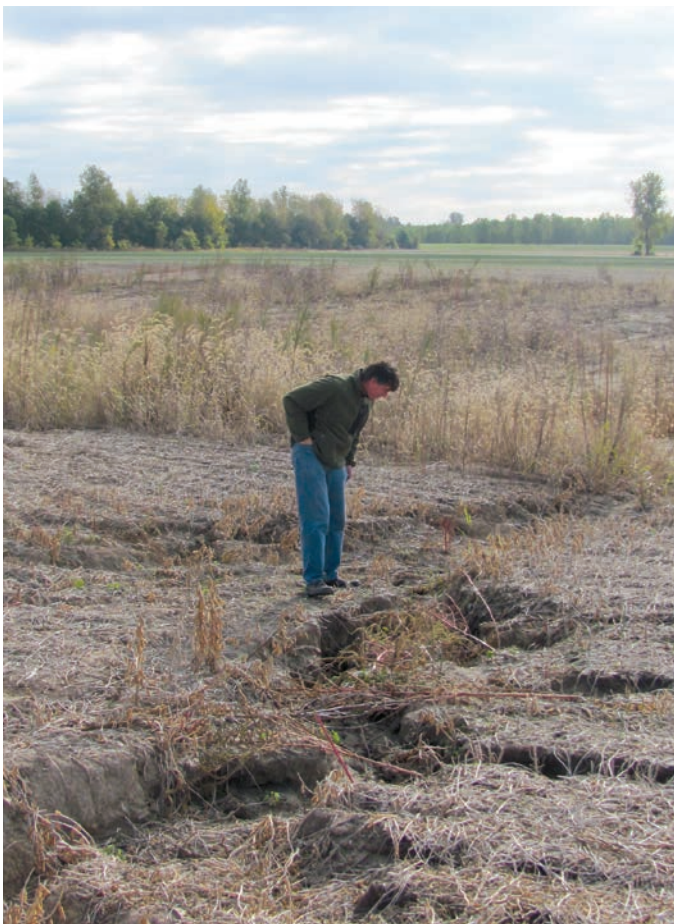
**FIGURE 13.6** Rill and gully erosion occurred after planting soybean in 2013 on regraded slopes and filled land.

The attempt to reshape the gullies by regrading and filling with soil to increase soybean production had the unintended outcome of creating rills (figure 13.6). The negative impacts of the cutting and filling operations on soil productivity will need to be remediated by restoring natural ecological functions to the affected soils. Organic matter additions to the soil, such as biosolids and composts, decrease the bulk density of soils, increase infiltration rates and porosity, and contribute to better soil structure [8, 9, 10]. The use of cover crops can also be an important management tool for protecting soils from erosion during dormant seasons and for reestablishing key soil quality indicators [11, 12].

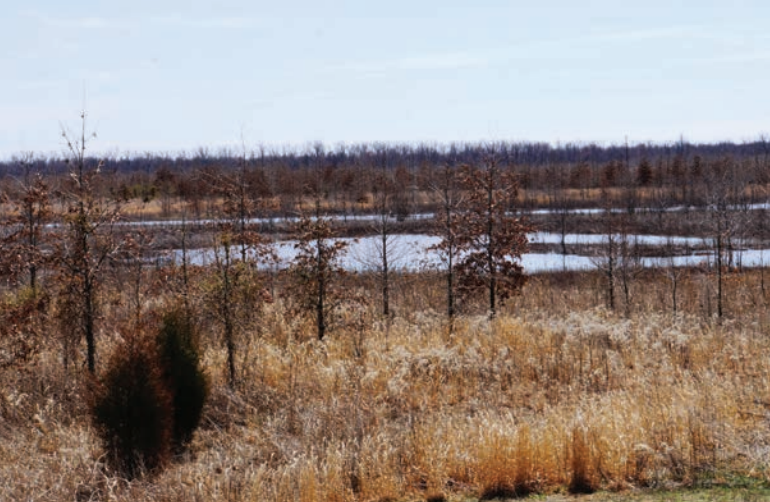
**FIGURE 14.1** Reestablishing wetland habitats at Grassy Slough near Karnak in the middle Cache River watershed.

stretches of the valley [2] provide evidence of this glacial flooding. With increasing sediment fill and changes in climate, the Ohio River shifted away from the Cache River into its present course. As a result, the Cache River became a slow-moving stream with extensive isolated, low, swampy areas (figure 14.1) and a water table that ebbed and flowed with seasonal precipitation [3].

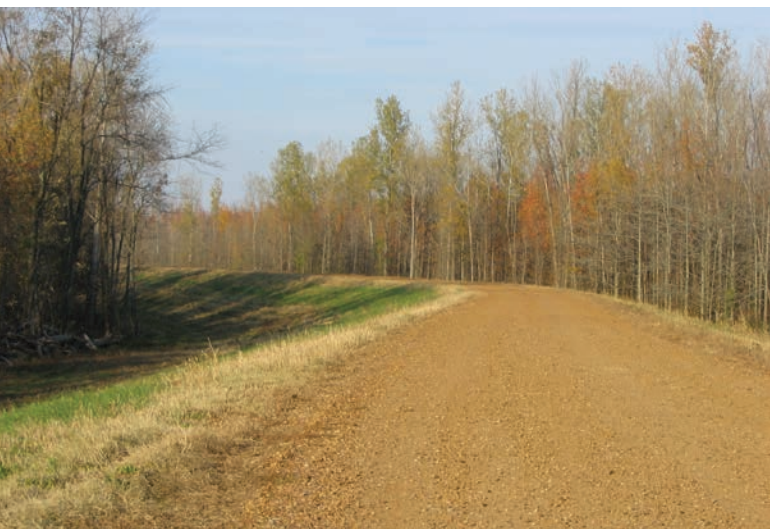
**FIGURE 14.2** The diversion embankment redirects the middle Cache River water into the Mississippi River and blocks it from draining into the Ohio River via the lower Cache River.

The Cache River basin drains 524,786 acres while meandering 110 miles throughout southern Illinois before emptying into the Mississippi River through a diversion ditch (figure 14.2) southwest of Mound City, Illinois [4]. In 1905, 250,000 acres of the Cache River watershed was considered to be too wet and worthless for farming. The Cache River Drainage District was created in 1911 with the specific purpose of constructing the Post Creek Cutoff to drain the northern region of swamps and sloughs to create agricultural lands [5]. The Post Creek Cutoff (map 14.1 and figure 14.3) was constructed between 1912 and 1915 and rerouted the upper Cache River water into the Ohio River southeast of Karnak, Illinois. By 1916 the 4.8-mile-long cutoff was 30 feet wide and 10 feet deep [6] and diverted 60% of the upper Cache River water due south and into the Ohio River. The Post Creek Cutoff gradient was 12 inches per mile near Grand Chain Bridge, and the diversion has become a canyon in size. The steep gradient and straight channel accelerated flows and started a severe erosion process. The

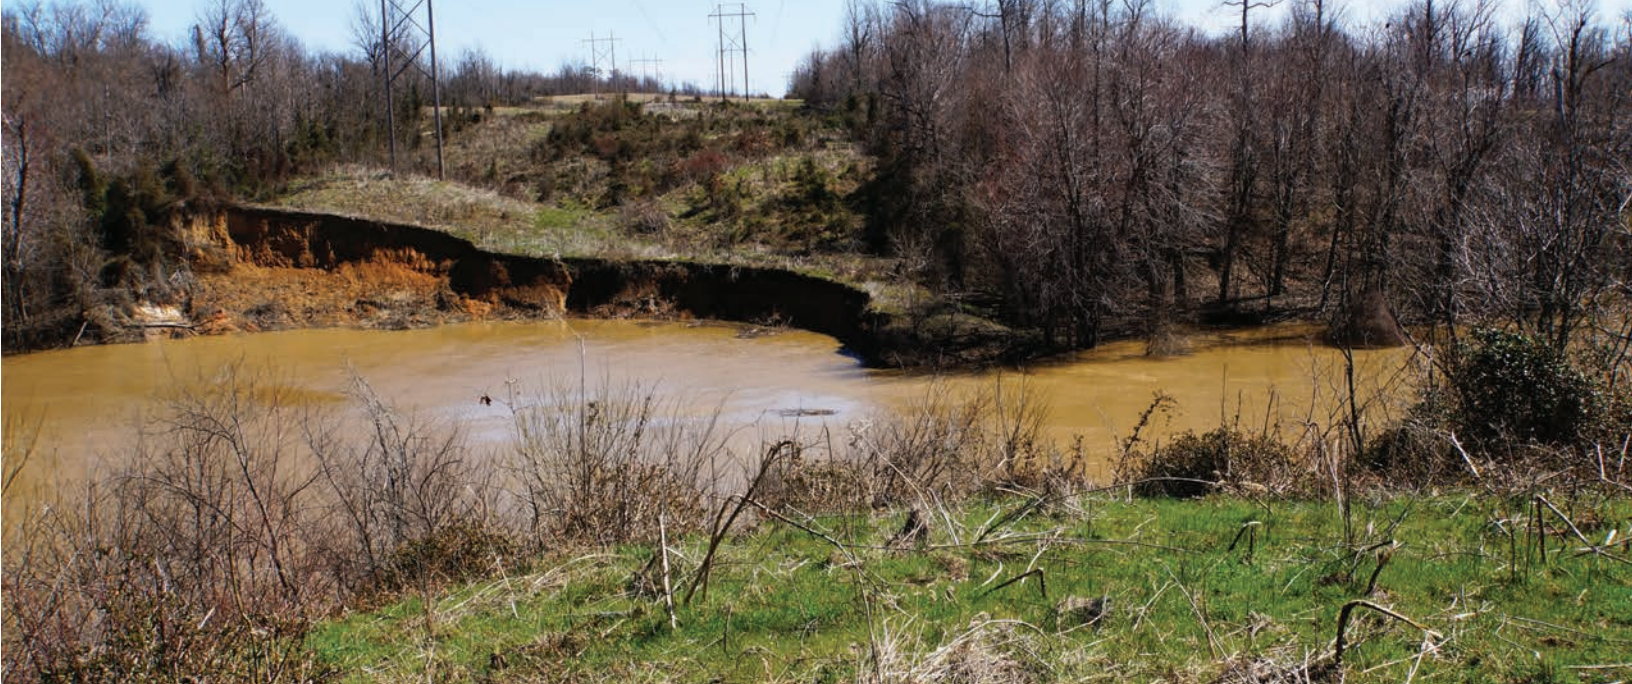
**FIGURE 14.3** The Post Creek Cutoff dug in 1912 has highly eroded banks and sediment loads that are deposited at its mouth as it drains into the Ohio River.

southern part of the channel, an old creek, is now 200 feet wide and 64 feet deep and represents severe gully advance and formation (figure 14.3).

Over time the Main Ditch (figure 14.4) and Post Creek Cutoff (figure 14.3) deepened and widened, as did many side streams and ditches. These laterals became gullies, some more than one mile long extending into adjacent farm fields, which created field equipment access problems and loss of usable farmland. The Main Ditch and Post Creek Cutoff also lowered the water table and resulted in loss of natural springs. Subsequently, these changes in hydrology have led to significant changes in natural plant and animal communities. The ditches drained water out of Black Slough and reduced the natural flood retention capabilities. Large silt deposits carried by the gullies and the series of laterals ended up at the mouth of the Post Creek Cutoff (figure 14.3) and washed into the current Ohio River. Annual dredging is now required to keep the Ohio River navigation channel deep enough for river traffic.

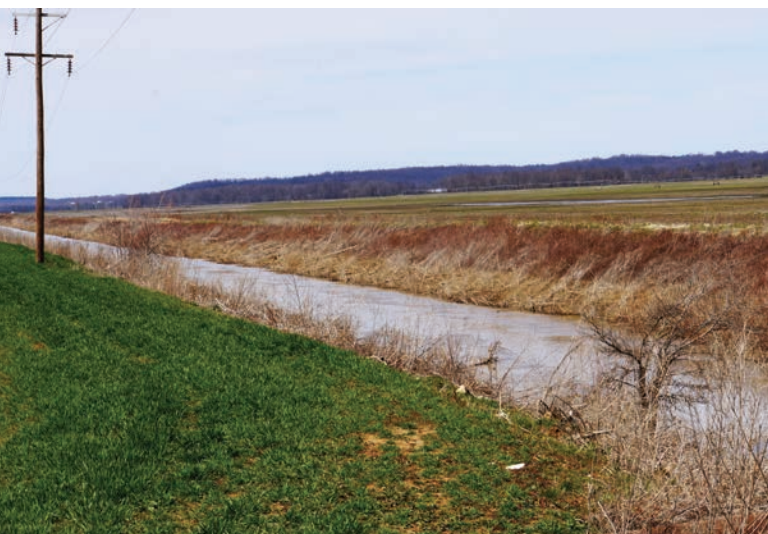
**FIGURE 14.4** Main Ditch drains water from agricultural lands in the upper Cache River valley.

Following the completion of the Post Creek Cutoff, the Main Ditch (figure 14.4) and other laterals were constructed through the Black Slough area, expanding the agricultural productivity of the region. About the same time period (1912 to 1915), the Reevesville levee (map 14.1) was built by the USACE to prevent Bay Creek from connecting to Main Ditch and the middle Cache River when the Ohio River was high and flooding agricultural lands in the middle Cache River valley. After the 1937 flood overtopped the Reevesville levee, the USACE built a higher structure that has since prevented such flows (figure 14.5) [7].

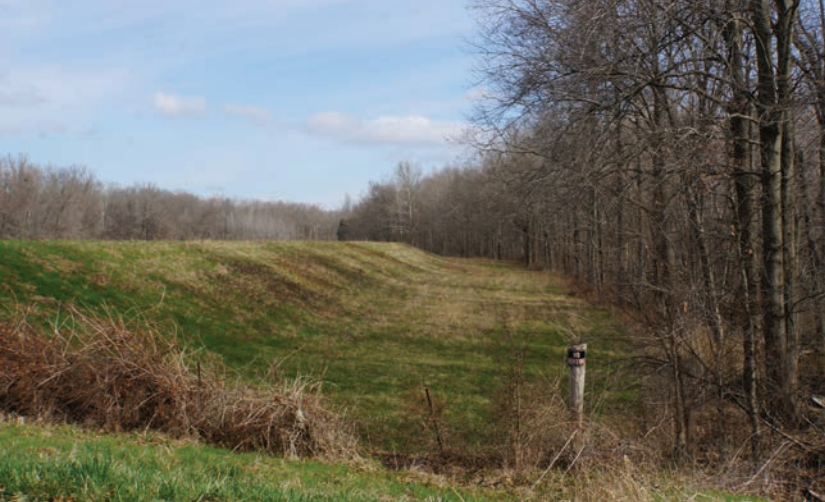
**FIGURE 14.5** The Reevesville levee protects the Main Ditch from Bay Creek floodwaters.

In April of 2011 the Ohio River approached a record high of 332 feet above sea level on the Cairo gage. It backed up water into Bay Creek at Golconda, Illinois, and pushed into the easternmost reach of the ancient Ohio River valley entrance. The Reevesville levee (figure 14.5), between Bay Creek and Main Ditch held and blocked the Ohio River floodwaters from entering

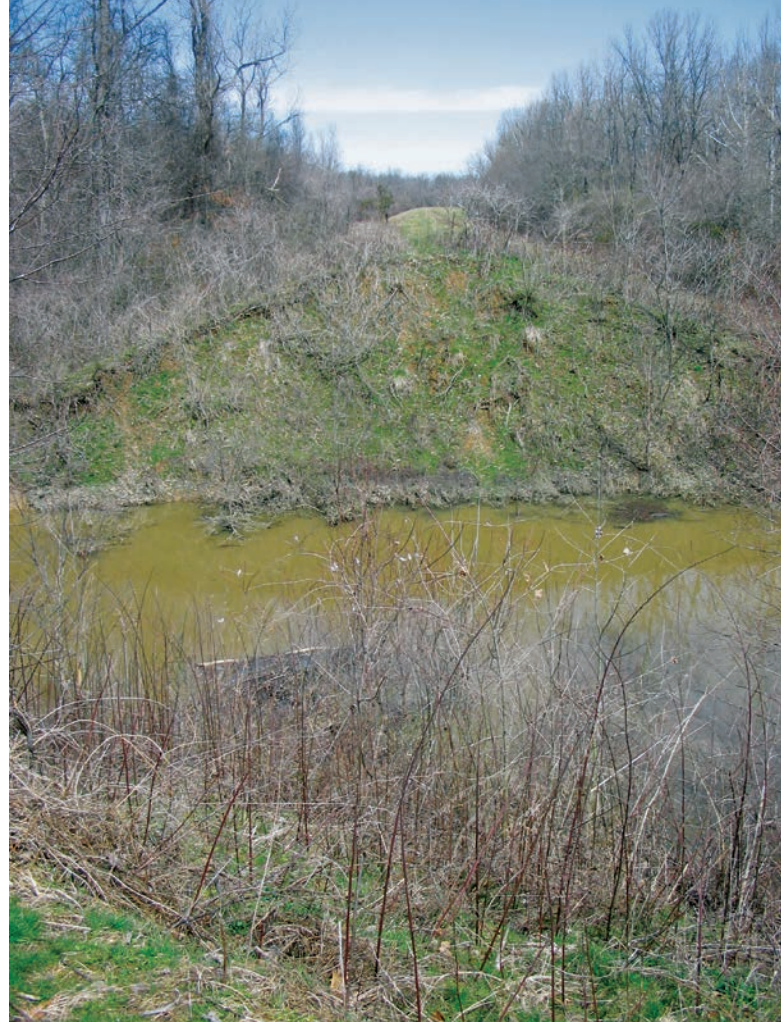
**FIGURE 14.6** The unrepaired Karnak levee breach allows Cache River floodwaters to flow west toward the Mississippi River diversion.

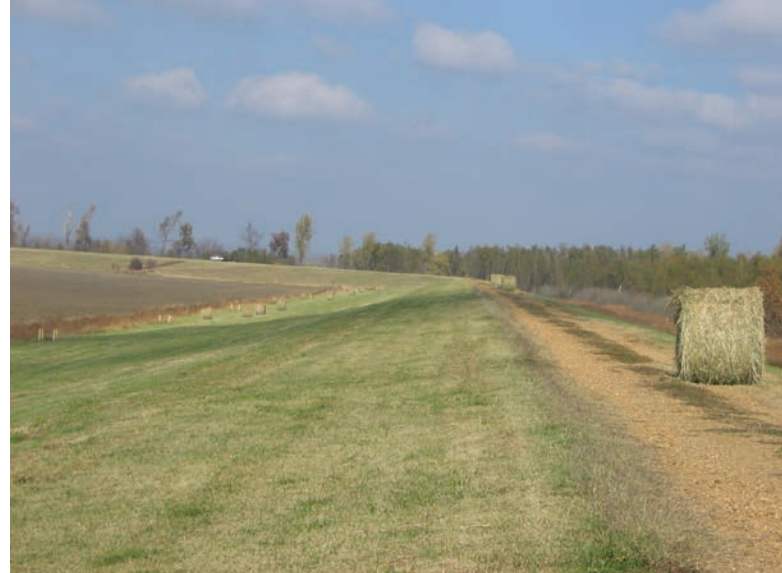
**FIGURE 15.3** Routine management of vegetation on the Commerce to Birds Point mainline US Army Corps of Engineers levee protects against woody encroachment and tree roots that can undermine the strength of levee structures.

The Commerce to Birds Point levee (figure 15.3) has long been considered by the MRC and the USACE to be the most critical levee in the Mississippi River valley. The Commerce to Birds Point levee, shown in maps 15.1, 15.2, and 15.3, has had two major threats from past major flooding events (1973 and 1993). During the 1973 flood, a 1,500-foot section of the Commerce to Birds

Point levee fell into the Mississippi River. The caving extended to the top of the levee. The USACE Memphis District placed 18,000 tons of riprap stone carried in by barges to prevent additional caving [4]. The Len Small–Fayville levee on the Illinois side of the Mississippi River (map 15.1) and across from the Commerce to Bird Point levee, Missouri, had historically overtopped or failed during larger flooding events, thereby reducing the pressure on the Commerce to Birds Point levee. The local levee and drainage district and owners of the Len Small–Fayville levee strengthened their levee during the 1980s, which increased pressure on the Commerce to Birds Point levee when the river rose above flood stage. As a result, in the 1993 flood event, the Len Small–Fayville levee held, and the Mississippi remained confined as it climbed to within 3 feet of the top of the Commerce to Birds Point levee. Sand boils developed in the Commerce levee and were treated until the underseepage stabilized. In 1995, the USACE Memphis District raised the height of and strengthened the Commerce to Birds Point levee and installed relief wells.

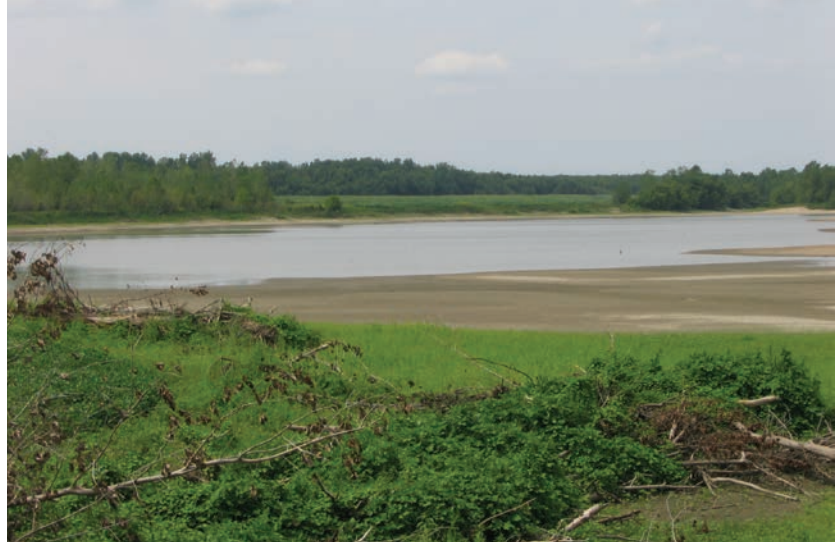
**FIGURE 15.4** Land scouring, gullies, and erosion north of the Len Small levee breach resulted in the loss of agricultural productivity in 2011.

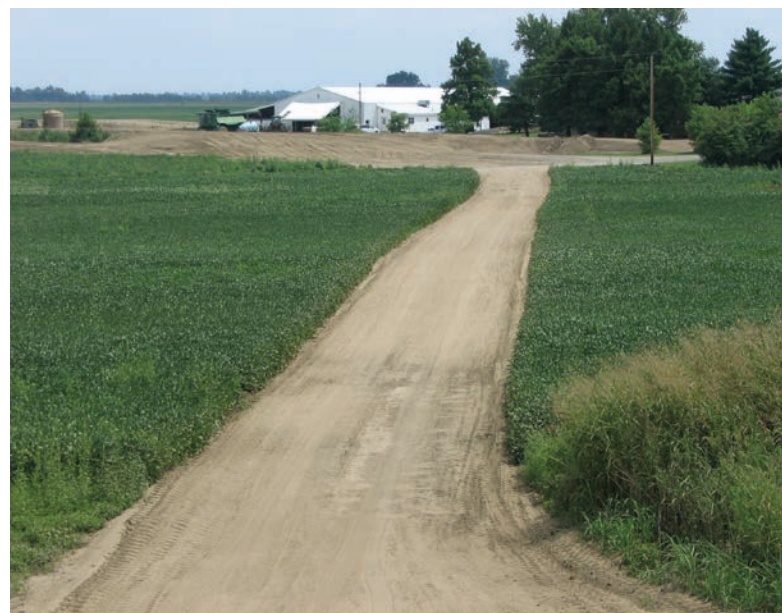
**FIGURE 15.5** Post-2011 Len Small levee breach, many farmers built small levees around their farmsteads to protect against internal flooding and future breaching.

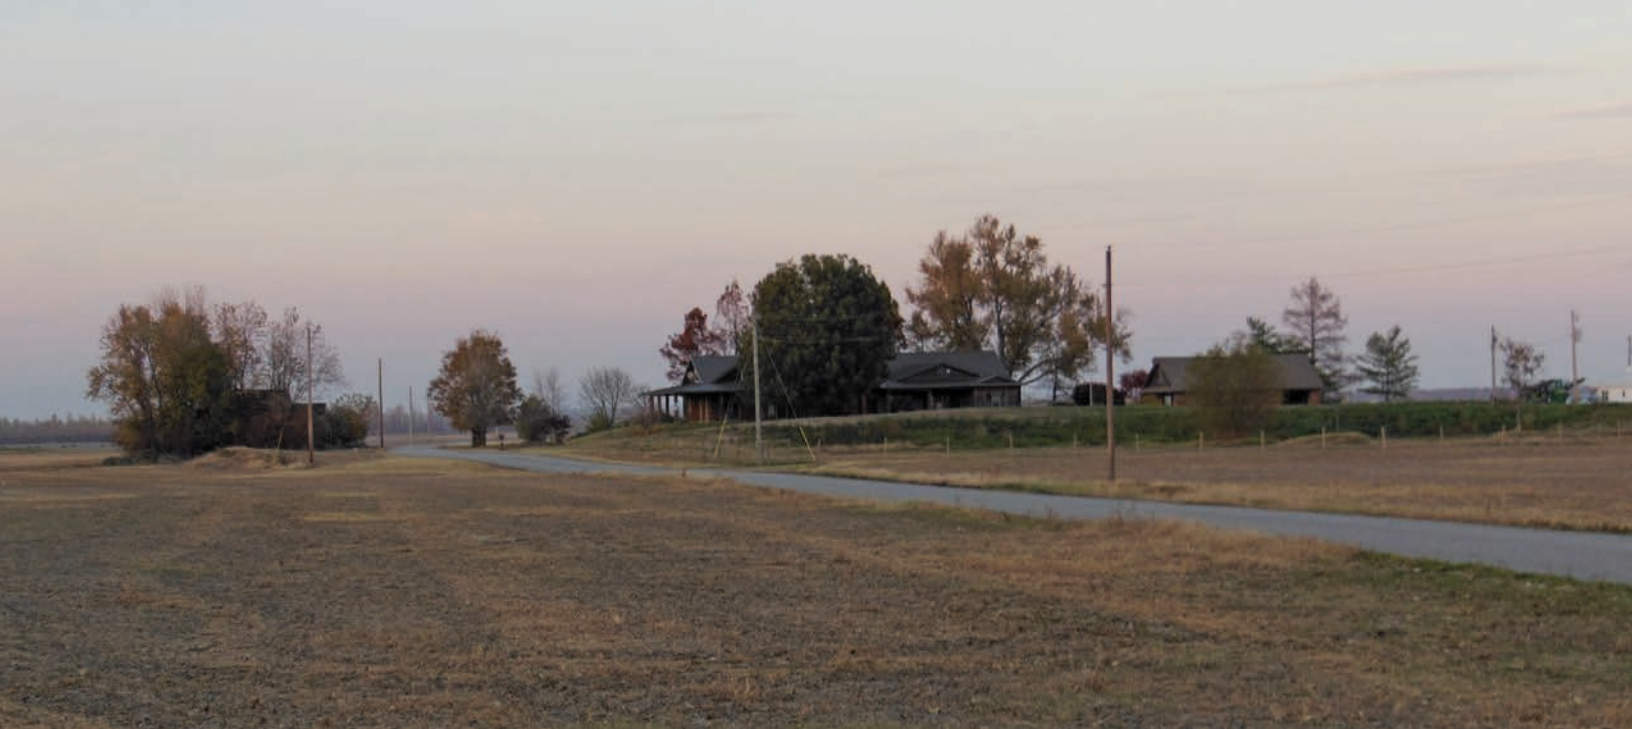
**FIGURE 15.6** This home, less than half a mile inside the Len Small levee, is surrounded by a farmer-built levee to protect against future flooding.

original levee. They hoped the USACE would cover the levee with a clay cap and restore it at least to the original height. The USACE agreed to do this in August of 2012 after receiving additional funds from Congress. The project was completed in 90 days. Some individual farmers created berms around their farmsteads (figure 15.5) and homes (figure 15.6) to protect their homes and buildings from any future flooding that might occur [9].

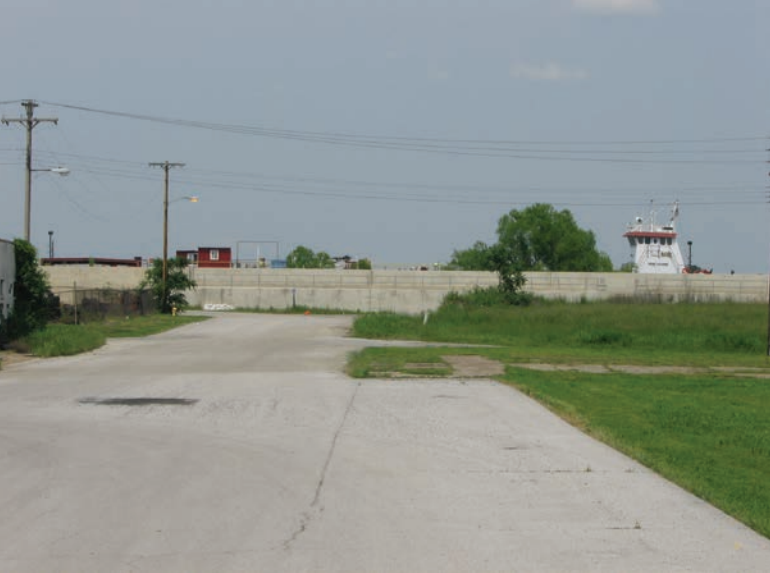
**FIGURE 16.1** The Cairo floodwall is built on the Ohio River side at the bend in the river where an earthen levee would be difficult to maintain. With the river 10 feet above flood stage, a tugboat is visible behind the floodwall.

After the Great Flood of 1927 [3], the USACE also created the current Cairo floodwall and levee system (figure 16.1) on the Ohio and Mississippi rivers. This system was sufficient to handle flood events until the

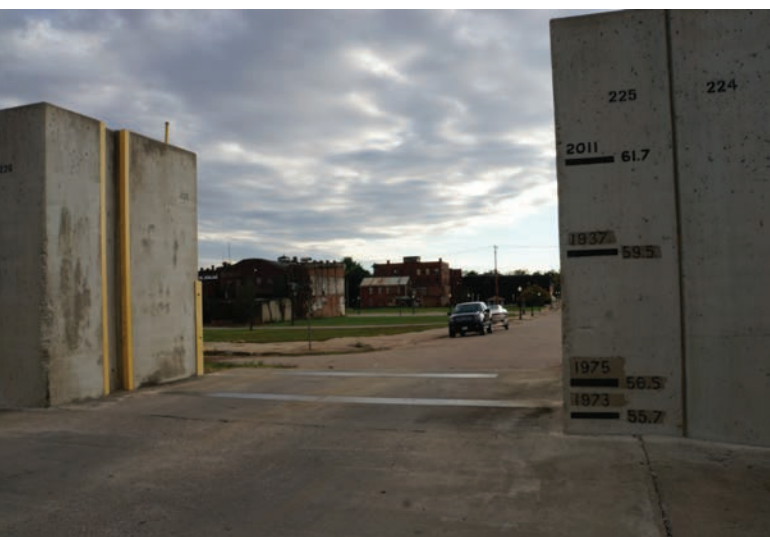
**FIGURE 16.2** An open floodwall gate in Cairo shows city buildings and industries adjacent to the protective wall. The wall has never been breached, and high water crests since 1937 are marked to show the Ohio River height as recorded on the Cairo gage.

River and flood agricultural lands in the New Madrid Floodway, Missouri, to protect the city of Cairo, Illinois, and prevent its levee and floodwall system (figure 16.2 and map 16.1) from breaching. This was a calculated risk built on a growing body of river science and prior flooding experiences. The decision was a difficult and complex engineering problem with significant social and political trade-offs between loss of human lives and loss of properties in urban and rural areas.

spring of 2011 (figure 16.2) when greater than average rains and snowmelt produced one of the most powerful floods in the river’s history and threatened to top and breach the flood control infrastructure [1]. Fort Defiance State Park (figure 16.3), at the tip of Cairo, Illinois, outside of the levee system provided valuable water storage at flood stage between the southernmost point of the Cairo levee and floodwall system and the confluence of the Ohio and Mississippi rivers (map 16.1). The park is the lowest point in the state of Illinois, with an elevation of 279 feet, and was underwater once the Ohio and Mississippi rivers reached flood stage in early April of 2011 and stayed underwater for almost two months. The 500 acres of Illinois farmland with Tice silty clay loam and Gorham silty clay loam soils [10] located west of the park and between the Mississippi River and the levee were also underwater when the Mississippi River was above flood stage.

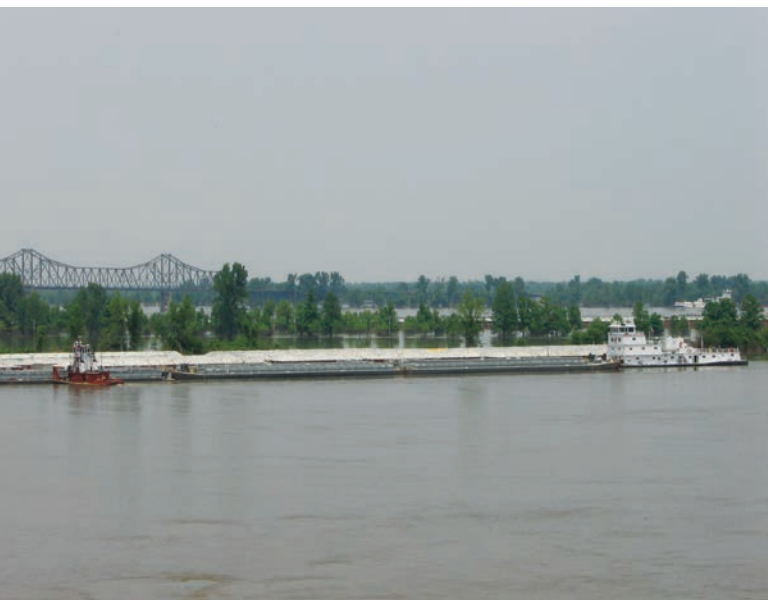
**FIGURE 16.3** Fort Defiance State Park, the southernmost point of Illinois, was under water most of spring of 2011, with only treetops visible. The park is located outside of the Cairo levee and floodwall system at the confluence of the Ohio (top of picture) and Mississippi (bottom of picture) rivers.

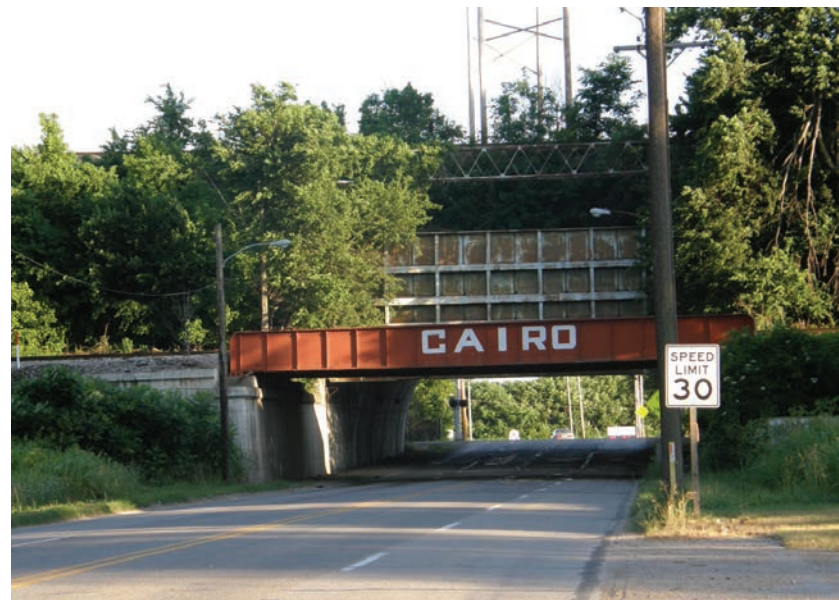
**FIGURE 16.4** A walled city. A raised railroad bed serves as a levee for the northern boundary of Cairo, Illinois, and provides an entry to the levee-enclosed city for Illinois Route 3 traffic. Flood gates on this entry could seal the city behind embankments and the floodwall if levees north of the city were to fail.
