# Managing Mississippi and Ohio River Landscapes

Kenneth R. Olson and Lois Wright Morton

Soil and Water Conservation Society  
Ankeny, Iowa

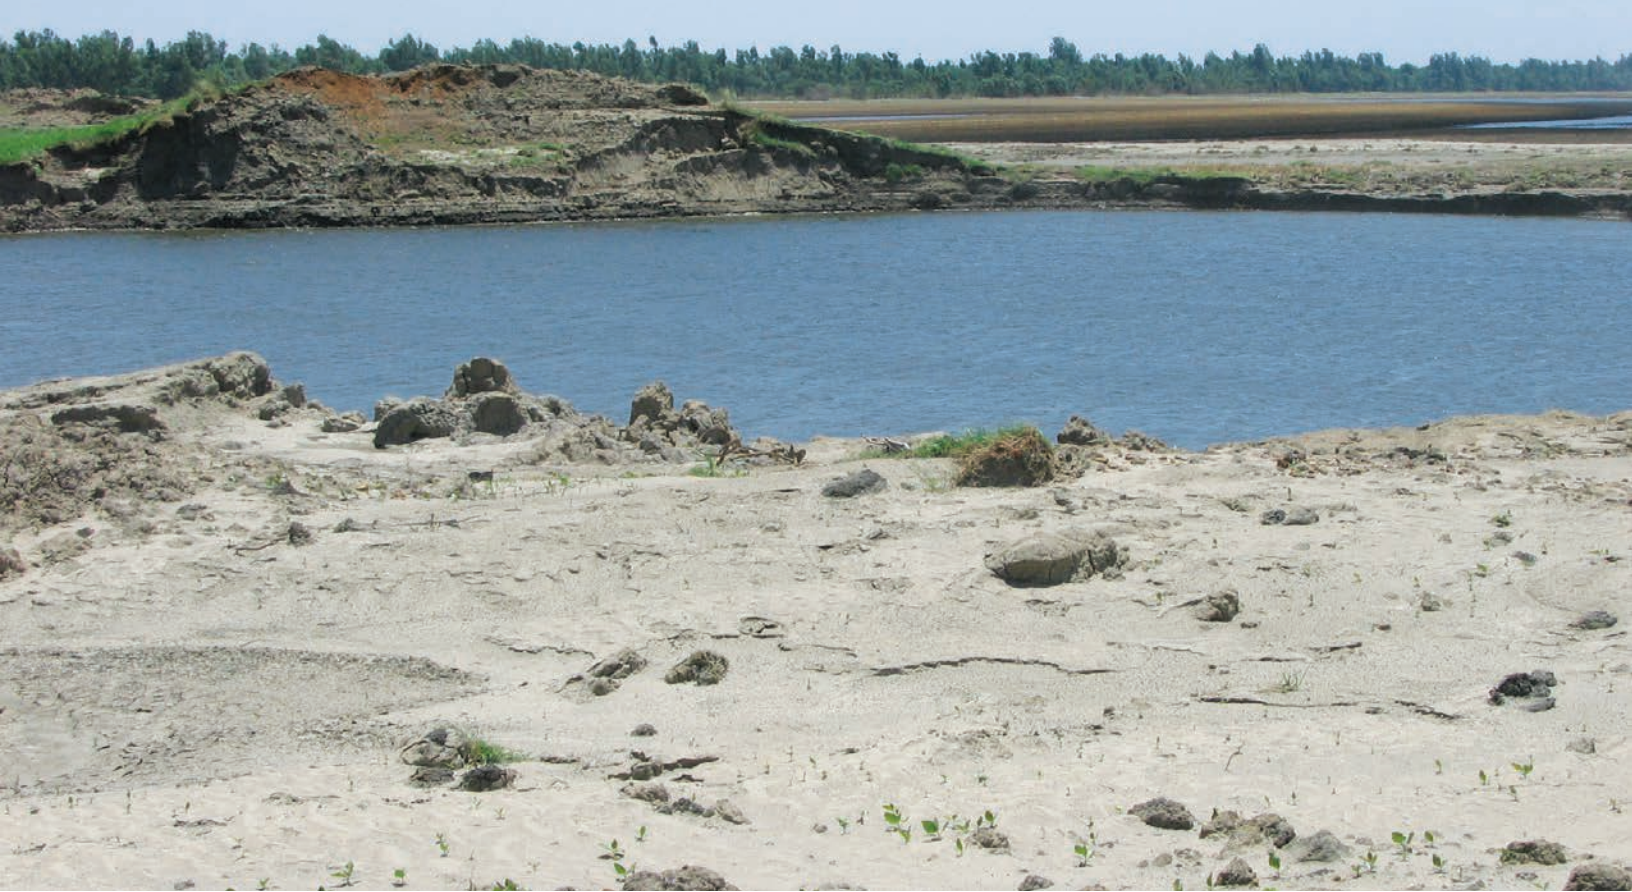
**FIGURE 16.5** The Birds Point levee was the site of the first explosion on May 2, 2011, that opened the New Madrid Floodway and relieved river pressure on the Cairo floodwall. Remnants of the fuse plug levee and the crater lake extend into the adjacent agricultural lands.

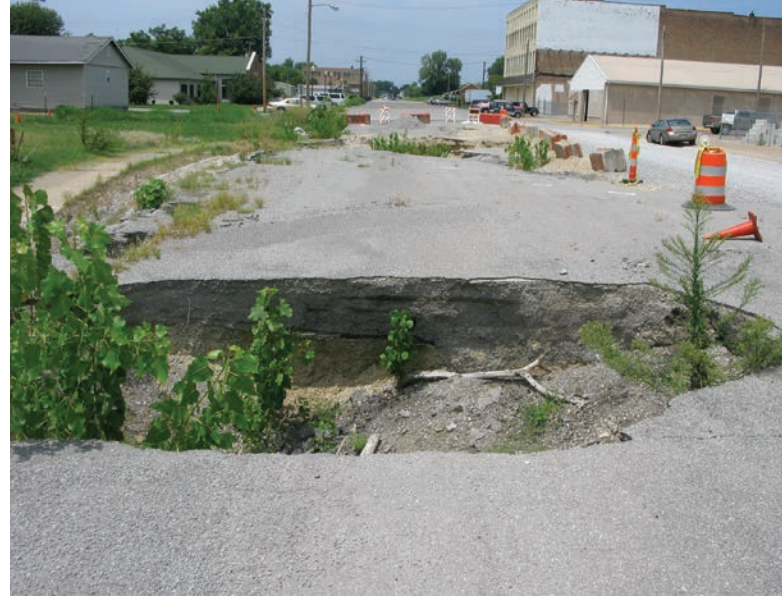
**FIGURE 17.1** The Commercial Avenue sinkholes in Cairo were near or above the sanitary sewer lines.

up (figure 17.1) where a sanitary sewer line flowed to the sewage treatment plant and parallel to the floodwall. Post-2011, short-term emergency measures to manage the sand boils were replaced with a series of relief wells and slurry trenches to strengthen the weakened levee system.

A number of sinkholes also developed in late April and early May of 2011 in downtown Cairo on Commercial Avenue and 15th Street (figure 17.1). A sinkhole is a hole in the ground surface created by the collapse of overlying material as supporting material below the

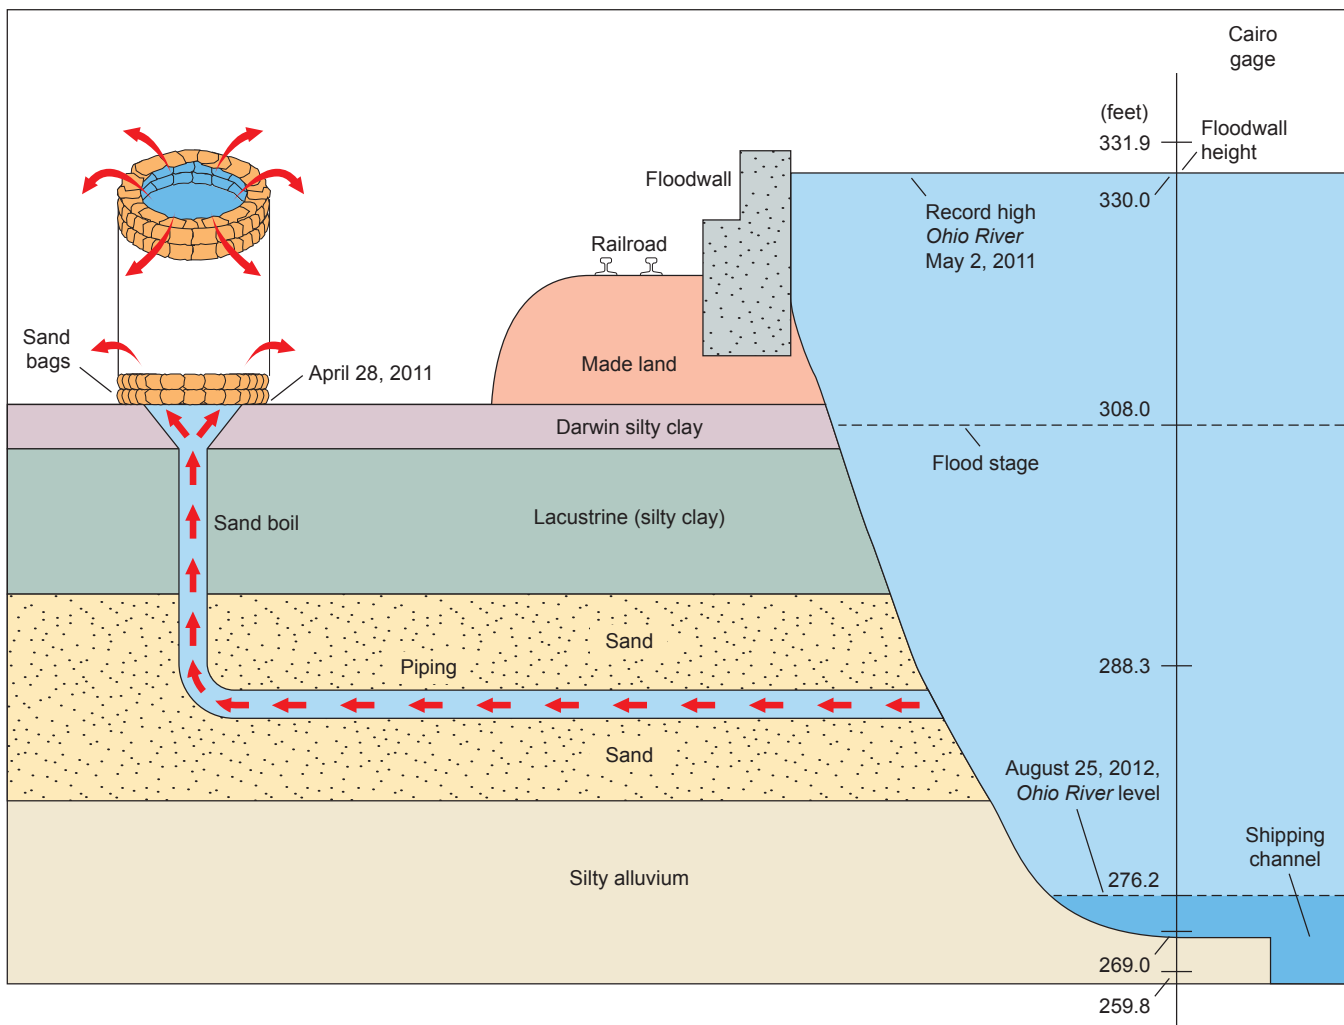
**FIGURE 17.2** Diagram of a sand boil at Cairo on April 28, 2011. The elevation of the highest flood level (332 feet) on May 2, 2011, and the lowest level from the drought of August 25, 2012, are noted on Cairo gage.

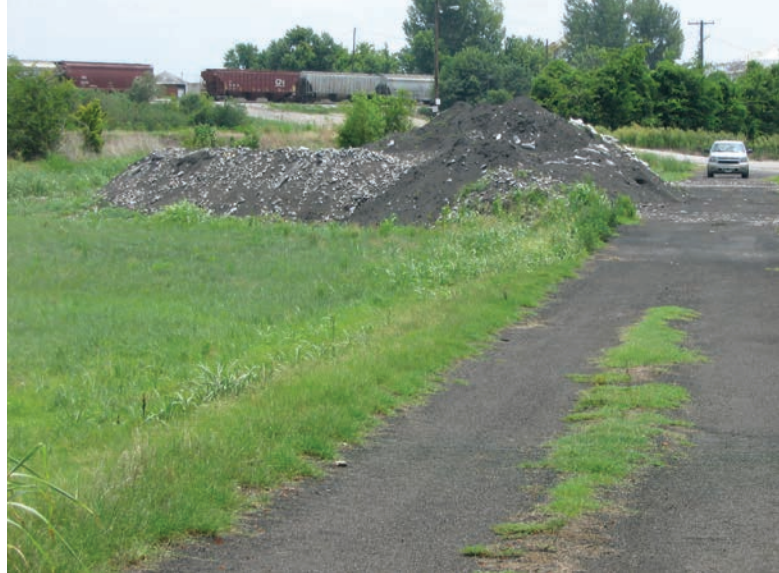
**FIGURE 17.3** The raised railroad bed is visible in the background of the 40th Street mega sand boil in Cairo near the water treatment plant. The mega sand boil was filled in and covered with a 13.2-foot-high pile of fly ash cinders.

The sand boil occurred on Darwin silty clay loam soil [4], and on the evening of April 28, 2011, this sand boil started to grow. In a few hours it enlarged dramatically from a few inches to 2 feet in diameter. The USACE quickly realized that this high-energy sand boil had the potential to cause the Ohio River floodwall to fail at a time when 2,900 people were still living in Cairo. The USACE decided that the traditional treatment of building a sandbag ring around the sand boil to keep water on the boil as a counter weight was insufficient and would not work this time. Instead they constructed a ring berm around the sand boil using a nearby stockpile of fly ash cinders (figure 17.3) owned by the Bunge Corporation [1]. A bank of emergency lights was brought in as well as a bulldozer, backhoes, loader, excavators, dump trucks, and a crew of 40 to contain the large sand boil. The crew constructed a 50-foot ring berm to a height of 6.6 feet. The sand boil continued to pipe sediment at an alarming rate. Since the city of Cairo still had many people who were not yet evacuated, the danger of the city being flooded with loss of life was a real concern. On May 2, 2011, after 48 hours of local rain, the fly ash cinder pile was turning to mush and had to be covered with a tarp [1]. The fly ash cinder pile was then raised to 13.2 feet (figure 17.3). This mega boil was among the most serious in the history of USACE use of earthen levees and floodwalls.

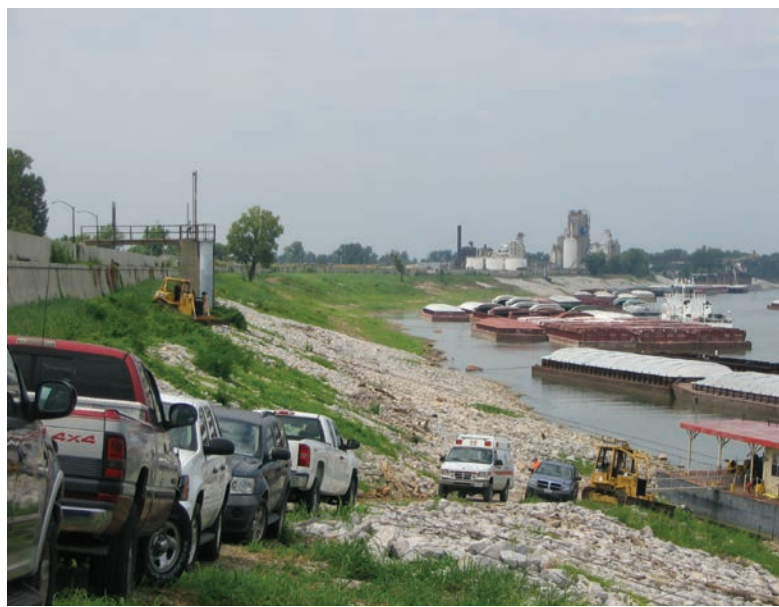
**FIGURE 17.4** More than 64 feet of the Ohio River floodwall in August of 2012 were exposed when the Ohio River was at 12 feet during the drought. This was 50 feet lower than the May 2, 2011, high water mark.

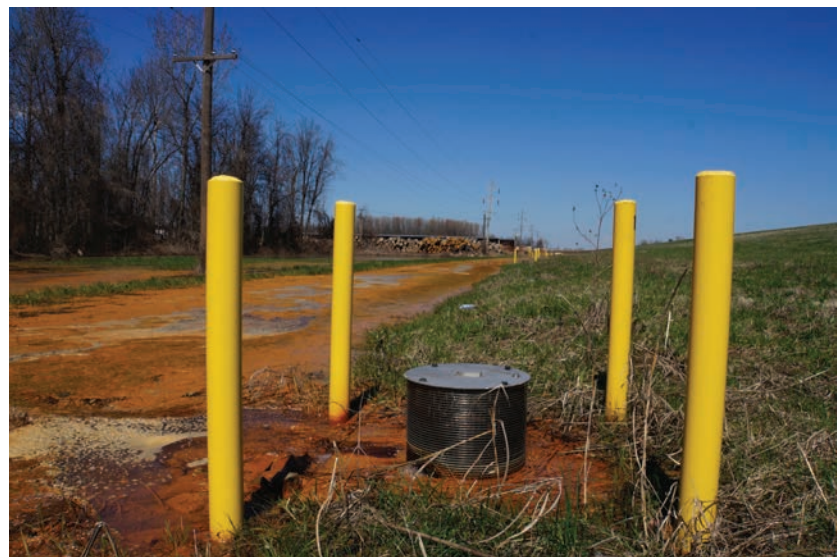
**FIGURE 17.5** A series of relief wells pump iron-rich, yellowish-red groundwater into a drainage ditch to relieve substratum pressure when the river is higher than the land inside the levee. The water is collected and pumped over the levee.

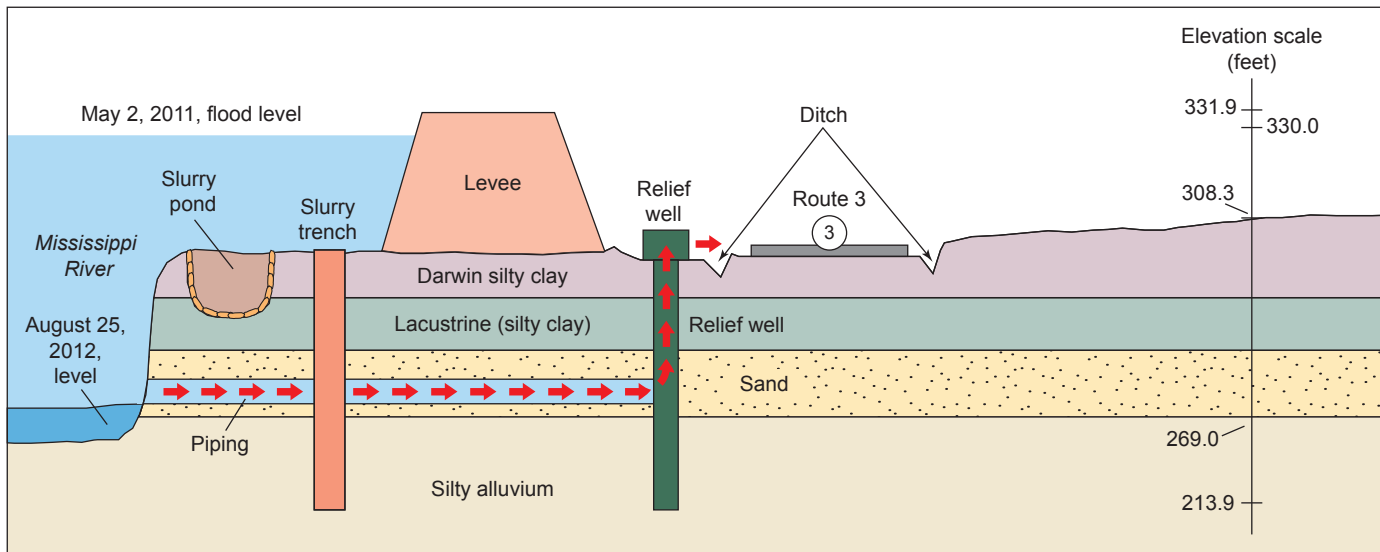
**FIGURE 17.6** This diagram illustrates the landscape relationship of the Mississippi River, the slurry trench, the levee, relief wells, ditches, and Route 3 north of Cairo.

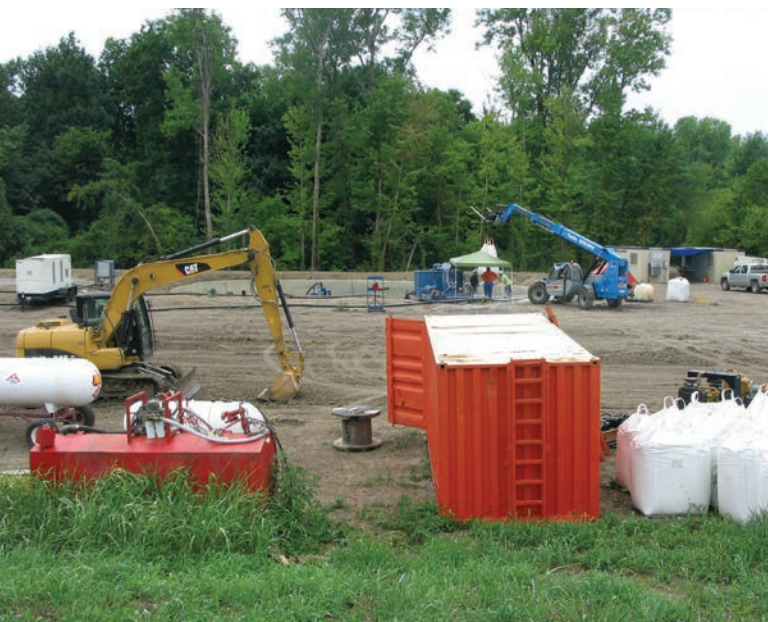
**FIGURE 17.7** Bentonite bags are dumped into these slurry ponds and mixed with water to create slurry for the trench.

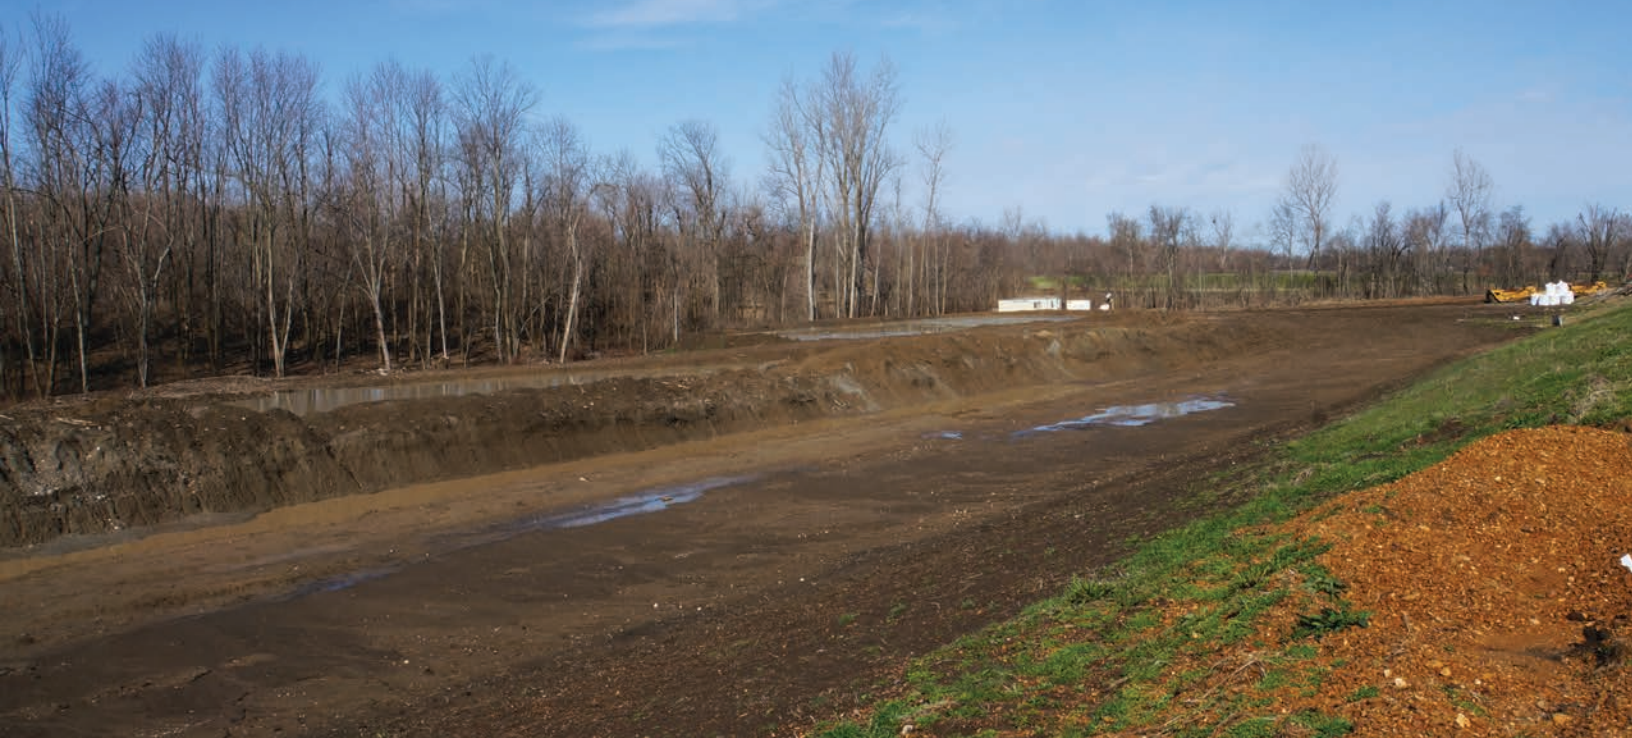
**FIGURE 17.8** This slurry trench between the levee and Mississippi River creates an impervious barrier that reduces river pressure and seepage.

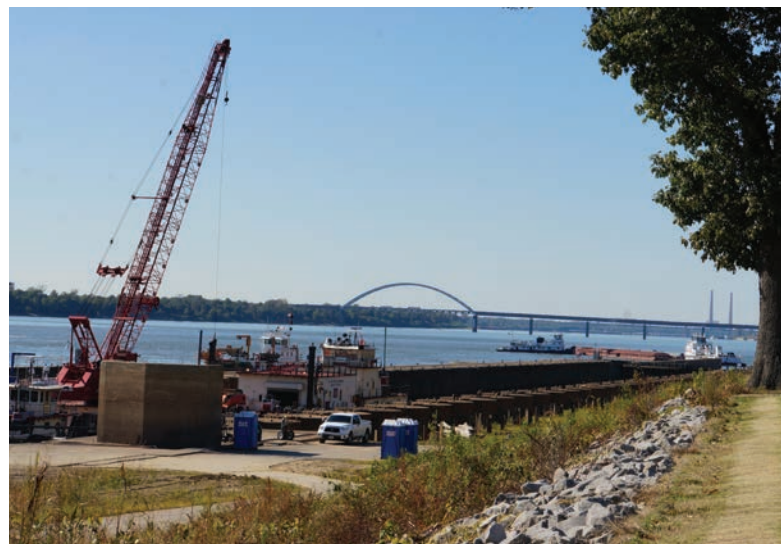
**FIGURE 18.3** Lock and Dam 52 is 1.5 miles downstream of Brookport, Illinois, at river mile 939 below Pittsburgh, Pennsylvania. The upper pool above the dam extends 20.5 feet to the Smithfield Lock and Dam.

The USACE role in providing a safe navigation infrastructure on the Ohio River is a mission without an end. The 981-mile-long Ohio River had 20 locks and dams in 2013 (map 18.2). The number will be reduced to 19 by 2020 when the Olmsted Lock and Dam (figures 18.2 and 18.9) replaces locks and dams 52 (figure 18.3) and 53 (figure 18.4). These locks and dams on the lower Ohio are the last of the old wicket dams. The Olmsted Lock and Dam is currently under construction (figure 18.9) at river mile 964.4 (37°11'1.7" N, 89°3'48.6" W) and will greatly reduce tow and barge delays and shorten navigation time from four hours to one hour. The dam will consist of five Tainter gates, a 1,400-foot navigable pass with steel wicket gates, and a fixed weir. In the raised position, the wickets will maintain the required navigation depths from the Olmsted project upstream to Smithland Locks and Dam. When river flows are sufficient, the wickets can be lowered to lie flat on the river bottom and allow traffic to navigate over the dam sill without having to pass through the locks. This reduces delays experienced by locking through the system. The lock chambers, completed in 2002 and located along the Illinois bank, are 110 feet wide and 1,200 feet long [6]. The capacity of this structure is projected to be sufficient to meet demands for tow traffic well into the twenty-first century.

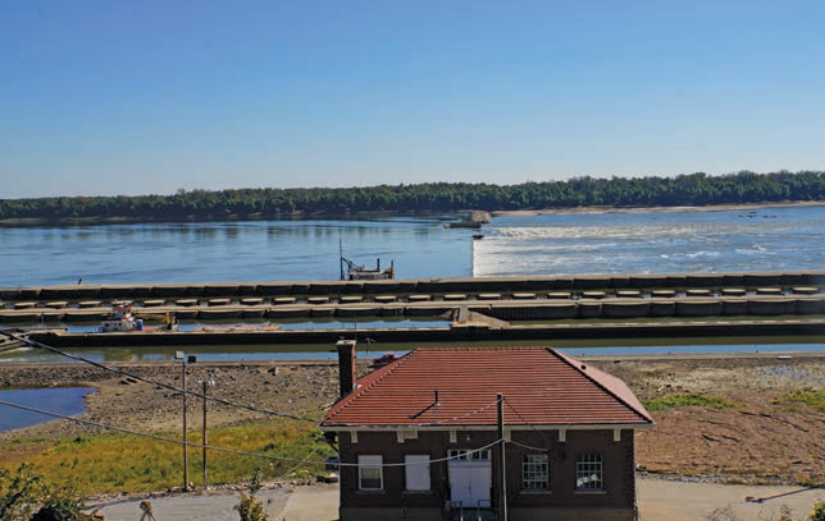
**FIGURE 18.4** Lock and Dam 53 at 962 river miles downstream from Pittsburgh has an upper pool above the dam that extends about 23 miles to Lock and Dam 52.

national flood control policy that coordinated efforts to construct floodwalls, levees, and upstream storage reservoirs to protect the economic security of the Ohio and Mississippi river basins. Navigation continues to be a high priority, and the network of locks and low dams on the Ohio River were modernized and enlarged in the 1960s and 1970s to support increased trade and navigation safety (map 18.2). The US Army Corps of Engineers (USACE) currently monitors and maintains the lock and dam infrastructure along the Ohio to provide a nine-foot navigation channel. The new Olmsted Lock and Dam, (figure 18.2) when completed in 2020, will replace the two oldest wicket dams, Lock and Dam 52 near Brookport, Illinois (figure 18.3), and Lock and Dam 53 (figure 18.4) located approximately 11 miles north of the Ohio-Mississippi confluence at Cairo, Illinois.

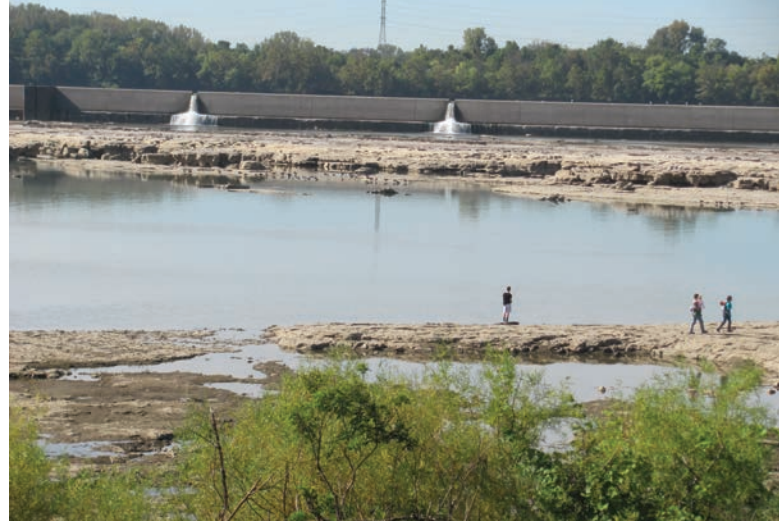
**FIGURE 18.5** The McAlpine Dam at Louisville, Kentucky, and Clarksville, Indiana, controls water levels on the Ohio River and allows barges and boats to bypass the falls of Ohio (in the foreground). The dam, an elongated “Z,” protects the ancient fossil beds of the falls of Ohio and has “castellations” or waterfalls in the dam to ensure water reaches the wetland next to the dam even in dry months so as to maintain wetland plant and animal species.

Like other travelers on the Ohio River, Lewis encountered the Falls of the Ohio River (figure 18.5) near Louisville, Kentucky. It was here in October of 1803 that Lewis, carrying instructions from President Thomas Jefferson to explore the newly acquired Louisiana western lands purchased from France and find the Northwest Passage to the Pacific Ocean, met William Clark at Clarksville in Indiana Territory. The Falls of the Ohio dropped 24 feet over a two-mile-long series of 387 million-year-old limestone ledges formed in the Devonian coral period. Only at high water could boats travel over the falls and continue downstream. Captains with paying customers who did not want to wait for high water would portage their cargo and boats around the falls [2]. Steamboats unloaded passengers and freight on one end of the falls and carried them over land to the other end of the falls to board another boat. Louisville became a key staging location for river travelers and cargo to be transferred to up- and downstream boats. With growth in river traffic, it soon became apparent that some type of canal and lock system was needed if steamboats and other river vessels were to avoid delays and travel unimpeded through the falls.

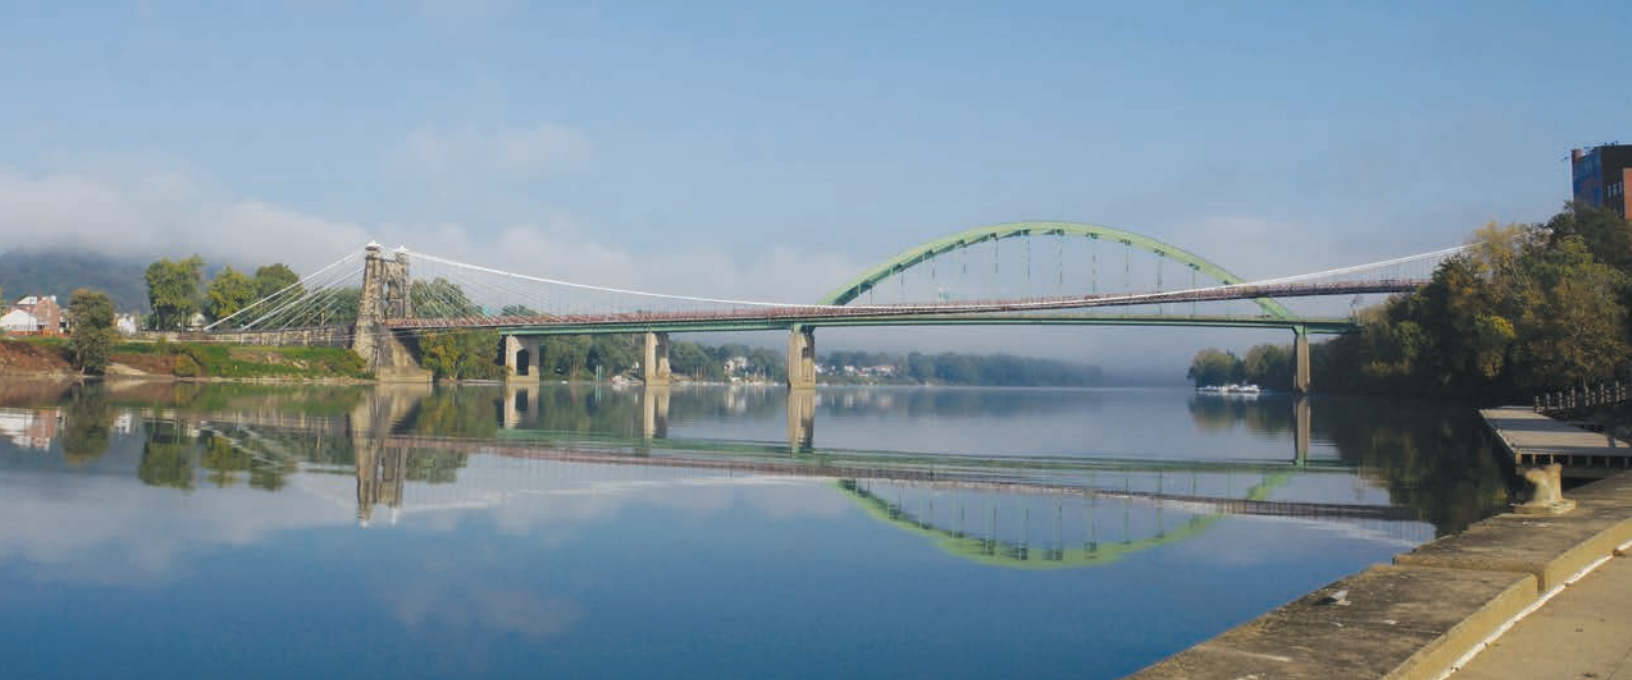
**FIGURE 18.6** A tale of two bridges. The Wheeling Suspension Bridge (foreground) built in 1849 on the National Road (US Route 40) at Wheeling, West Virginia, was the first bridge to cross the Ohio River opening the west to thousands of pioneers. The US Interstate 70 Fort Henry Bridge (green in background) carries four lanes of traffic across the Ohio River and is a major transportation route connecting eastern states to the upper Midwest today.

The first bridge over the Ohio River was the Wheeling Suspension Bridge constructed in 1849. A 1,010-foot single-span bridge between Wheeling and Wheeling Island, it extended the National Road through Ohio, Indiana, and Illinois. The bridge (figure 18.6), designed after ancient Peruvian rope bridges, had 12 main cables that spanned two stone portals and was anchored in the rock under the city. Each cable contained more than 550 strands of wire. It was a toll bridge with fares as follows: man and a horse, \$0.10; six-horse carriage, \$0.15; four-horse mail coach, \$1.25 per month; hogs and sheep, \$0.02 per animal; and western stagecoach, \$2,000 per year [5].

it a toll road (a turnpike) since they also lacked funds. The construction of the Wheeling Suspension Bridge (figure 18.6) challenged Pittsburgh, Pennsylvania’s claim as gateway to the west and led to a contentious political battle between Wheeling and Pittsburgh. The City of Pittsburgh, Pennsylvania, filed suit against City of Wheeling, Virginia, for building the Wheeling Suspension Bridge, claiming the bridge’s height impeded Ohio River traffic to Pittsburgh. The Supreme Court agreed. However, before it was demolished, in 1852 an act of Congress maintained that the bridge was vital to the country and should remain standing. This secured Wheeling’s claim as the gateway to the west.

the replacement of the Wheeling Suspension Bridge. In 1968 the Fort Henry Bridge was constructed about a mile upstream of the old Wheeling Suspension Bridge on the new Interstate 70 (figure 18.6). Although the suspension bridge on the National Road was scheduled for demolition, local preservation groups and the West Virginia Department of Highways rescued it, making it one of the few historic landmarks in the state. The National Road (US Route 40) now extends from the Atlantic Ocean (New Jersey and/or New York) through Wheeling, West Virginia, to the Pacific Ocean (California).

sion bridge (figure 18.8) that connected Cincinnati, Ohio, and Covington, Kentucky [1]. The suspension bridge at Wheeling, West Virginia (figure 18.6), was above the floodwaters, but the west end of the bridge and all of Wheeling Island were flooded.

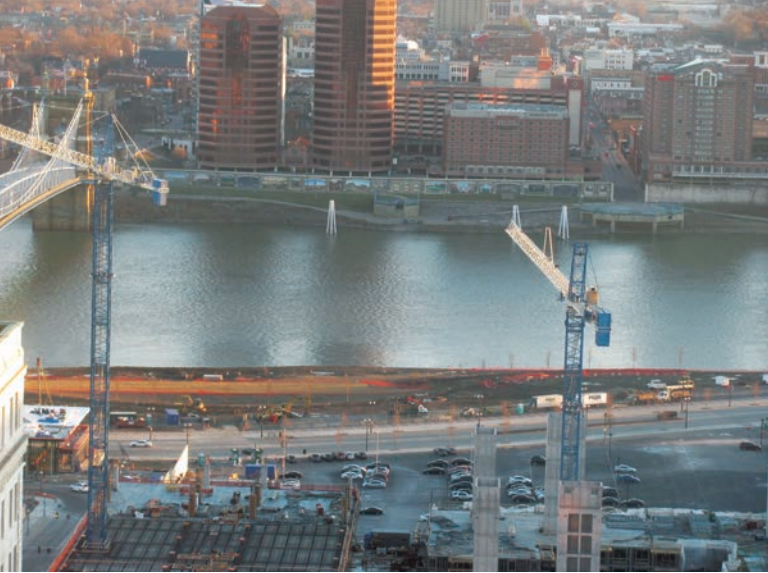
**FIGURE 18.8** The Covington to Cincinnati bridge was the only functioning bridge crossing from Steubenville, Ohio, to Cairo, Illinois, during the 1937 flood.

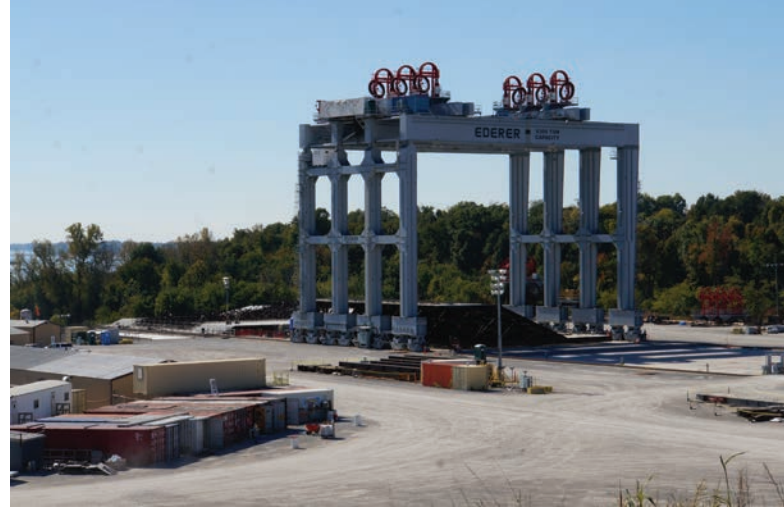
**FIGURE 18.9** A giant 5,304-ton lift built on the construction site of the Olmsted Lock and Dam is used to carry cement frames to barges on the Ohio River for placement in the river.

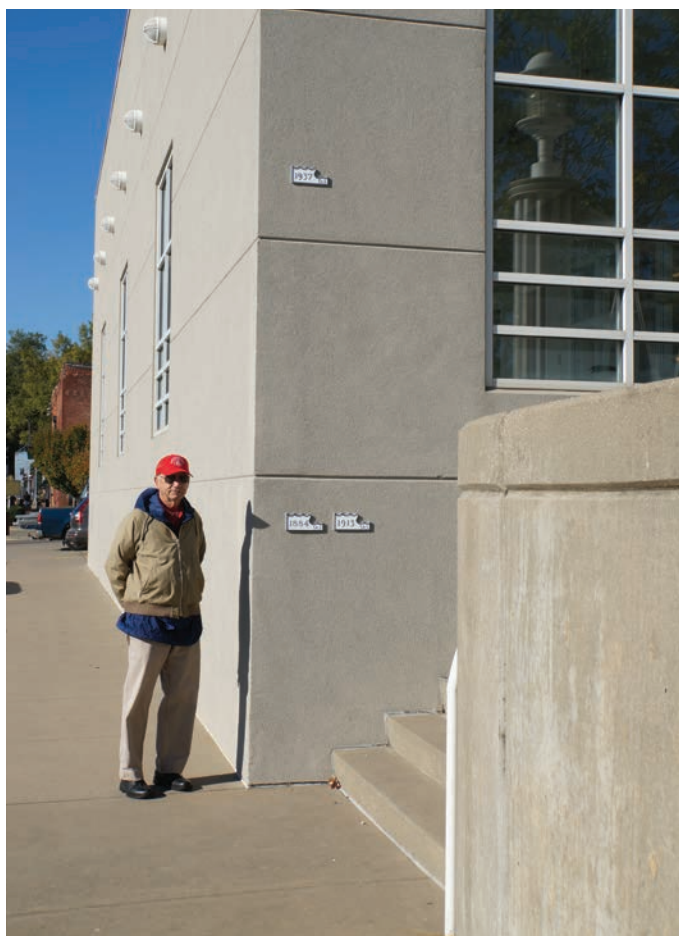
**FIGURE 19.1** The floods of 1884, 1913, and 1937 and their crests at Paducah, Kentucky, on the Ohio River are marked on a downtown club building. John Crivello, one of the many Paducah Ambassador Club volunteers who are leading the effort to revitalize the city as a port on the Ohio River, shows past flood crests.

quence of major river flood disasters (1913, 1927, 1936, and 1937; figure 19.1) before the federal government, with public support, took leadership in constructing the system of dams and reservoirs we have today in the Ohio River basin (see chapter 18) [1, 2].

record levels, breached the levees, and flooded the entire downtown (figure 19.1 and see chapter 18) [2].

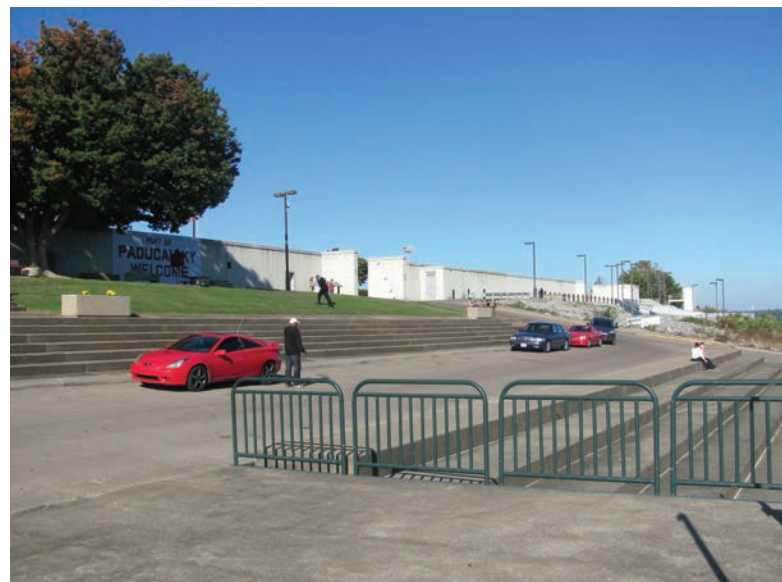
**FIGURE 19.2** The river side of the floodwall at Paducah, Kentucky, is a park to view the Ohio River at low water and a protection against the river at high water. The floodwall was constructed after the 1937 flood, which destroyed most of downtown Paducah.

back-to-the-river renaissance now celebrates its river history with new industries, downtown redevelopment, riverfront stores and museums, and a floodwall that documents historical river events [1]. This spirit of recovery for Paducah is made possible by the 13-foot floodwall (figure 19.2) and 1940s construction of the Kentucky Dam (figure 19.3), a 184-mile-long reservoir, which can hold back and store 4,008,000 acre-feet of water from the Tennessee River before releasing it into the Ohio River.

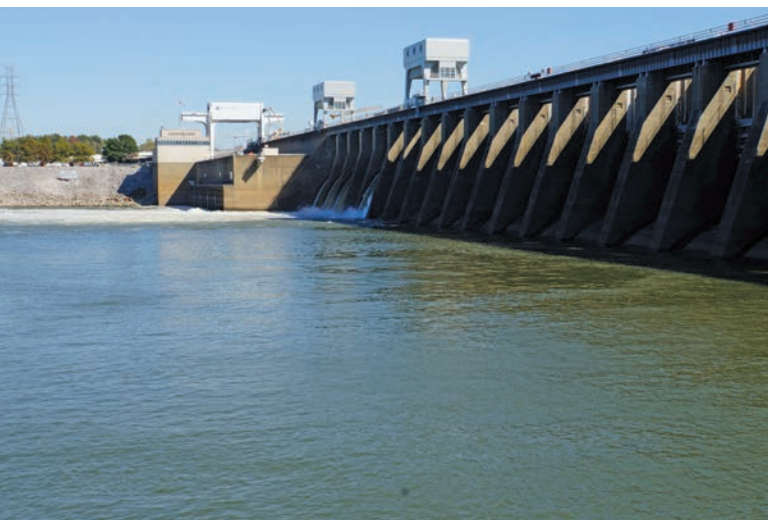
**FIGURE 19.3** The Kentucky Dam at Gilbertsville, Kentucky, was built on the Tennessee River 22 miles upstream from its confluence with the Ohio River.

As early as the 1920s and prior to the flood of 1937, area communities along the Tennessee River and their leaders lobbied Congress to have a dam constructed. The Kentucky Dam, a hydroelectric dam on the Tennessee River on the county line between Livingston County and Marshall County in the state of Kentucky, was sited in Gilbertsville, Kentucky, after extensive geologic evaluation. The dam is 22 miles above the mouth of the Tennessee River, which empties into the Ohio River east of Paducah, Kentucky (map 19.2). After absorbing the Tennessee River, the Ohio River flows another 46 miles before meeting the Mississippi River at Cairo, Illinois. The Kentucky Dam (figure 19.3), started in 1938 and completed in 1944, is the lowermost of nine dams designed to hold back the Tennessee River. Above 55 feet (the original river depth), the dam controls the release of water into the Ohio River and helps manage the fast rise of the Ohio and lower Mississippi rivers during spring snowmelt and rains. At 206 feet high and 8,422 feet long, it is the widest dam on the Tennessee River and in the TVA system. The dam impounds Kentucky Lake, which covers 160,000 acres, making it the largest of the TVA reservoirs and the largest artificial lake by area in eastern United States. Kentucky Lake has 2,064 miles of shoreline and the most flood storage capacity (4,008,000 acre-feet) of any lake in the TVA system.

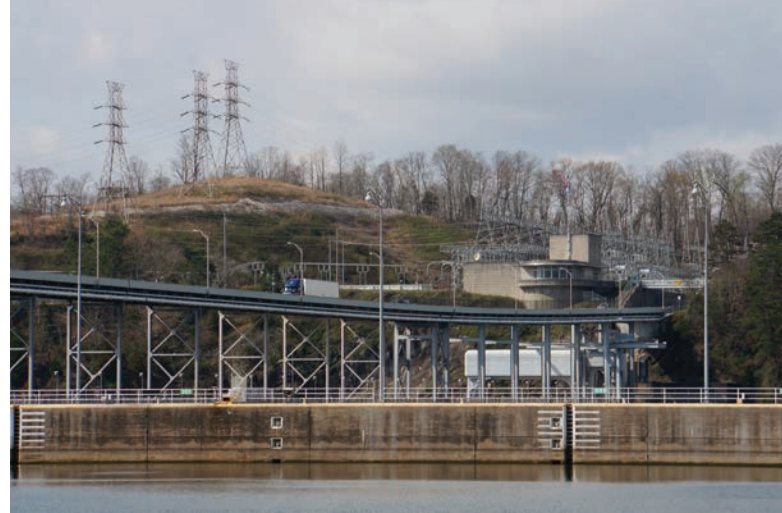
**FIGURE 19.8** Watts Bar Dam on the Tennessee River between Knoxville and Chattanooga, Tennessee, generates hydroelectricity, contributes to downstream flood management, and enables navigation on the Tennessee River via its locking system.

Watts Bar Lock and Dam construction was started in 1939 and completed in January of 1942, three weeks after the Pearl Harbor attack. The lock and dam and shipping channel moved raw materials and manufactured products throughout the region, increasing the value of the Tennessee River as an important inland transportation system during World War II. The reservoir has a dam that is 112 feet high and 2,960 feet across, which creates 39,090 acres of surface water and holds 379,000 acre-feet of water. The winter pool has a sea level elevation of 745 feet and a summer elevation of 740 to 741 feet to ensure navigation. There are five hydroelectric generators (figure 19.8) capable of generating 182 megawatts per day. The reservoir provides 72 miles of navigation on the Tennessee River with 20 miles of slack water on the Cinch River and 12 miles on the Emory River. The Watts Bar Lock is 60 by 360 feet with a lift of 70 feet to the downstream Chickamauga Reservoir. The Watts Bar Nuclear Power Plant (figure 19.9) is located on 1,770 acres along

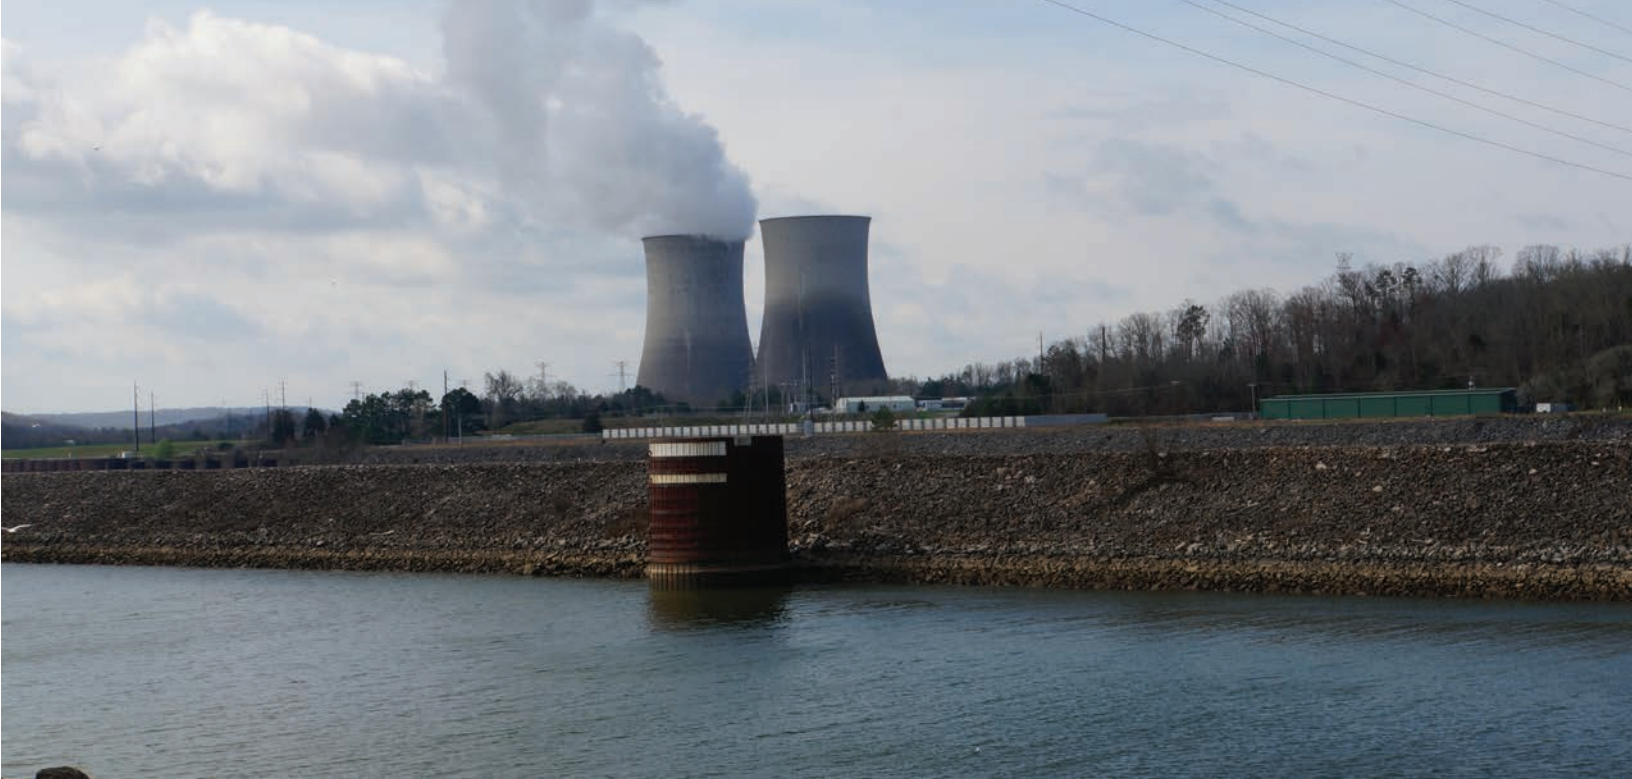
**FIGURE 19.9** Nuclear cooling towers near Watts Bar and adjacent to the Tennessee River contribute to the power production of the region.

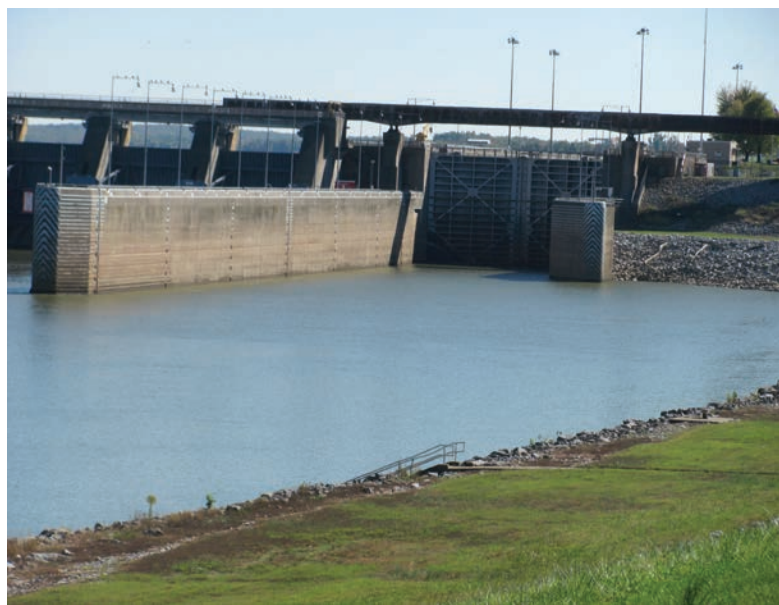
**FIGURE 20.2** A railroad built above the Barkley Lock and Dam on the Cumberland River transports iron ore and manufactured products.

The USACE determined that the small locks and dams up and down the Cumberland River were not sufficient for flood control, so the construction of the Barkley Dam began in 1959 and was completed in 1964. Between 1958 and 1963 about 1,400 families in western Kentucky and Tennessee were moved from their homes along the Cumberland River to make way for a second large dam and reservoir, the Barkley [2]. The Barkley Locks and Dam (figure 20.2) were con-

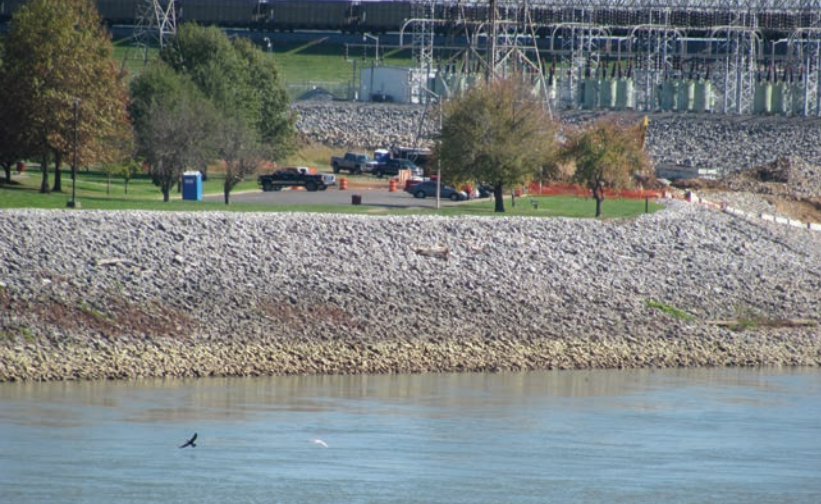
**FIGURE 20.3** The Barkley Dam generates hydroelectric power for the region.

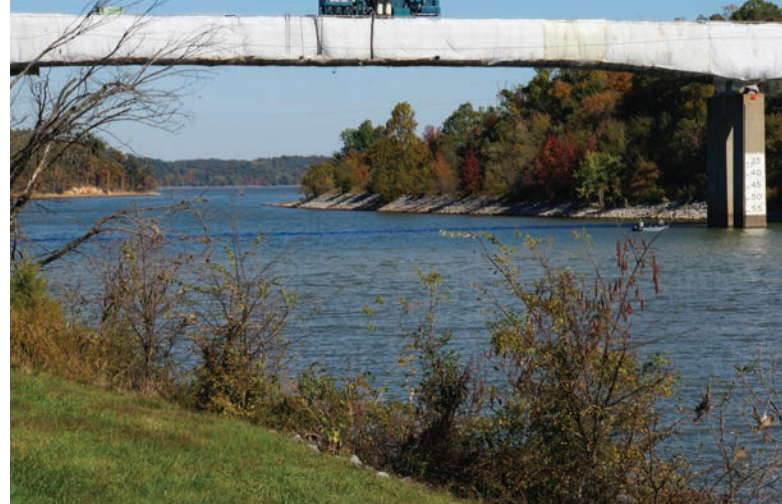
**FIGURE 20.4** The Barkley Canal connects the Barkley and Kentucky lakes and provides barges and pleasure craft easy access to the Cumberland and Tennessee rivers.

The Cumberland and Tennessee rivers flow north into the Ohio River side by side for a hundred miles (map 20.1 and figure 20.4) with only a mile of land between them at their narrowest point. The land between the two rivers consists of layers of gravel, sand, clay, limestone, iron ore, hematite, limonite, and magnetite [2]. Iron ore and limestone in the region were used for iron

production in the nineteenth century. With the construction of the Barkley Dam and Reservoir in the 1960s, almost 20 years after the Kentucky Dam and Lake was built, the land between the two lakes was purchased by the federal government and became known as the Land Between the Lakes. From 1963 to 1968, about 3,000 people were moved from their homes in the area between the lakes to create a national recreation area. The lakes are connected where they run closest together by the Barkley shipping channel (figure 20.4), making this 170,000 acre area the largest inland peninsula in the United States.

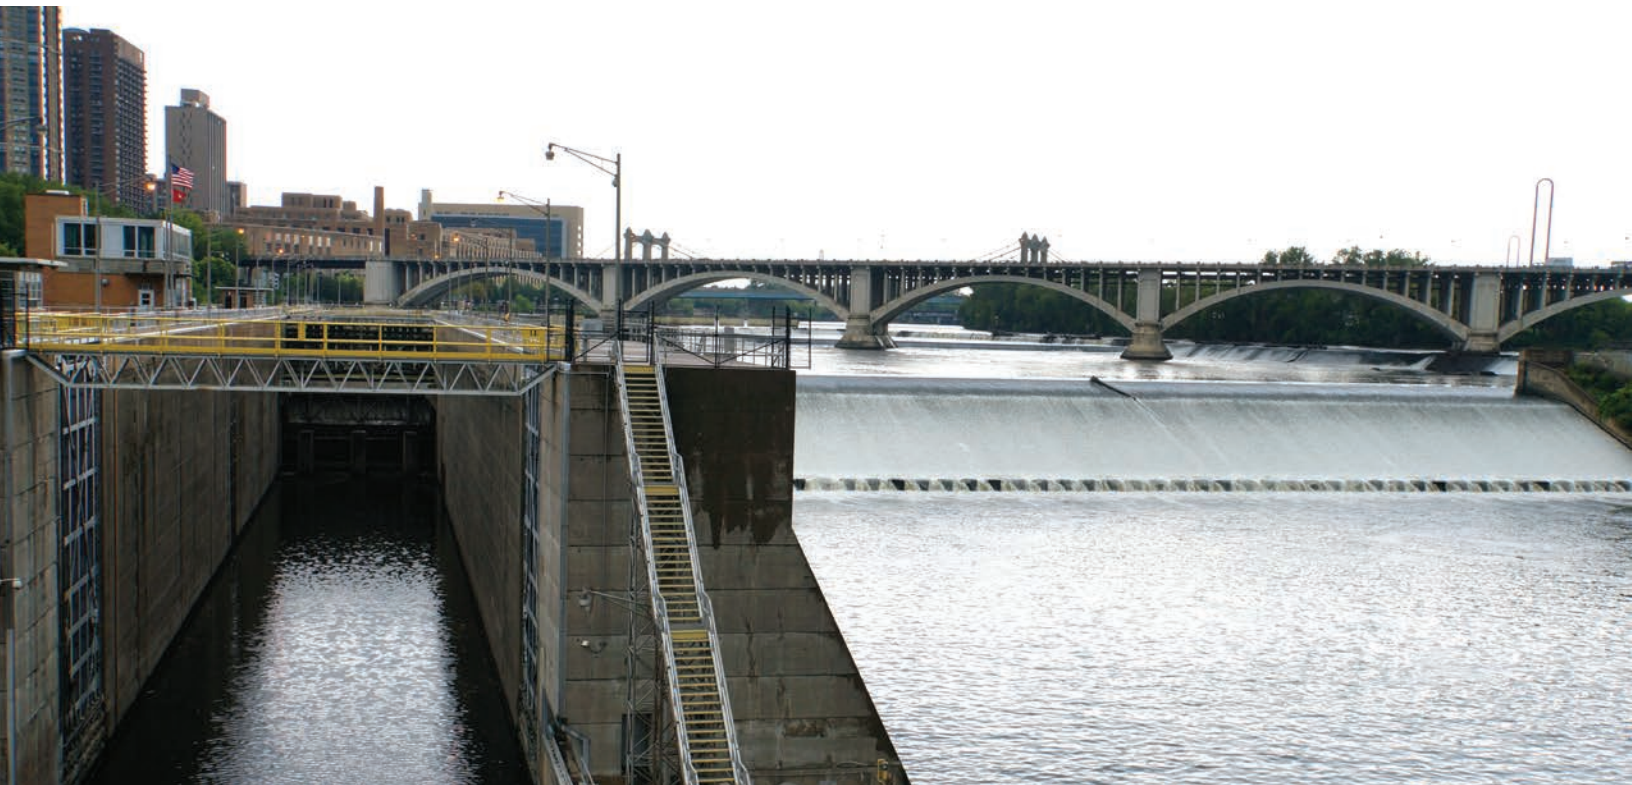
**FIGURE 21.3** The St. Anthony Lock and Dam (left) and the Falls of St. Anthony, Minneapolis, Minnesota, are easily viewed from the stone bridge east of the falls. The lock and dam was closed in June of 2015 for repairs.

upper Mississippi River (map 21.2). Most of the locks and dams are numbered in order from north to south. There is one missing lock and dam, number 23 (Missouri reach), and three additional lock and dams referred to as Upper St. Anthony Falls (currently closed; map 21.2 and figure 21.3), Lower St. Anthony Falls, and Lock and Dam 5A in Minnesota; which were not assigned a primary number. This system created what is commonly called a “stairway of water” as the Mississippi falls 420 feet from the Falls of St. Anthony in Minnesota to Lock and Dam 27 in Granite City, Illinois.

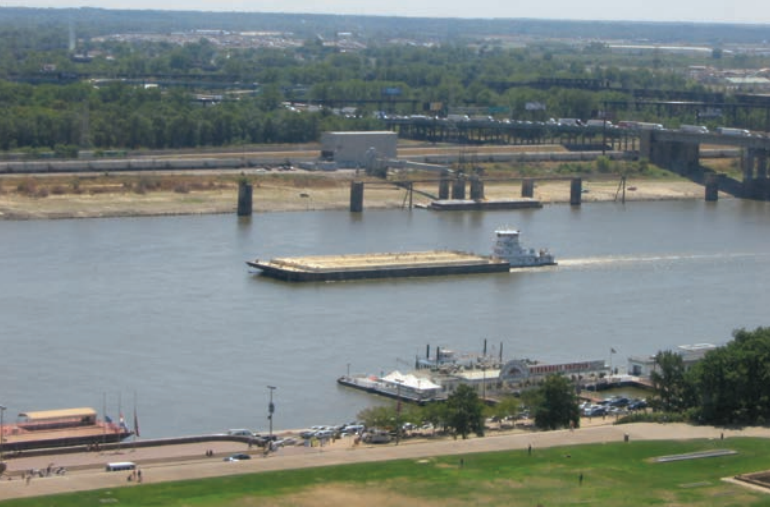
**FIGURE 21.5** Barge traffic on the upper Mississippi River near St. Louis can be viewed from the St. Louis Arch. The port at St. Louis ranked 18 in total tonnage at US ports in 2011.

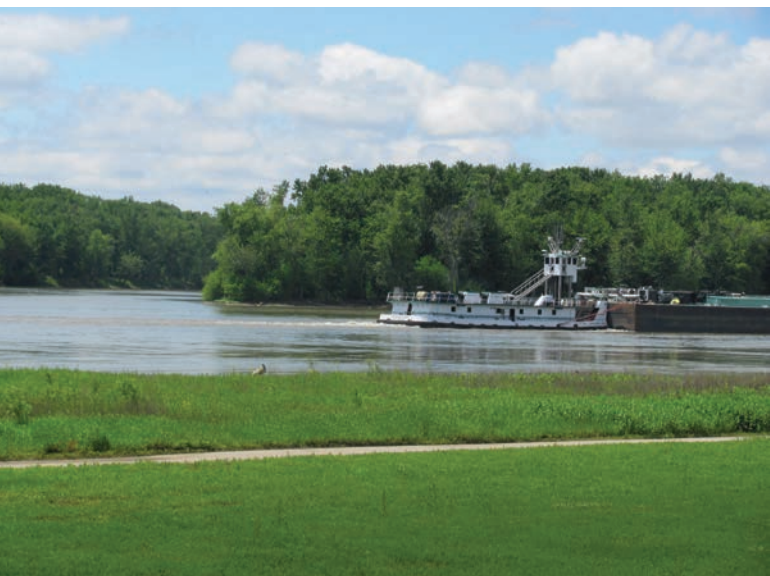
**FIGURE 21.6** Barge traffic from Chicago and the Great Lakes is transported down the Illinois River to its confluence with the Mississippi River at Grafton, Illinois.

A large variety of riverboats and vessels are used to transport people and products from one place to another. The tow, which is one towboat pulling/pushing one or more barges (figure 21.6), is the most common way products are moved on the river. Different types of barges are used to move freight depending on whether the cargo needs protection from the weather. Bulky solid cargo such as dry cement, fertilizers, corn, wheat, soybeans, and other farm products are carried in covered barges to keep them dry. Bulk products including wood chips, scrap metal, coal, stone aggregates, and large finished products such as steel and wire coils and wind turbine blades do not need protection from the weather and are carried in open hopper barges. Liquid cargo (tank) barges carry chemicals, petroleum, oil, molasses and other liquid products. The deck barge carries equipment and materials that can be tied down and don't need weather protection.
