# Managing Mississippi and Ohio River Landscapes

Kenneth R. Olson and Lois Wright Morton

Soil and Water Conservation Society  
Ankeny, Iowa

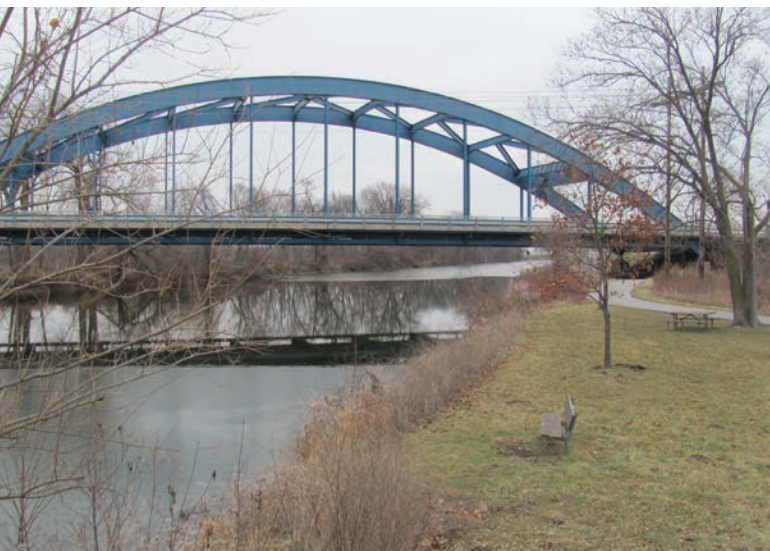
**FIGURE 21.7** The Hennepin Canal walking path at Rock Island, Illinois, offers areas for picnics, fishing, and scenic views.

The completion of the Hennepin Canal in 1907 reduced the distance from Chicago, Illinois, to Rock Island, Illinois, on the Mississippi by 419 miles. The canal was intended to connect the Illinois and Mississippi rivers (figure 21.7) and increase passenger and commercial exchanges throughout the region. Land and river surveys authorized in 1871 provided data for siting the canal and dredging alluvial soils in the channel of the ancient Mississippi. During the construction of the Hennepin Canal, separate legislation gave the USACE authorization to deepen the channel and widen the locks on the Illinois and Mississippi rivers. This increased river traf-

fic from Grafton, Illinois, at the confluence of the Mississippi and Illinois rivers upstream to Chicago and had the effect of making the Hennepin Canal obsolete before it was fully operational. As a result, the 75.2-mile-long Hennepin Canal with a 29.3-mile feeder canal was used primarily for recreation by the late 1930s (figure 21.7). Concrete instead of cut stone was used to build the lock chambers, and similar to the Panama Canal, a feeder canal from a human-made lake provided water for the canal [9]. The Hennepin Canal had 33 locks [10] and Marshall gates, which were specially made for the system. It originally had nine aqueducts that carried water and vessels when the canal crossed larger rivers and streams [10]. Today a paved trail along the Hennepin Canal is used for walking, jogging, biking and snowmobiling depending on the season.

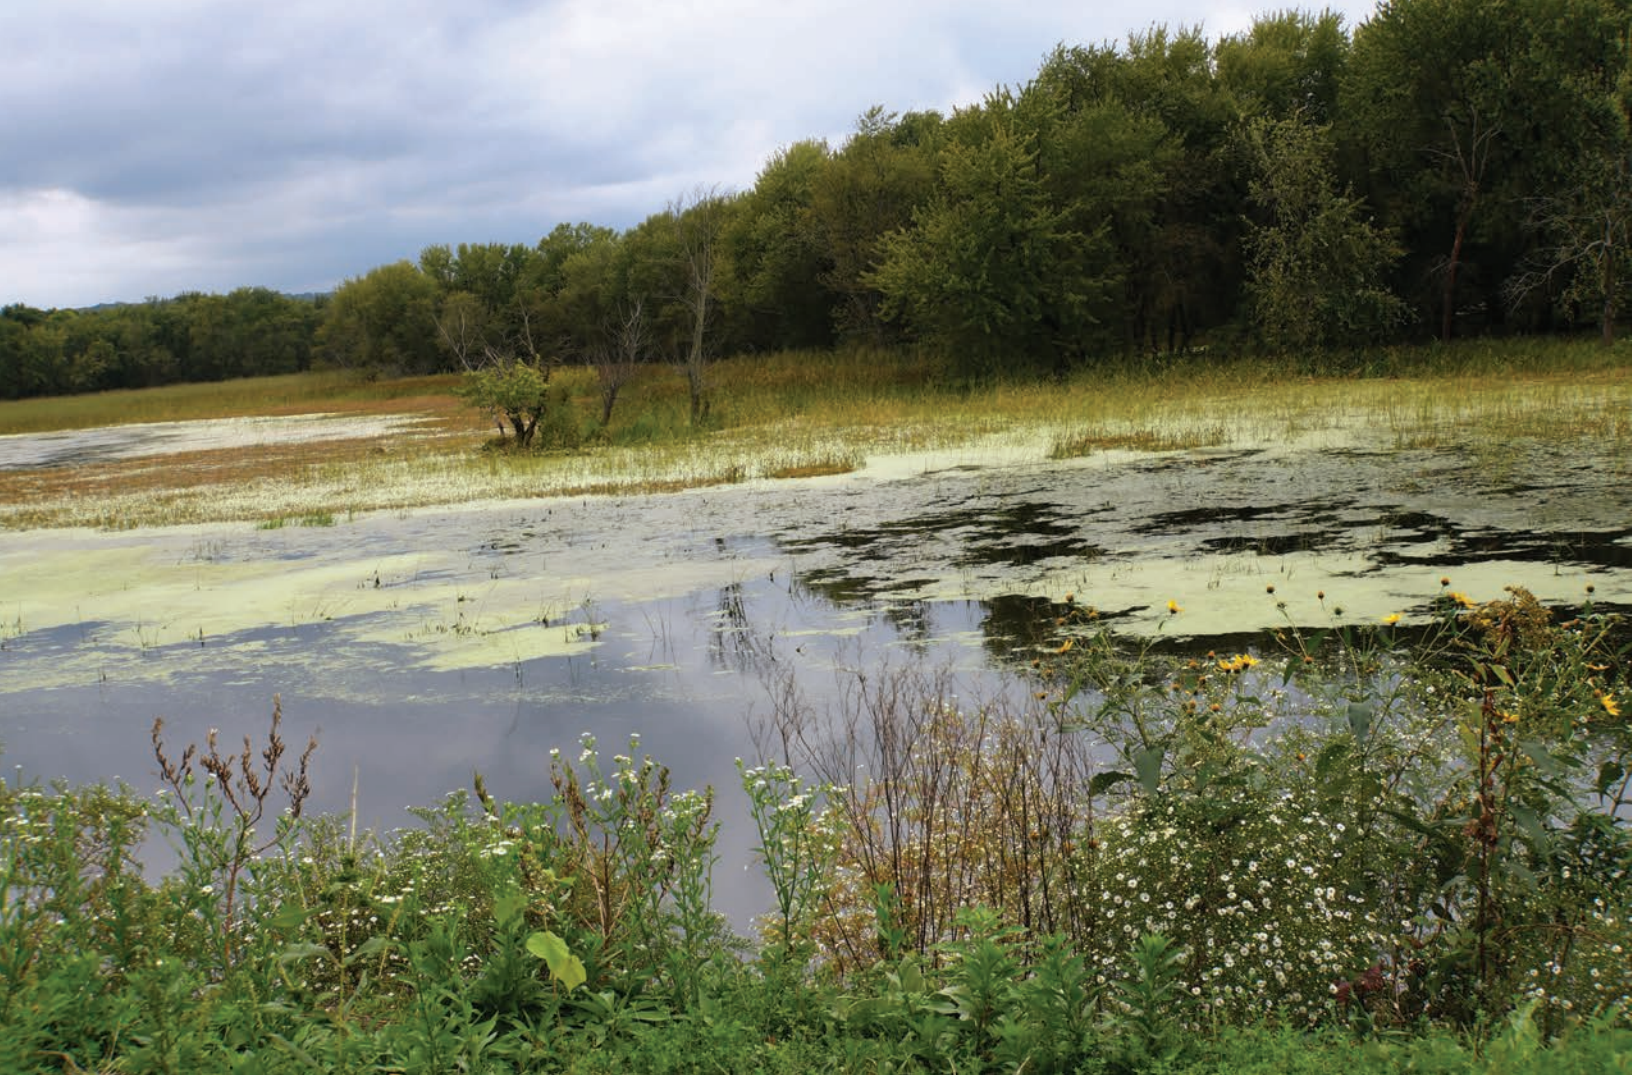
**FIGURE 21.10** The backwaters of the upper Mississippi River south of Lake Pepin on the Illinois side form an extensive wetland complex that protects the river ecology and provides recreational hunting, fishing, and boating opportunities.

The locks and dams on the upper Mississippi River have created lakes and extensive marshes, swamps, open sloughs, and backwater sloughs that provide natural habitats for a wide variety of wildlife (figure 21.10). More than 125 species of fish and 30 species of freshwater mussels live in the reaches of the upper

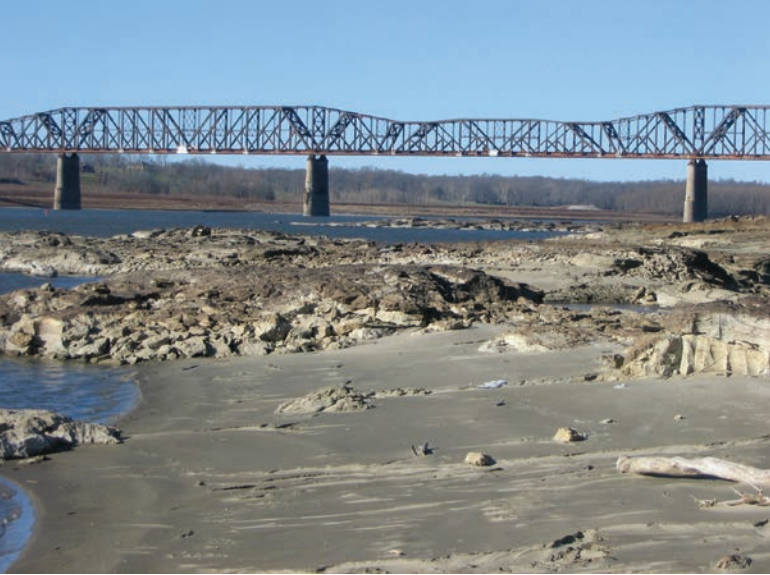
**FIGURE 22.1** Bedrock was exposed and a threat to navigation on the Mississippi River near the Thebes railroad bridge on December 21, 2012, when the river reached a low of seven feet.

the upland bedrock ridge and rerouted the ancient Mississippi River through, rather than around, the upland bedrock ridge (map 22.1) of the former southern Illinois land bridge (see map 2.6). Throughout the summer of 2012, as the drought deepened and river levels fell, the USACE increased the removal of sand and other unconsolidated sediments along the upper Mississippi navigation channel. The six-mile fractured bedrock-lined channel, starting just south of Gale, Illinois, and extending past Thebes, Illinois, to Commerce, Missouri, and the underlying river bottom materials required substantive excavating of rock as the narrow bedrock channel under drought conditions became shallow with hidden and exposed rock (figure 22.1), a dangerous obstacle to barge and other boat traffic.

Funds were appropriated in 2012 to begin dredging of the bedrock-lined Mississippi River channel near Thebes, Illinois. The USACE usually dredges alluvial and outwash sediment with specialized equipment, such as a hydraulic dredge, a crane, or a backhoe, to maintain a 300-foot wide and 9-foot deep shipping channel. However, there was great concern as to whether these techniques would work in the Thebes Gap section of the Mississippi River channel. The six mile section of the Mississippi River channel, two miles to the north of the 1905 Thebes railroad bridge and four miles to the south, is underlain with fractured bedrock with the distance between the Illinois and Missouri bedrock-controlled escarpment only 4,000 feet and the river channel 2,000 feet wide. There is very little bottomland since most of the area is occupied by the Mississippi River between the two bedrock uplands. With bedrock exposed on both sides of the channel and underlying the river (figure 22.1), dredging of rock is difficult (figure 22.2).

Five local railroads pooled their resources to build a permanent bridge. The bridge was designed by Ralph Modjeski, a famous bridge builder. The original design called for two railroad tracks that could be used at the same time and for an auto deck to be added at some point in time. The deck was never added, but the bridge was engineered to handle the extra weight. Due to this extra strength and solid bedrock foundation, this bridge was long known as the strongest bridge to span the Mississippi River. Bridge abutments were made out of reinforced concrete and anchored into the bedrock escarpment (figure 22.4) on both valley walls (figure 22.5) and at the river bottom. The bridge structure is located at river mile marker 42.7. The normal river elevation is 308 feet at Thebes, and the bridge is 104 feet above the river. The total length of the bridge is 4,000 feet, with the longest span across the shipping channel of 651 feet. Unfortunately, the 1905 bridge streamlined the flow of rail traffic, and the trains no longer had a reason to stop at Thebes. As a consequence, Thebes experienced hard times, and the population declined rapidly. The two track bridge stands today (figure 22.1) and still handles 35 trains per day after more than 110 years of service.

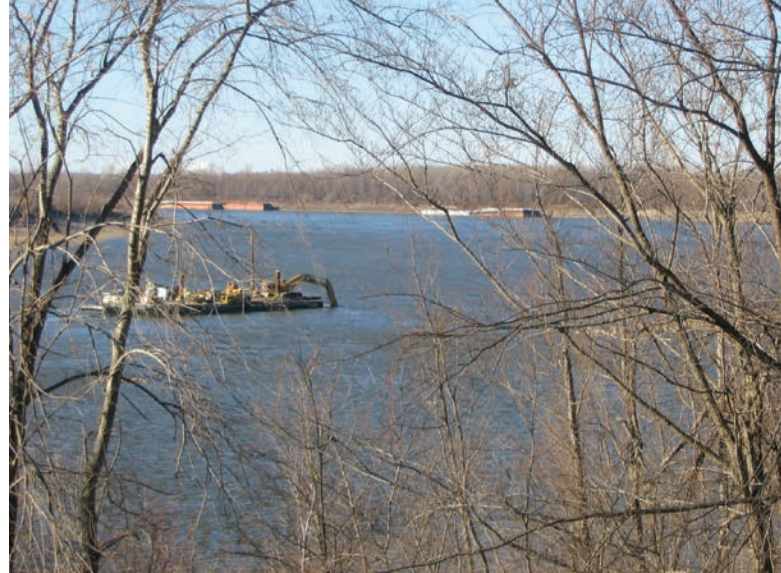
**FIGURE 22.2** River bottom bedrock is dredged using an excavator to increase the navigation depth.

two separate locations on December 18, 2012, to begin the 30- to 45-day dredging process (figure 22.2). It was anticipated that explosives would be required to loosen some of the attached rock prior to removal. However, giant excavators proved to effectively loosen and remove massive amounts of bedrock and rock materials without the need for explosives. The rocks were removed using spud barges and a hydrohammer (a huge aquatic jackhammer) to break up bigger chunks of rock for removal by the giant excavators [4]. This technique was much faster than expected, and 75% of the project was completed by February 1, 2013. Excavation occurred during the daytime, and the Mississippi River remained open each night for barge traffic. By February, the river began to rise from increased runoff in the upper Mississippi, and the excavators could no longer reach and remove rock at the bottom of the shipping channel. The barges with these excavators were then moved 31 river miles north to remove additional rock from the shipping channel near Grand Tower, Illinois.

tion channel for barge traffic. The USACE successfully dredged (figure 22.2) other parts of the Mississippi River to keep the shipping channel open, but those channels were underlain with unconsolidated sediments (sands and alluvial materials) that could be removed with equipment routinely used to maintain the river depths and widths for navigation. However the dredging of the six-mile, narrow, bedrock-lined channel near the town of Thebes, Illinois, required large excavators capable of breaking loose the consolidated river bottom in order to deepen the channel. Without the dredging work by the USACE, the shipping on the Mississippi River would have stopped, possibly for months. The 9-foot deep and 300-foot wide Mississippi River channel was dredged at a time when the excavators could easily reach the bottom of the shipping lane and were able to restore and maintain the shipping lane for barge traffic as water levels dropped during the drought of 2012 to 2013.

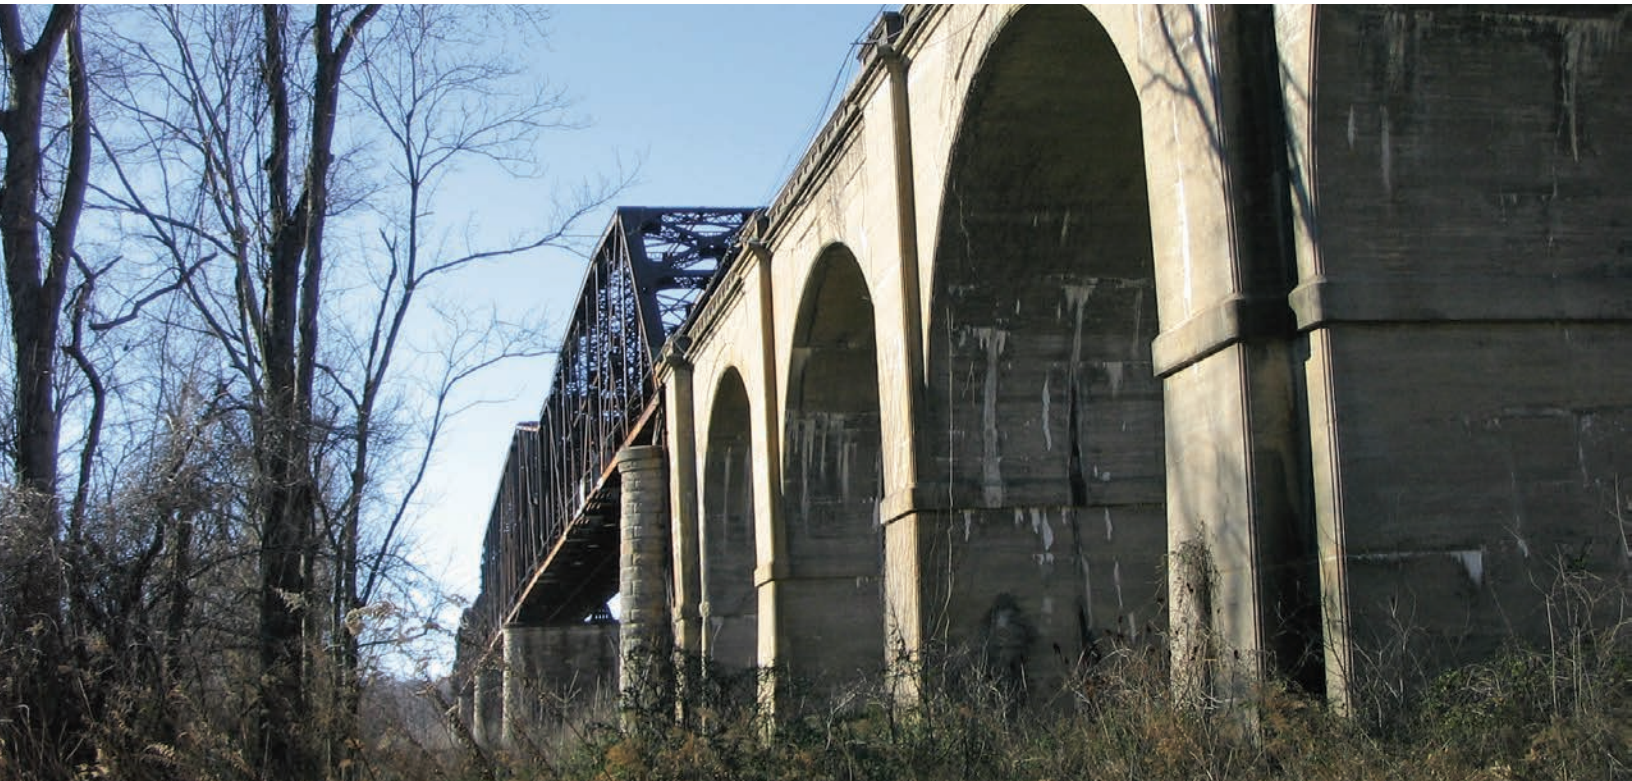
**FIGURE 22.4** The reinforced concrete, two-track railroad bridge was built in 1905 to connect Illinois to Missouri and enabled east-west commerce throughout the region.

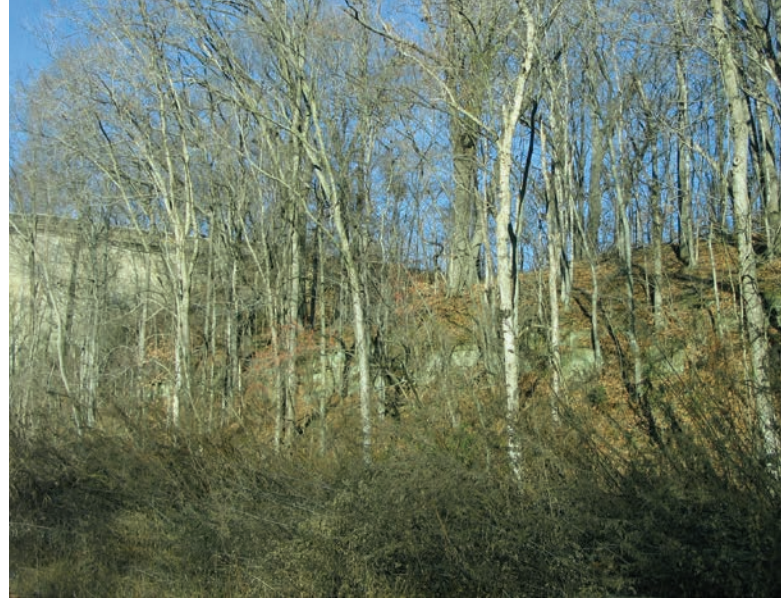
**FIGURE 22.5** Exposed valley wall bedrock at Thebes, Illinois, provided an anchor to the bridge abutment on the east side of the Mississippi River.

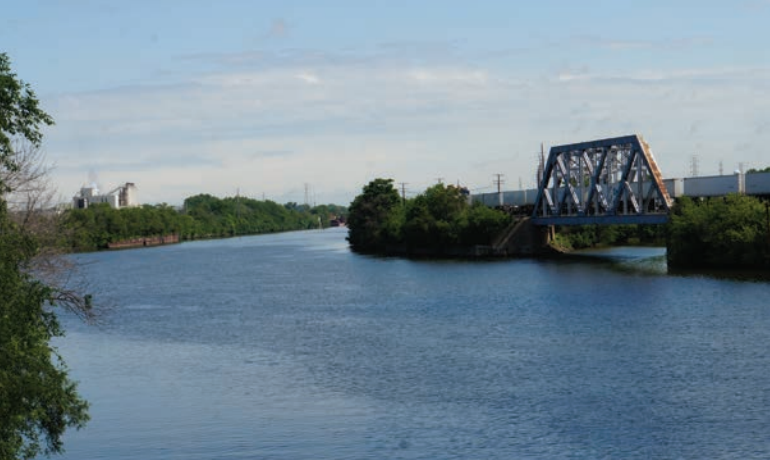
**FIGURE 23.2** The old Illinois and Michigan Canal (right) flows under a railroad bridge as it merges with the wider and deeper Chicago Sanitary and Ship Canal (left) just above the Des Plaines River.

replaced the Illinois and Michigan Canal with the wider and deeper Chicago Sanitary and Ship Canal (figure 23.2). A few years later, the Chicago Waterway system was expanded by the construction of two additional canals, the North Shore Channel in 1910 and the Calumet-Saganashkee Channel in 1922 (map 23.3).

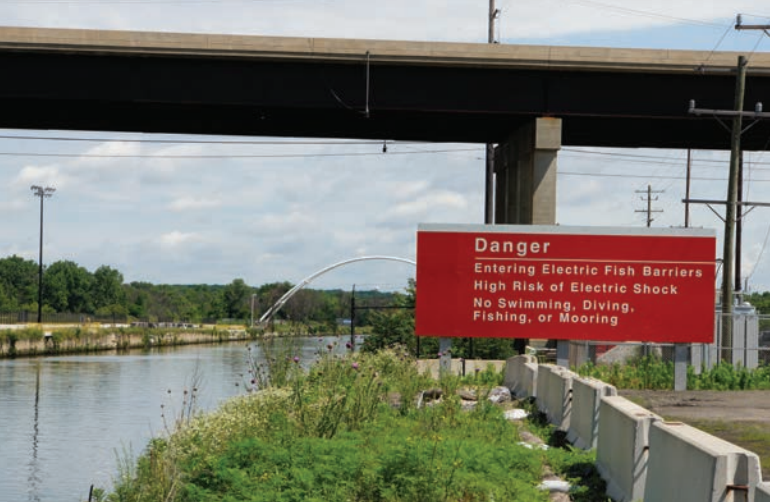
**FIGURE 23.4** Electric fish barriers constructed in the Chicago Sanitary and Ship Canal are designed to prevent invasive species of Asian carp from passing from the canal into Lake Michigan.

Three electric fish barriers have been built by the USACE to prevent Asian carp from entering Lake Michigan (figure 23.4). The Chicago Sanitary and Ship Canal was temporarily closed on December 2, 2009, after the USACE disclosed on November 20, 2009, that a single sample of Asian carp DNA had been found above the electric barrier (map 23.3). The USEPA and the Illinois Department of Natural Resources applied a fish poison, rotenone, in the water to kill any fish that had escaped north of the Lockport electric barrier. Inspection of the fish kill and two months of intensive commercial fishing and electrofishing did not find any Asian carp. Alarmed by the potential disaster of Asian carp in Lake Michigan, Michigan State Attorney General Mike Cox filed a lawsuit on December 21, 2009, with the

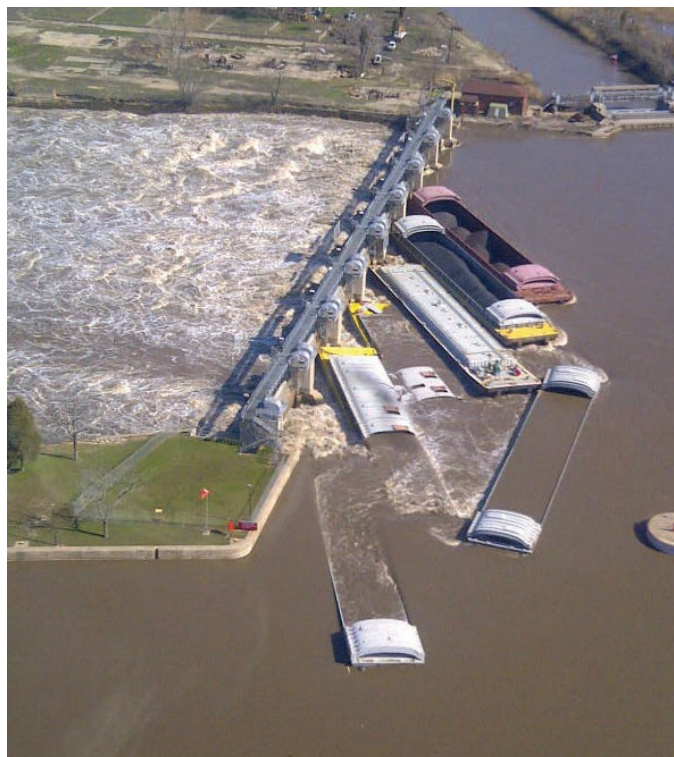
**FIGURE 23.5** Seven partially sunken barges at the Marseilles Dam blocked the flow of water and prevented the gates from fully opening to release floodwater in April of 2013. Photo credit: Major General John W. Peabody, commander of the Mississippi Valley Division, US Army Corps of Engineers, and president of the Mississippi River Commission.

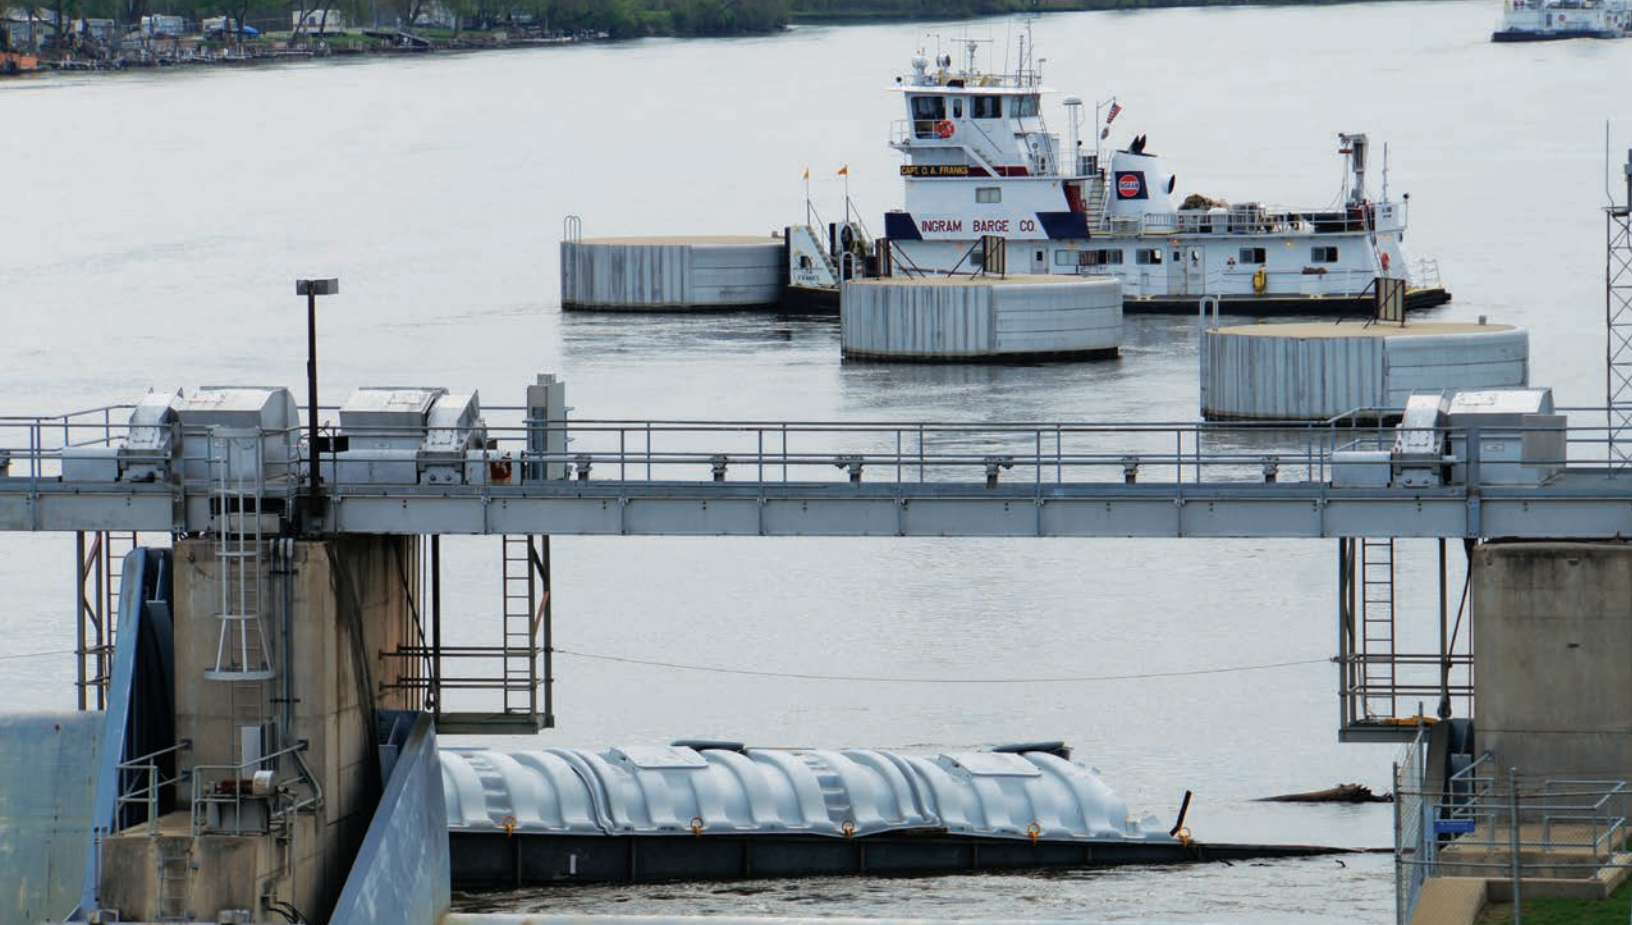
**FIGURE 23.6** A partially sunken barge in April of 2013 blocked the flow of floodwaters and damaged the Tainter gates that control the level of water in the pool behind the Marseilles Dam.

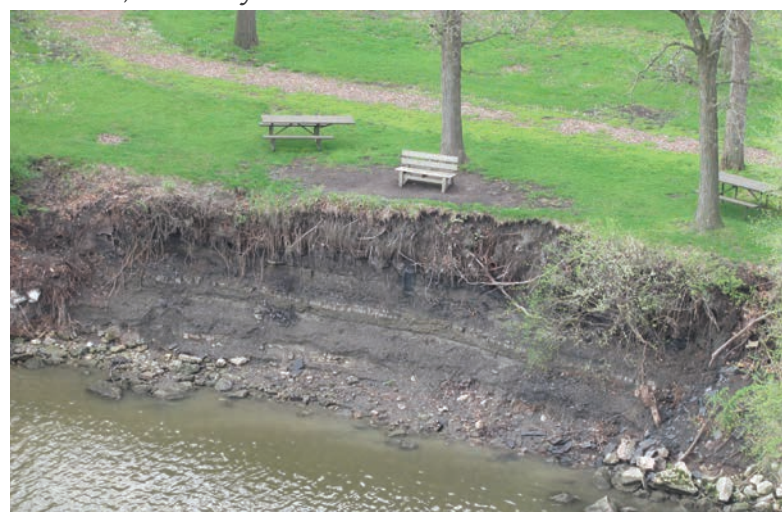
**FIGURE 23.7** Fast-moving floodwaters in the spring of 2013 deeply scoured the riverbank at Illini State Park.

housed in area hotels for weeks. The barge accident and 2013 flooding of Marseilles did some damage to parklands (figure 23.7), sidewalks, and roads. The greatest agricultural impact was the suspension of the shipping of fertilizers and grains. Damages to the dam structure reduced the capacity to manage the Marseilles water pool for navigation on the Illinois Waterway and to limit flooding in the town of Marseilles.

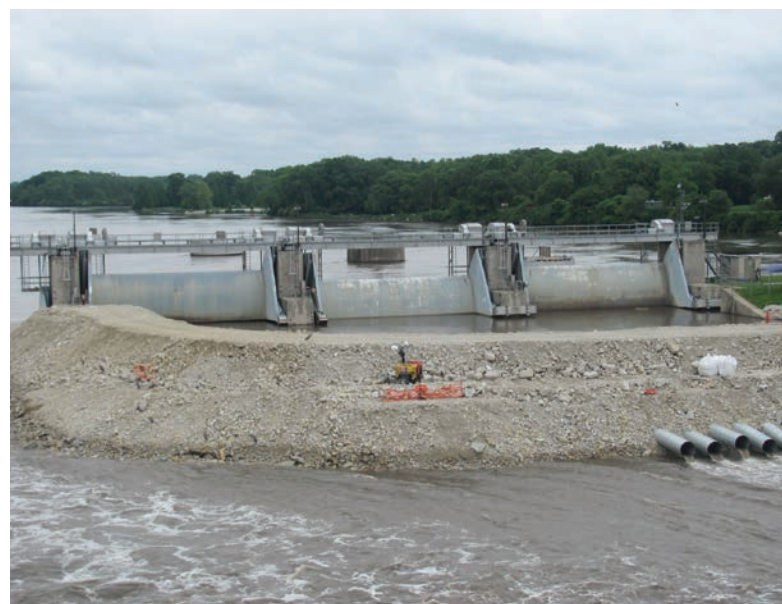
**FIGURE 23.10** The US Army Corps of Engineers constructed a dike and pond to temporarily manage the water pool behind the dam after the gates were damaged in April of 2013 at Marseilles.

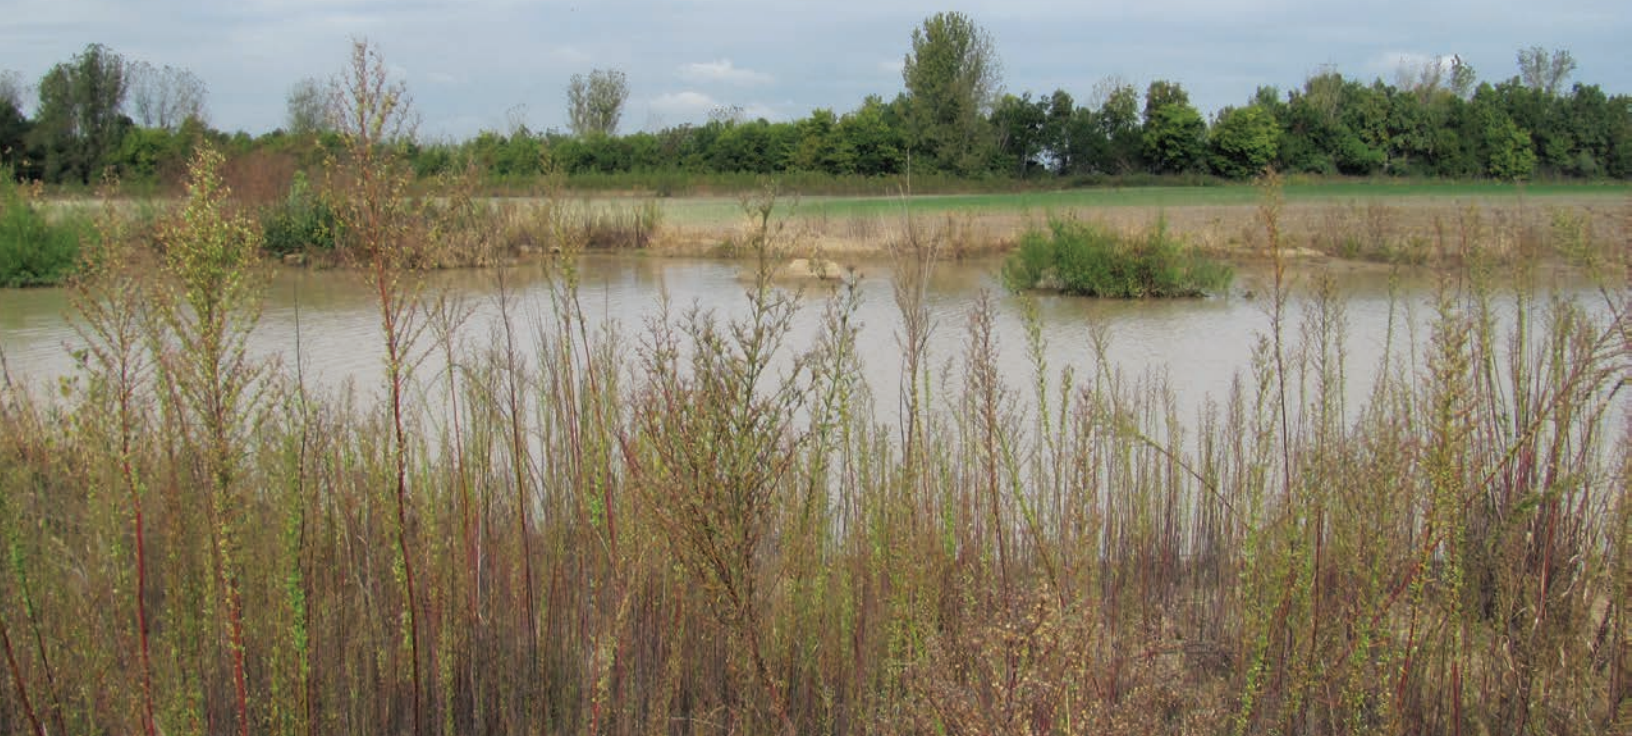
**FIGURE 24.3** Wetlands and ponds in the deep gullies of O'Bryan Ridge (October of 2013) replace a productive soybean field after the May of 2011 levee breach and flooding.

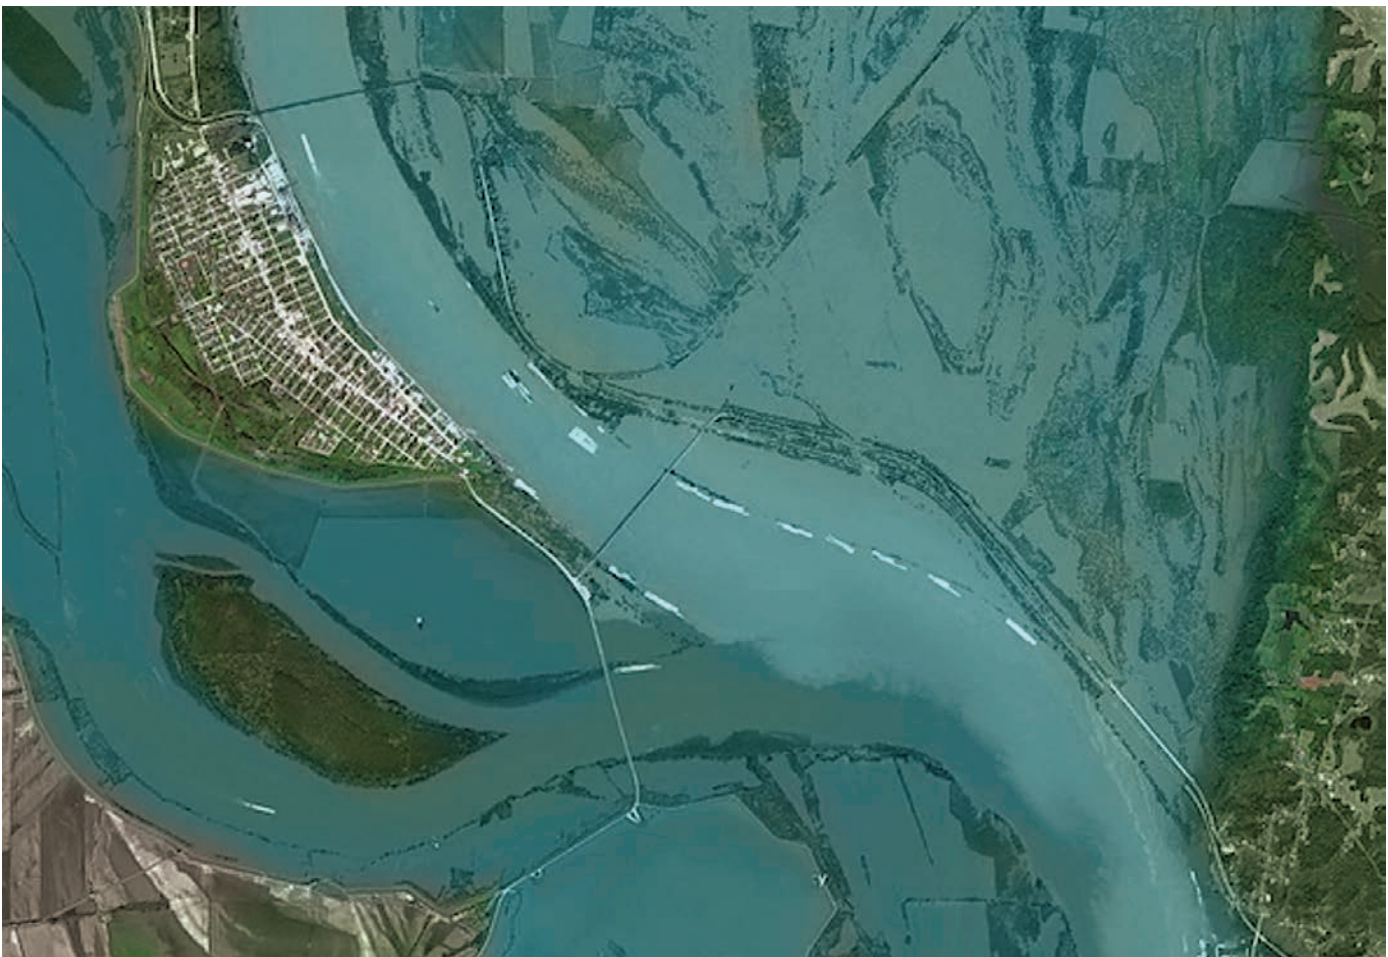
**FIGURE 25.1** The confluence of the Mississippi and Ohio rivers south of Cairo, Illinois, during the flood of 2011 was more than five miles wide and inundated bottomlands in Kentucky, Missouri, and Illinois.
